# Peace River Streambank Restoration and Myakka River Watershed Threats Assessment and Fish Assemblage Monitoring

Final Report 1 July 2019 – 31 March 2023  
State Wildlife Grant 2953 – PID 9100 250 2953

Submitted to Florida State Wildlife Grants Program  
1 June 2023

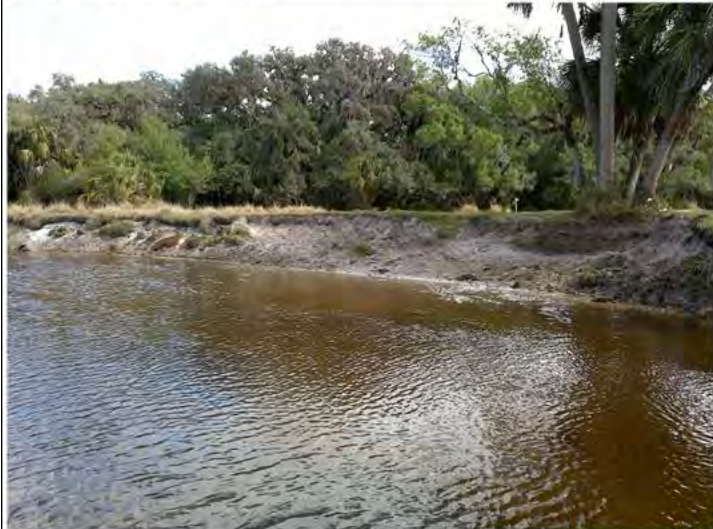
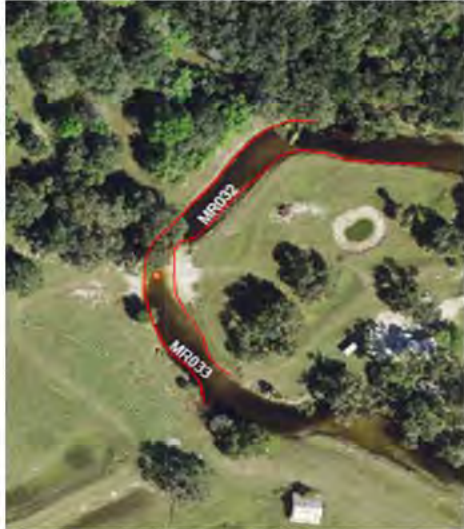
Risk Factor	Ranking	Score	Restoration Option 2
Pfankuch-Channel Stability:	Poor	1.5	
Channel Alteration:	None	0	
Bank Erosion:	Mass-Wasting	1.5	
BEHI:	High (38.27)	1	
Local NPSP:	Obvious Sources	1.5	
Shoring Structures:	None	0	Additional Site Features
Pipe Discharge:	Not Present	0	Stream Channel Woody Material: Infrequent
Water Odor:	Normal	0	Impoundments: Manmade (Ford)
Fish Passage Barrier:	Not Present	0	Substrate Composition: Fine sand
RB: Riparian Buffer (ft.):	0	0.75	Bank Material: Sand
LB: Riparian Buffer (ft.):	50	0.5	Near Bank Stress: Moderate
RB: Floodplain Access:	Full	0	Livestock Access: Yes
LB: Floodplain Access:	Full	0	RB Landuse: Pasture, Natural Forest, Residential

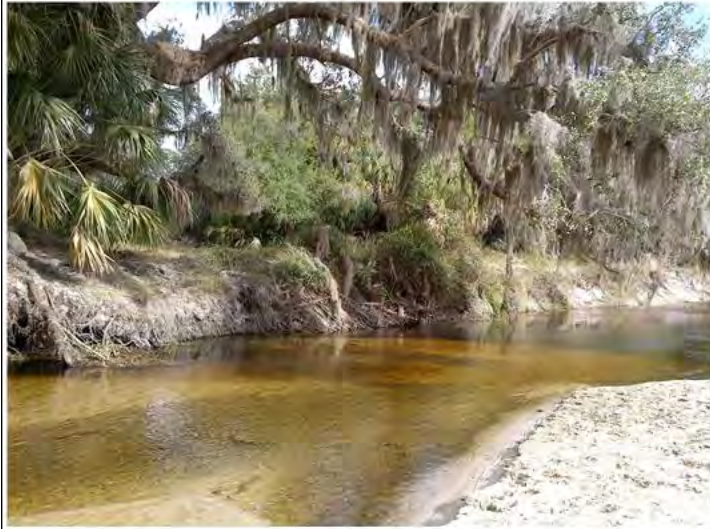
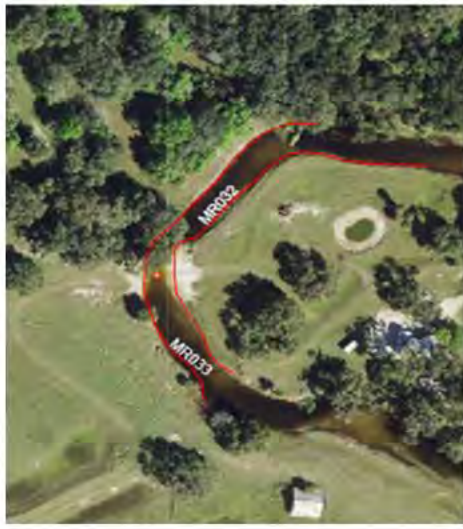
<b>Risk Factor</b>	<b>Ranking</b>	<b>Score</b>	<b>Restoration Option 2</b>
Pfankuch-Channel Stability:	Poor	1.5	
Channel Alteration:	None	0	
Bank Erosion:	Active Erosion	1	
BEHI:	High (37.89)	1	
Local NPSP:	Obvious Sources	1.5	
Shoring Structures:	None	0	
Pipe Discharge:	Not Present	0	
Water Odor:	Normal	0	
Fish Passage Barrier:	Not Present	0	
RB: Riparian Buffer (ft.):	0	0.75	
LB: Riparian Buffer (ft.):	25	0.75	
RB: Floodplain Access:	Full	0	
LB: Floodplain Access:	Full	0	
<b>Severity Scale:</b>		<b>6.5</b>	<b>Additional Site Features</b>
			Stream Channel Woody Material: Infrequent
			Impoundments: Manmade (Ford)
			Substrate Composition: Fine sand
			Bank Material: Sand

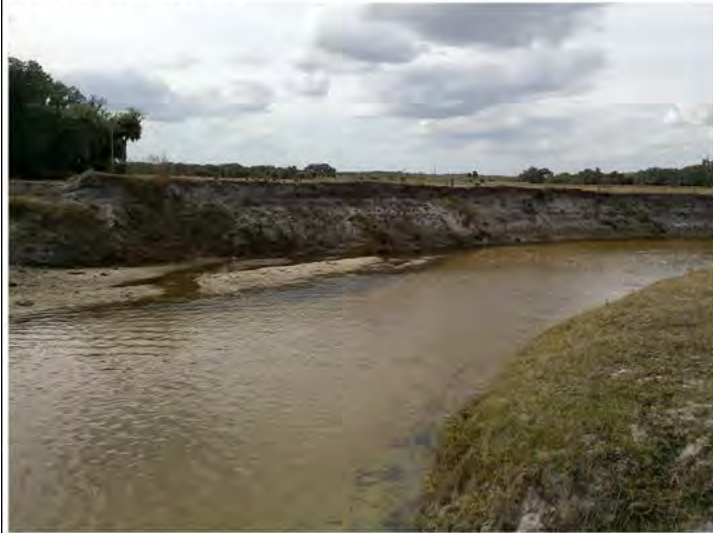
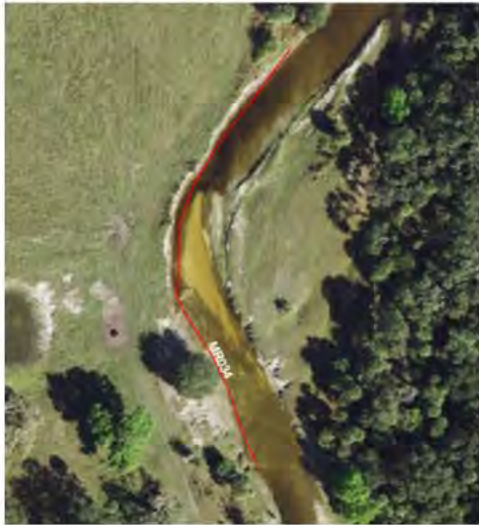
Risk Factor	Ranking	Score	Restoration Option 1
Pfankuch-Channel Stability:	Poor	1.5	
Channel Alteration:	None	0	
Bank Erosion:	Mass-Wasting	1.5	
BEHI:	Extreme (50.65)	1.5	
Local NPSP:	Obvious Sources	1.5	
			Additional Site Features
Shoring Structures:	None	0	Stream Channel Woody Material: Infrequent
Pipe Discharge:	Not Present	0	Impoundments: None
Water Odor:	Normal	0	Substrate Composition: Fine sand
Fish Passage Barrier:	Not Present	0	Bank Material: Sand
RB: Riparian Buffer (ft.):	0	0.75	Near Bank Stress: Moderate
LB: Riparian Buffer (ft.):	0	0.75	Livestock Access: Yes
RB: Floodplain Access:	Full	0	RB Landuse: Pasture and Natural Forest
LB: Floodplain Access:	Full	0	LB Landuse: Pasture and Natural Forest

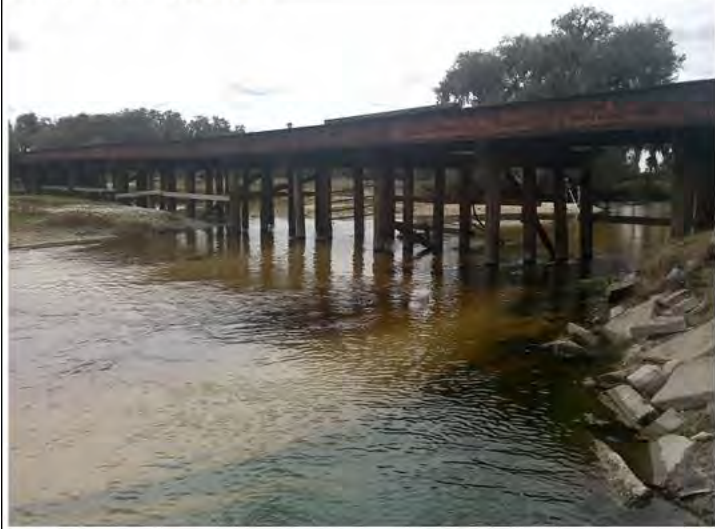
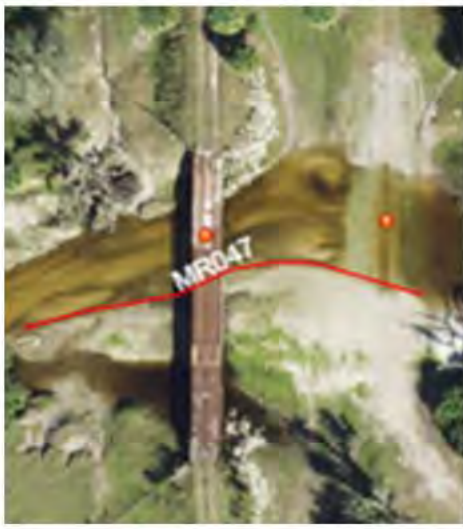
Risk Factor	Ranking	Score	<b>Restoration Option 2</b>  <b>Additional Site Features</b> Stream Channel Woody Material: Infrequent Impoundments: Manmade (ford + bridge) Substrate Composition: Fine sand, Cobble Bank Material: Sand Near Bank Stress: Very low Livestock Access: Yes RB Landuse: Pasture and Natural Forest LB Landuse: Pasture and Natural Forest
Pfankuch-Channel Stability:	Poor	1.5	
Channel Alteration:	None	0	
Bank Erosion:	Active Erosion	1	
BEHI:	Very High (40.55)	1.5	
Local NPSP:	Obvious Sources	1.5	
Shoring Structures:	Present (Riprap)	1.5	
Pipe Discharge:	Not Present	0	
Water Odor:	Normal	0	
Fish Passage Barrier:	Not Present	0	
RB: Riparian Buffer (ft.):	0	0.75

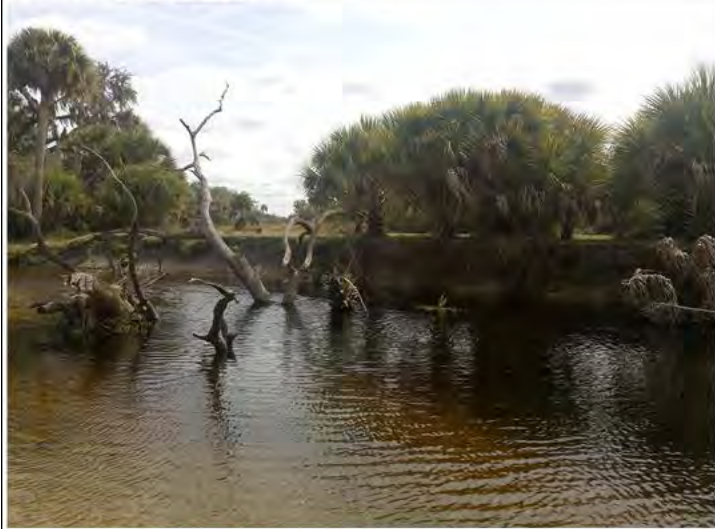
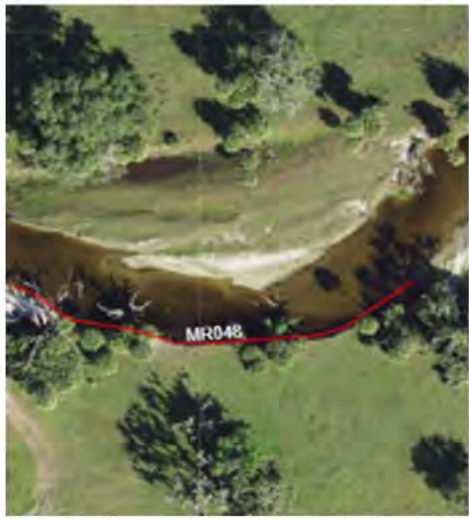
Risk Factor	Ranking	Score	Restoration Option 1
Pfankuch-Channel Stability:	Poor	1.5	
Channel Alteration:	None	0	
Bank Erosion:	Active Erosion	1	
BEHI:	Exteme (46.01)	1.5	
Local NPSP:	Obvious Sources	1.5	
Shoring Structures:	None	0	Additional Site Features
Pipe Discharge:	Not Present	0	Stream Channel Woody Material: Numerous
Water Odor:	Normal	0	Impoundments: None
Fish Passage Barrier:	Not Present	0	Substrate Composition: Fine sand
RB: Riparian Buffer (ft.):	25	0.75	Bank Material: Sand
LB: Riparian Buffer (ft.):	25	0.75	Near Bank Stress: High
RB: Floodplain Access:	Full	0	Livestock Access: Yes
LB: Floodplain Access:	Full	0	RB Landuse: Pasture and Natural Forest

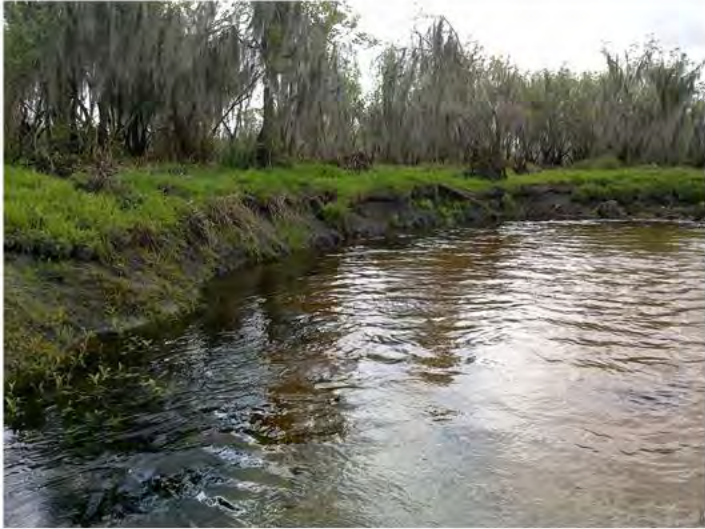
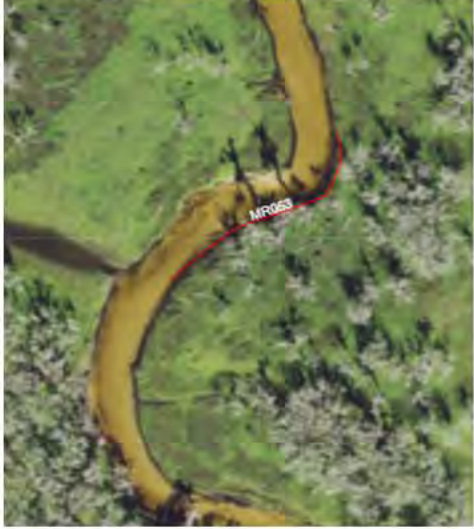
Risk Factor	Ranking	Score	Restoration Option 3
Pfankuch-Channel Stability:	Fair	1	
Channel Alteration:	None	0	
Bank Erosion:	Historic	0.5	
BEHI:	Very High (41.27)	1.5	
Local NPSP:	No Evidence	0	
Shoring Structures:	None	0	
Pipe Discharge:	Not Present	0	
			Additional Site Features
Water Odor:	Normal	0	Stream Channel Woody Material: Moderate
Fish Passage Barrier:	Not Present	0	Impoundments: None
RB: Riparian Buffer (ft.):	100	0	Substrate Composition: Medium Sand
LB: Riparian Buffer (ft.):	100	0	Bank Material: Sand
RB: Floodplain Access:	Full	0	Near Bank Stress: Moderate
LB: Floodplain Access:	Full	0	RB Landuse: Historic Pasture + Natural Forest
	<b>Severity Scale:</b>	<b>3</b>	LB Landuse: Historic Pasture + Natural Forest

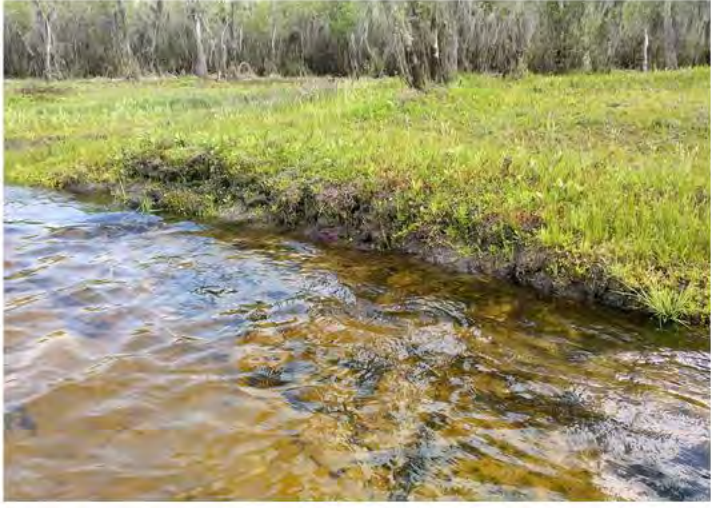
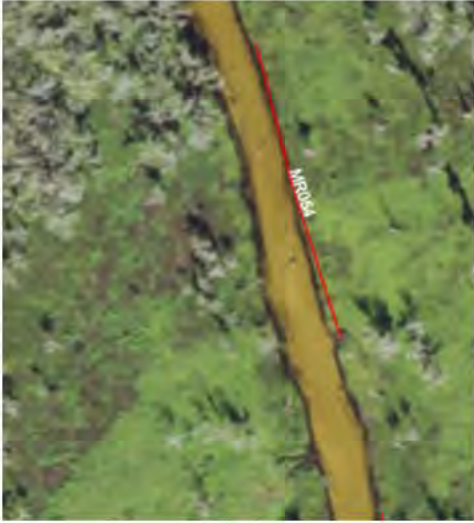
Risk Factor	Ranking	Score	Restoration Option 3
Pfankuch-Channel Stability:	Fair	1	
Channel Alteration:	None	0	
Bank Erosion:	Historic	0.5	
BEHI:	High (39.18)	1	
Local NPSP:	No Evidence	0	
Shoring Structures:	None	0	
Pipe Discharge:	Not Present	0	Additional Site Features
Water Odor:	Normal	0	Stream Channel Woody Material: Infrequent
Fish Passage Barrier:	Not Present	0	Impoundments: None
RB: Riparian Buffer (ft.):	100	0	Substrate Composition: Medium Sand
LB: Riparian Buffer (ft.):	100	0	Bank Material: Sand
RB: Floodplain Access:	Full	0	Near Bank Stress: Moderate
LB: Floodplain Access:	Full	0	RB Landuse: Historic Pasture + Natural Forest
<b>Severity Scale:</b>		<b>2.5</b>	LB Landuse: Historic Pasture + Natural Forest

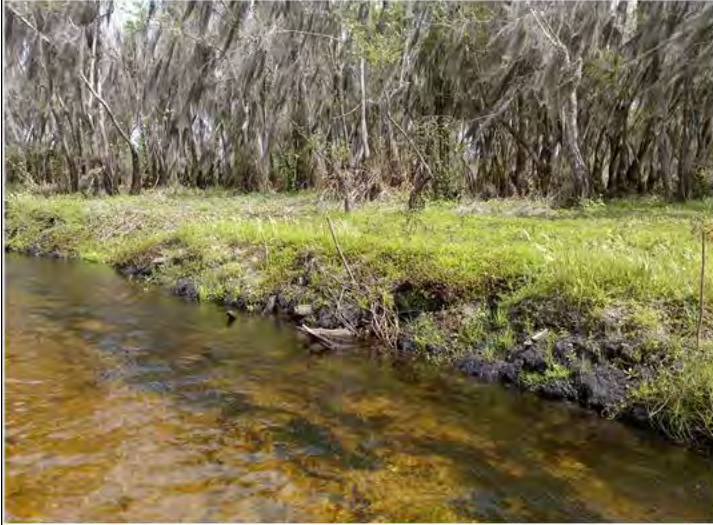
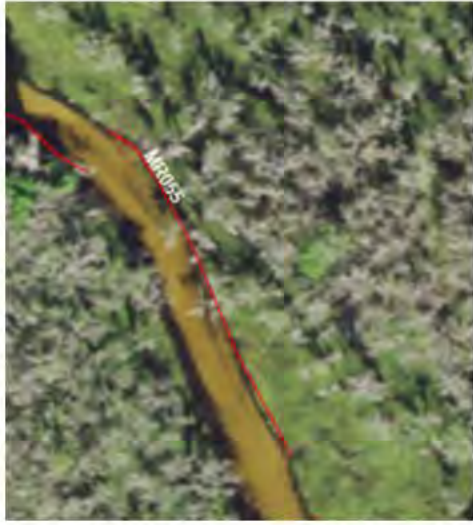
Risk Factor	Ranking	Score	Restoration Option 3
Pfankuch-Channel Stability:	Fair	1	
Channel Alteration:	None	0	
Bank Erosion:	Historic	0.5	
BEHI:	High (37.12)	1	
Local NPSP:	No Evidence	0	
Shoring Structures:	None	0	
Pipe Discharge:	Not Present	0	Additional Site Features
Water Odor:	Normal	0	Stream Channel Woody Material: Moderate
Fish Passage Barrier:	Not Present	0	Impoundments: None
RB: Riparian Buffer (ft.):	100	0	Substrate Composition: Medium Sand
LB: Riparian Buffer (ft.):	100	0	Bank Material: Sand
RB: Floodplain Access:	Full	0	Near Bank Stress: Moderate
LB: Floodplain Access:	Full	0	RB Landuse: Historic Pasture + Natural Forest
<b>Severity Scale:</b>		<b>2.5</b>	LB Landuse: Historic Pasture + Natural Forest

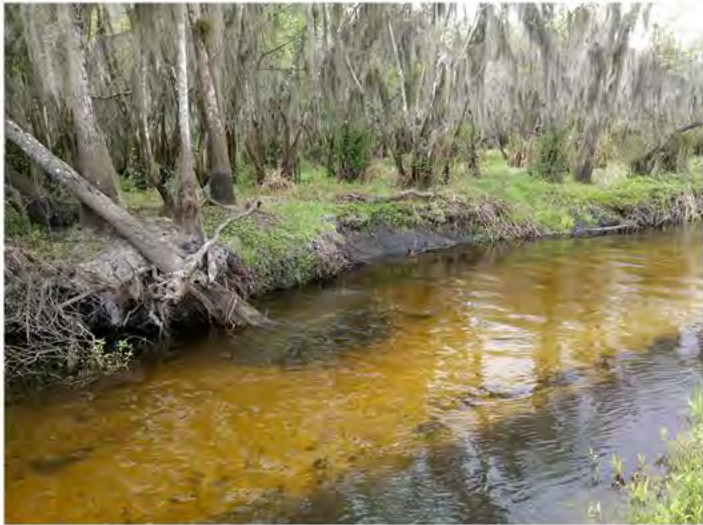
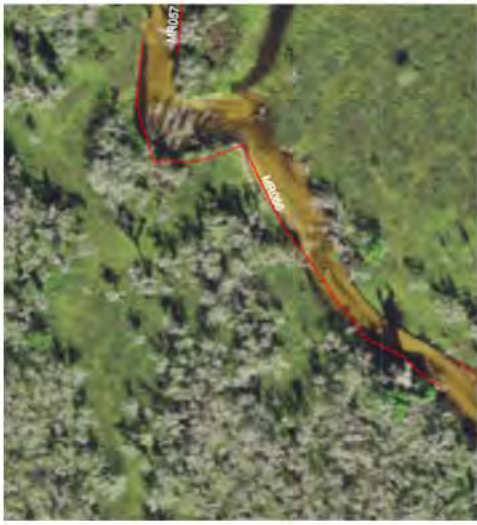
Risk Factor	Ranking	Score	Restoration Option 3
Pfankuch-Channel Stability:	Fair	1	
Channel Alteration:	None	0	
Bank Erosion:	Historic	0.5	
BEHI:	Very High (40.13)	1.5	
Local NPSP:	No Evidence	0	
Shoring Structures:	None	0	
Pipe Discharge:	Not Present	0	
			Additional Site Features
Water Odor:	Normal	0	Stream Channel Woody Material: Moderate
Fish Passage Barrier:	Not Present	0	Impoundments: None
RB: Riparian Buffer (ft.):	100	0	Substrate Composition: Medium Sand
LB: Riparian Buffer (ft.):	100	0	Bank Material: Sand
RB: Floodplain Access:	Full	0	Near Bank Stress: Moderate
LB: Floodplain Access:	Full	0	RB Landuse: Historic Pasture + Natural Forest
	<b>Severity Scale:</b>	<b>3</b>	LB Landuse: Historic Pasture + Natural Forest

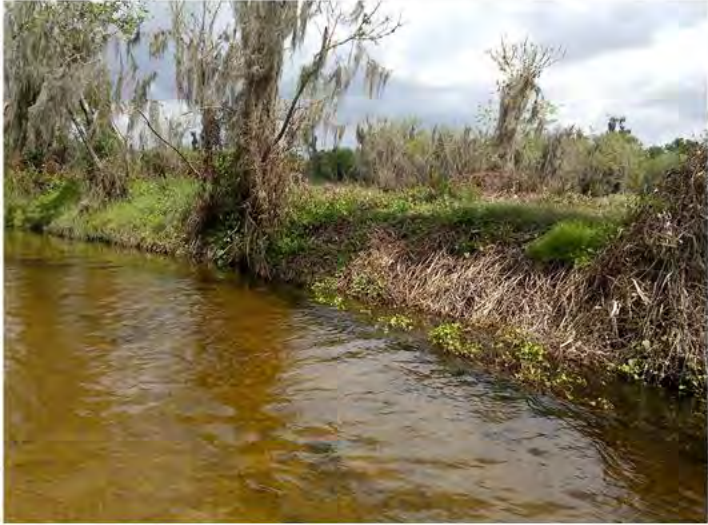
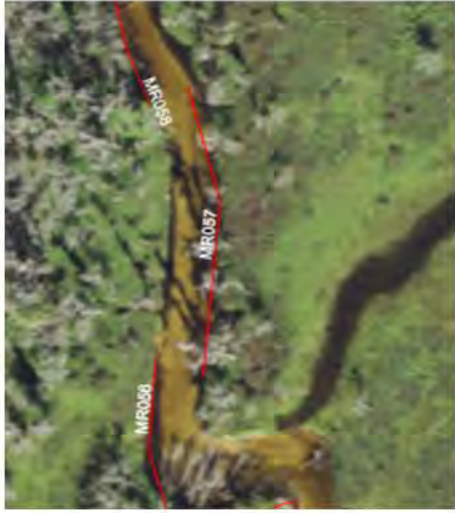
Risk Factor	Ranking	Score	Restoration Option 3
Pfankuch-Channel Stability:	Fair	1	
Channel Alteration:	None	0	
Bank Erosion:	Historic	0.5	
BEHI:	High (38.52)	1	
Local NPSP:	No Evidence	0	
Shoring Structures:	None	0	
Pipe Discharge:	Not Present	0	Additional Site Features
Water Odor:	Normal	0	Stream Channel Woody Material: Moderate
Fish Passage Barrier:	Not Present	0	Impoundments: None
RB: Riparian Buffer (ft.):	100	0	Substrate Composition: Medium Sand
LB: Riparian Buffer (ft.):	100	0	Bank Material: Sand
RB: Floodplain Access:	Full	0	Near Bank Stress: Moderate
LB: Floodplain Access:	Full	0	RB Landuse: Historic Pasture + Natural Forest
<b>Severity Scale:</b>		<b>2.5</b>	LB Landuse: Historic Pasture + Natural Forest

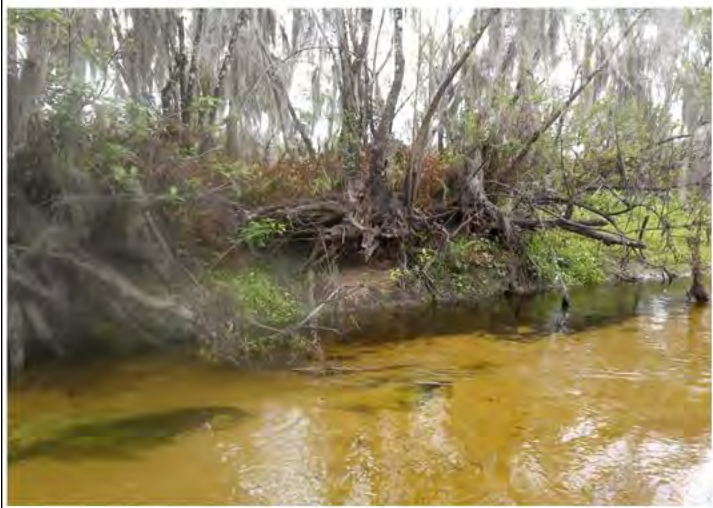
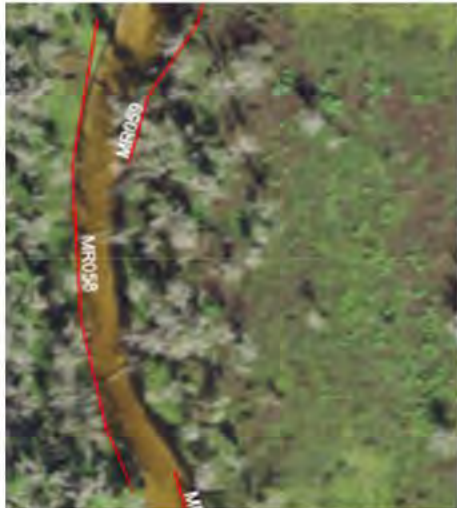
Risk Factor	Ranking	Score	Restoration Option 3
Pfankuch-Channel Stability:	Fair	1	
Channel Alteration:	None	0	
Bank Erosion:	Historic	0.5	
BEHI:	Very High (43.75)	1.5	
Local NPSP:	No Evidence	0	
Shoring Structures:	None	0	
			Additional Site Features
Pipe Discharge:	Not Present	0	Stream Channel Woody Material: Moderate
Water Odor:	Normal	0	Impoundments: None
Fish Passage Barrier:	Not Present	0	Substrate Composition: Medium Sand
RB: Riparian Buffer (ft.):	100	0	Bank Material: Sand
LB: Riparian Buffer (ft.):	100	0	Near Bank Stress: Moderate
RB: Floodplain Access:	Full	0	RB Landuse: Historic Pasture + Natural Forest
LB: Floodplain Access:	Full	0	LB Landuse: Historic Pasture + Natural Forest
		<b>Severity Scale:</b>	<b>3</b>

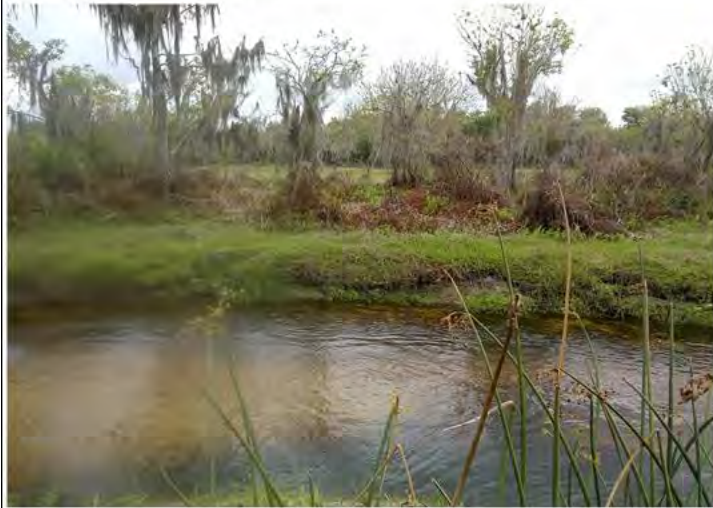
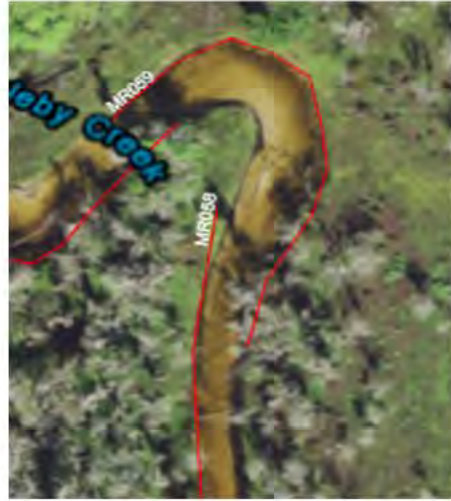
Risk Factor	Ranking	Score	Restoration Option 3
Pfankuch-Channel Stability:	Fair	1	
Channel Alteration:	None	0	
Bank Erosion:	Historic	0.5	
BEHI:	High (38.02)	1	
Local NPSP:	No Evidence	0	
Shoring Structures:	None	0	
Pipe Discharge:	Not Present	0	Additional Site Features
Water Odor:	Normal	0	Stream Channel Woody Material: Infrequent
Fish Passage Barrier:	Not Present	0	Impoundments: None
RB: Riparian Buffer (ft.):	100	0	Substrate Composition: Medium Sand
LB: Riparian Buffer (ft.):	100	0	Bank Material: Sand
RB: Floodplain Access:	Full	0	Near Bank Stress: High
LB: Floodplain Access:	Full	0	RB Landuse: Historic Pasture + Natural Forest
<b>Severity Scale:</b>		<b>2.5</b>	LB Landuse: Historic Pasture + Natural Forest

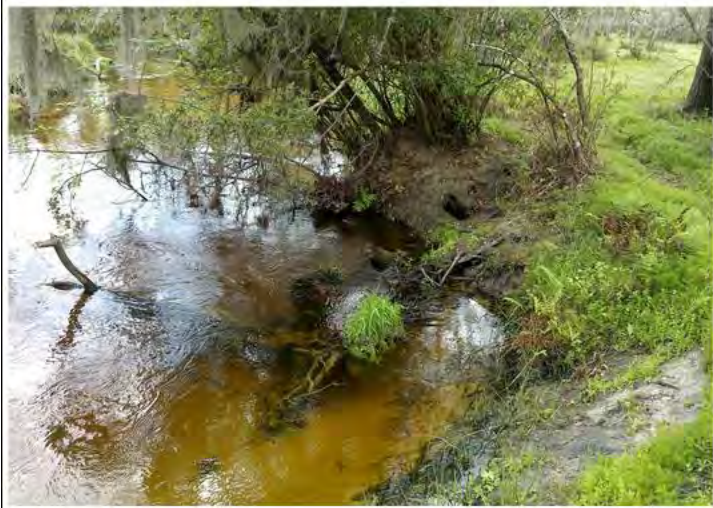
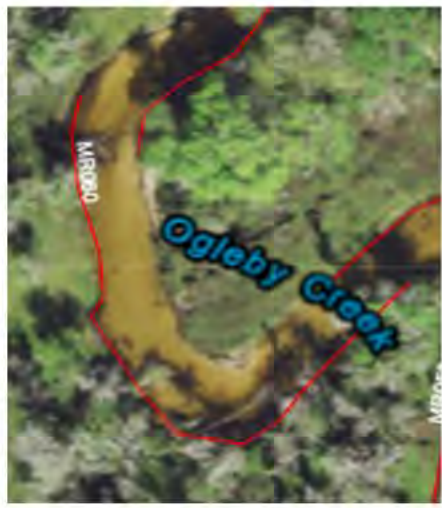
Risk Factor	Ranking	Score	Restoration Option 3
Pfankuch-Channel Stability:	Fair	1	
Channel Alteration:	None	0	
Bank Erosion:	Historic	0.5	
BEHI:	High (38.38)	1	
Local NPSP:	No Evidence	0	
Shoring Structures:	None	0	
Pipe Discharge:	Not Present	0	Additional Site Features
Water Odor:	Normal	0	Stream Channel Woody Material: Moderate
Fish Passage Barrier:	Not Present	0	Impoundments: None
RB: Riparian Buffer (ft.):	100	0	Substrate Composition: Medium Sand
LB: Riparian Buffer (ft.):	100	0	Bank Material: Sand
RB: Floodplain Access:	Full	0	Near Bank Stress: High
LB: Floodplain Access:	Full	0	RB Landuse: Historic Pasture + Natural Forest
<b>Severity Scale:</b>		<b>2.5</b>	LB Landuse: Historic Pasture + Natural Forest

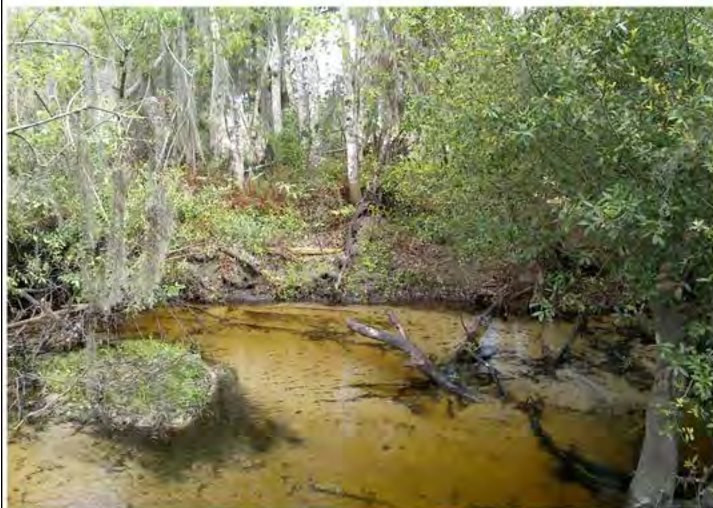
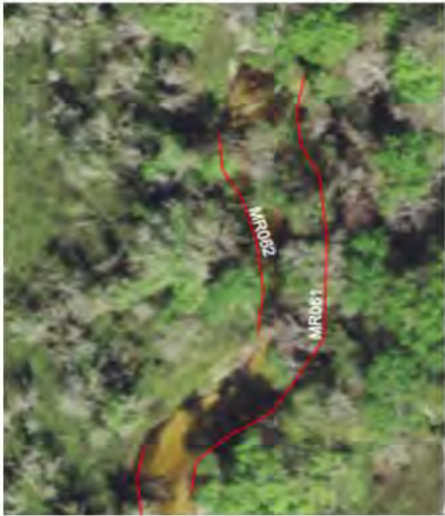
Risk Factor	Ranking	Score	Restoration Option 3
Pfankuch-Channel Stability:	Fair	1	
Channel Alteration:	None	0	
Bank Erosion:	Historic	0.5	
BEHI:	High (37.44)	1	
Local NPSP:	No Evidence	0	
Shoring Structures:	None	0	
Pipe Discharge:	Not Present	0	Additional Site Features
Water Odor:	Normal	0	Stream Channel Woody Material: Numerous
Fish Passage Barrier:	Not Present	0	Impoundments: None
RB: Riparian Buffer (ft.):	100	0	Substrate Composition: Medium Sand
LB: Riparian Buffer (ft.):	100	0	Bank Material: Sand
RB: Floodplain Access:	Full	0	Near Bank Stress: Moderate
LB: Floodplain Access:	Full	0	RB Landuse: Historic Pasture + Natural Forest
<b>Severity Scale:</b>		<b>2.5</b>	LB Landuse: Historic Pasture + Natural Forest

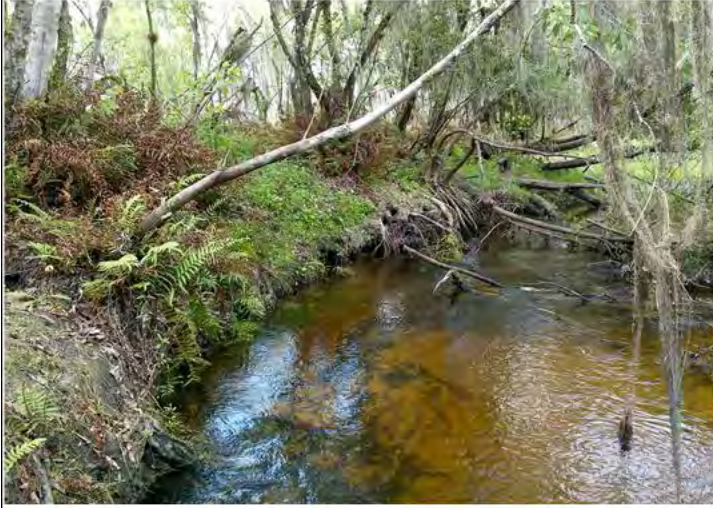
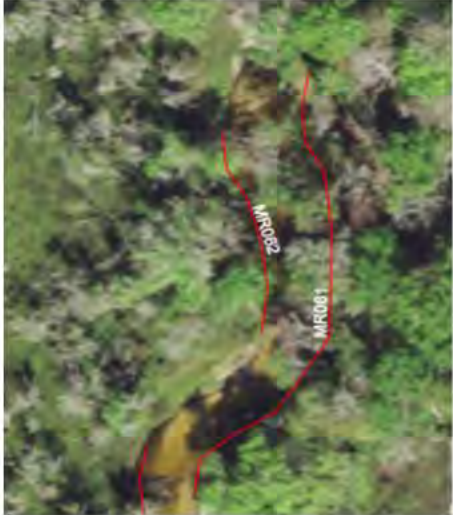
Risk Factor	Ranking	Score	Restoration Option 3
Pfankuch-Channel Stability:	Fair	1	
Channel Alteration:	None	0	
Bank Erosion:	Historic	0.5	
BEHI:	Very High (45.33)	1.5	
Local NPSP:	No Evidence	0	
Shoring Structures:	None	0	
Pipe Discharge:	Not Present	0	
			Additional Site Features
Water Odor:	Normal	0	Stream Channel Woody Material: Numerous
Fish Passage Barrier:	Not Present	0	Impoundments: None
RB: Riparian Buffer (ft.):	100	0	Substrate Composition: Medium Sand
LB: Riparian Buffer (ft.):	100	0	Bank Material: Sand
RB: Floodplain Access:	Full	0	Near Bank Stress: Low
LB: Floodplain Access:	Full	0	RB Landuse: Historic Pasture + Natural Forest
	<b>Severity Scale:</b>	<b>3</b>	LB Landuse: Historic Pasture + Natural Forest

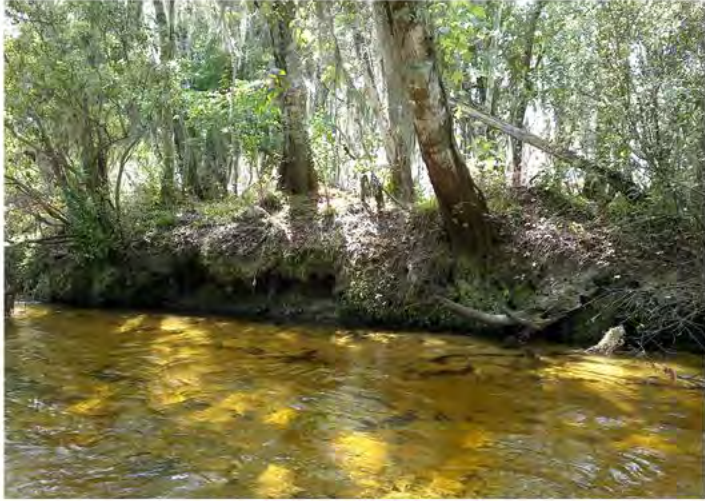
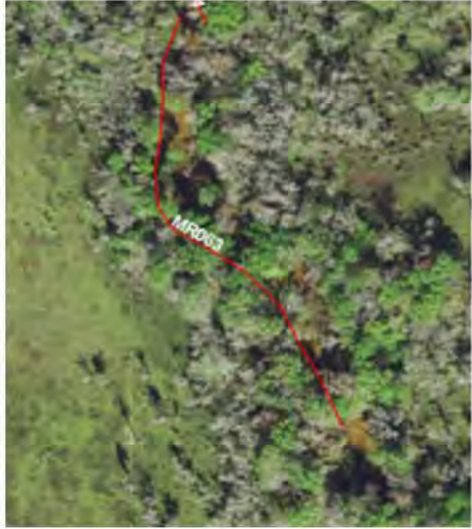
Risk Factor	Ranking	Score	Restoration Option 3
Pfankuch-Channel Stability:	Fair	1	
Channel Alteration:	None	0	
Bank Erosion:	Historic	0.5	
BEHI:	Very High (42.19)	1.5	
Local NPSP:	No Evidence	0	
Shoring Structures:	None	0	
Pipe Discharge:	Not Present	0	Additional Site Features
Water Odor:	Normal	0	Stream Channel Woody Material: Numerous
Fish Passage Barrier:	Not Present	0	Impoundments: None
RB: Riparian Buffer (ft.):	100	0	Substrate Composition: Medium Sand
LB: Riparian Buffer (ft.):	100	0	Bank Material: Sand
RB: Floodplain Access:	Full	0	Near Bank Stress: Moderate
LB: Floodplain Access:	Full	0	RB Landuse: Historic Pasture + Natural Forest
		<b>Severity Scale:</b>	LB Landuse: Historic Pasture + Natural Forest

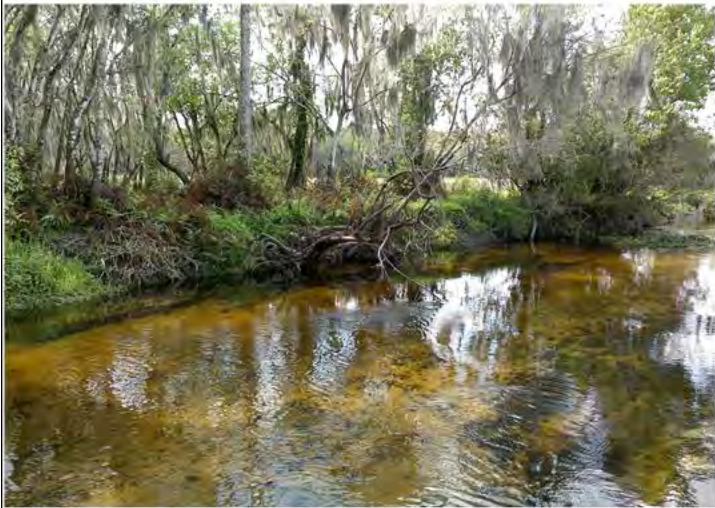
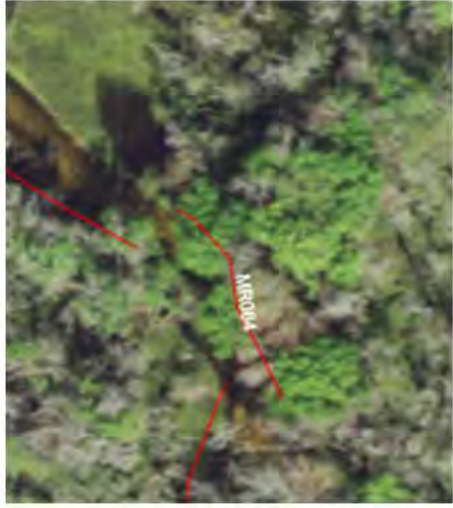
Risk Factor	Ranking	Score	Restoration Option 3
Pfankuch-Channel Stability:	Fair	1	
Channel Alteration:	None	0	
Bank Erosion:	Historic	0.5	
BEHI:	Very High (40.14)	1.5	
Local NPSP:	No Evidence	0	
Shoring Structures:	None	0	
Pipe Discharge:	Not Present	0	Additional Site Features
Water Odor:	Normal	0	Stream Channel Woody Material: Numerous
Fish Passage Barrier:	Not Present	0	Impoundments: None
RB: Riparian Buffer (ft.):	100	0	Substrate Composition: Medium Sand
LB: Riparian Buffer (ft.):	100	0	Bank Material: Sand
RB: Floodplain Access:	Full	0	Near Bank Stress: Moderate
LB: Floodplain Access:	Full	0	RB Landuse: Historic Pasture + Natural Forest
<b>Severity Scale:</b>			LB Landuse: Historic Pasture + Natural Forest

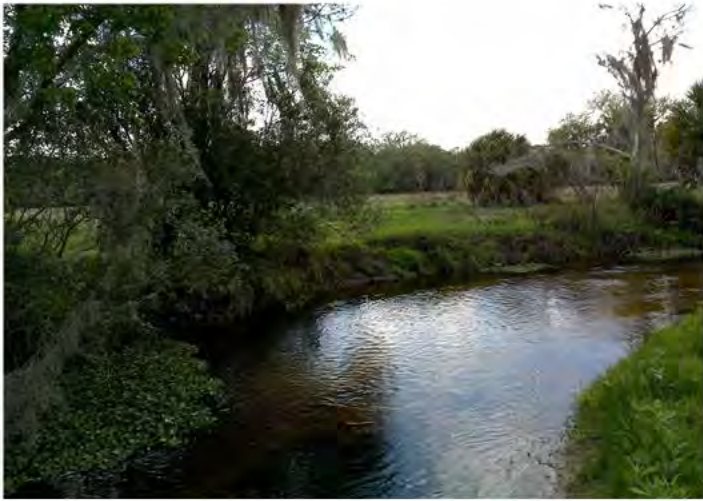
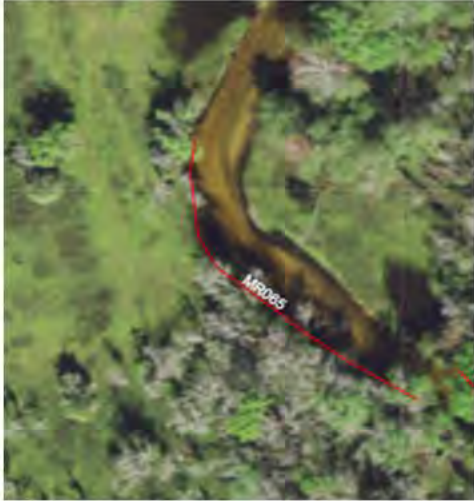
Risk Factor	Ranking	Score	Restoration Option 3
Pfankuch-Channel Stability:	Fair	1	
Channel Alteration:	None	0	
Bank Erosion:	Historic	0.5	
BEHI:	High (39.69)	1	
Local NPSP:	No Evidence	0	
Shoring Structures:	None	0	
Pipe Discharge:	Not Present	0	Additional Site Features
Water Odor:	Normal	0	Stream Channel Woody Material: Numerous
Fish Passage Barrier:	Not Present	0	Impoundments: None
RB: Riparian Buffer (ft.):	100	0	Substrate Composition: Medium Sand
LB: Riparian Buffer (ft.):	100	0	Bank Material: Sand
RB: Floodplain Access:	Full	0	Near Bank Stress: Moderate
LB: Floodplain Access:	Full	0	RB Landuse: Historic Pasture + Natural Forest
<b>Severity Scale:</b>		<b>2.5</b>	LB Landuse: Historic Pasture + Natural Forest

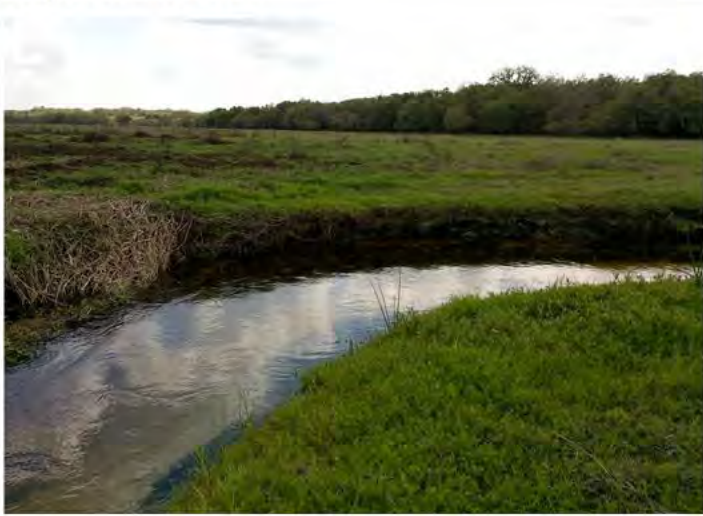
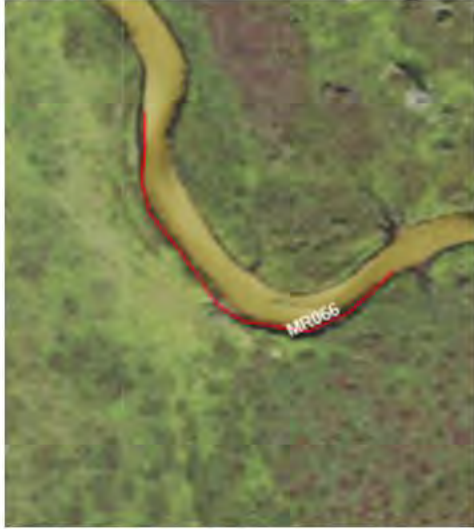
Risk Factor	Ranking	Score	Restoration Option 3
Pfankuch-Channel Stability:	Fair	1	
Channel Alteration:	None	0	
Bank Erosion:	Historic	0.5	
BEHI:	High (39.31)	1	
Local NPSP:	No Evidence	0	
Shoring Structures:	None	0	
Pipe Discharge:	Not Present	0	Additional Site Features
Water Odor:	Normal	0	Stream Channel Woody Material: None
Fish Passage Barrier:	Not Present	0	Impoundments: None
RB: Riparian Buffer (ft.):	100	0	Substrate Composition: Medium Sand
LB: Riparian Buffer (ft.):	100	0	Bank Material: Sand
RB: Floodplain Access:	Full	0	Near Bank Stress: High
LB: Floodplain Access:	Full	0	RB Landuse: Historic Pasture + Natural Forest
<b>Severity Scale:</b>		<b>2.5</b>	LB Landuse: Historic Pasture + Natural Forest

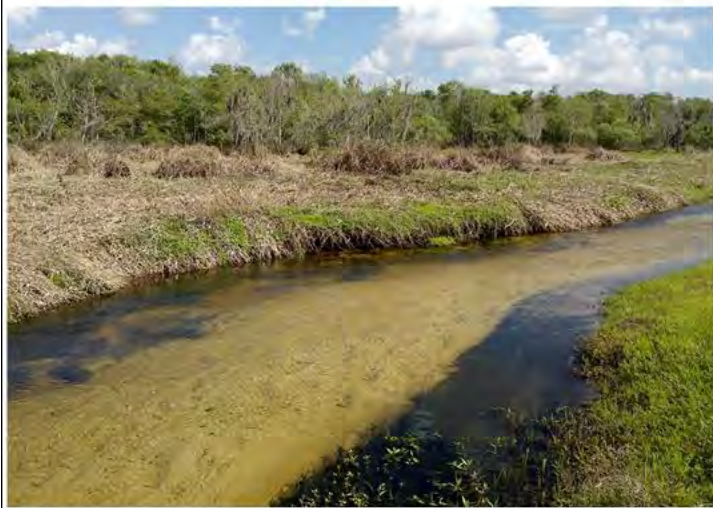
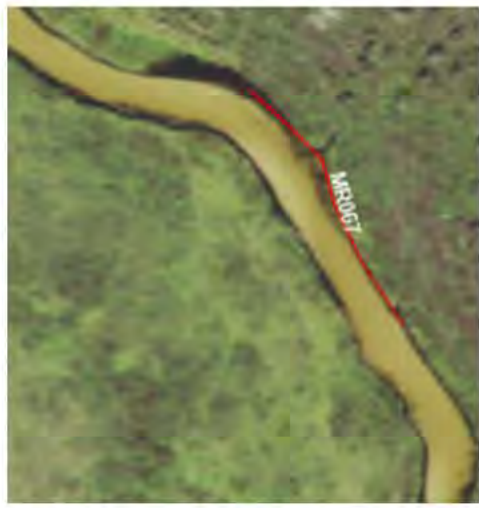
Risk Factor	Ranking	Score	Restoration Option 3
Pfankuch-Channel Stability:	Fair	1	
Channel Alteration:	None	0	
Bank Erosion:	Historic	0.5	
BEHI:	High (33.96)	1	
Local NPSP:	No Evidence	0	
Shoring Structures:	None	0	
Pipe Discharge:	Not Present	0	
			Additional Site Features
Water Odor:	Normal	0	Stream Channel Woody Material: None
Fish Passage Barrier:	Not Present	0	Impoundments: None
RB: Riparian Buffer (ft.):	100	0	Substrate Composition: Medium Sand
LB: Riparian Buffer (ft.):	100	0	Bank Material: Sand
RB: Floodplain Access:	Full	0	Near Bank Stress: Moderate
LB: Floodplain Access:	Full	0	RB Landuse: Historic Pasture + Natural Forest
	<b>Severity Scale:</b>	<b>2.5</b>	LB Landuse: Historic Pasture + Natural Forest

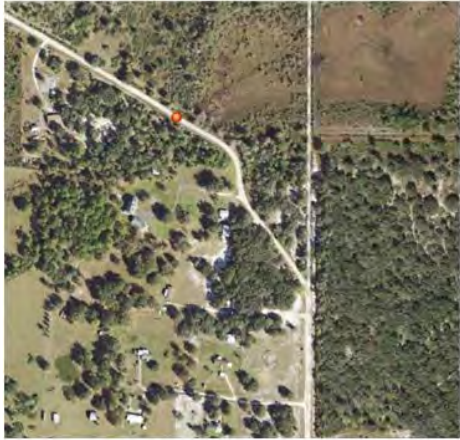
<p>Crossing Structure: Downstream</p>	
Risk Factor	Ranking	Score

<p><b>Additional Site Features</b></p> <p>Crossing Type and Quantity: Culvert, 2</p> <p>Crossing Material: Reinforced Concrete</p> <p>Culvert Outfall Drop: 0.35 in.</p> <p>Fish Passage Barrier: Present</p> <p>Notes: Channel was dry. Upstream crossing has hole between culverts, some damage to structure.</p>
US Channel Morph	Wetland	5	
DS Channel Morph	G	1	
DS Bank Alteration	High	1	
Upstream Skew Angle	5° to 30°	3	
Crossing fill condition	Good/Vegetated	5	
Inlet/Outlet Condition	Sediment/Scouring	3

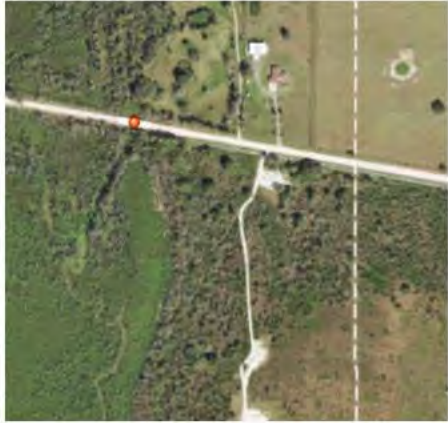
US Channel Morph	Wetland	5		
DS Channel Morph	Wetland	5		
DS Bank Alteration	High	1		
Upstream Skew Angle	<5°	5		
Crossing fill condition	Fair/Rip Rap	3		
Inlet/Outlet Condition	No Impairment	5		
Potential Eroded Vol.	21 to 40 c.y.	3		
Soil K Factor	<0.20	5		
Approach Slope Mean	<2.0%	5		
Road Approach Material	All Aggregate	5		
Upstream Rt Outlet	Rip Rap	1		
Upstream Lt Outlet	Rip Rap	1		
Upstream Rt Ditch	Vegetated	1		<b>Additional Site Features</b>
Upstream Lt Ditch	Vegetated	1		Crossing Type and Quantity: Bridge

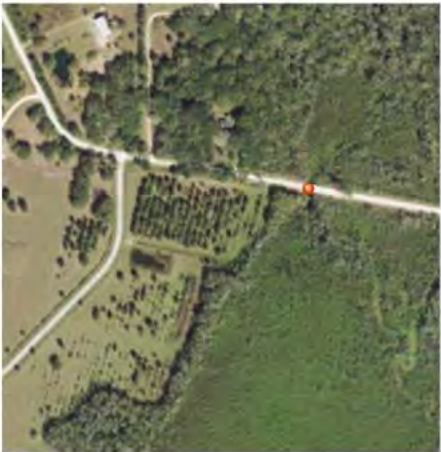
US Channel Morph	Wetland	5	
DS Channel Morph	Wetland	5	
DS Bank Alteration	Natural	5	
Upstream Skew Angle	<5°	5	
Crossing fill condition	Good/Vegetated	5	
Inlet/Outlet Condition	No Impairment	5	
Potential Eroded Vol.	>40 c.y.	1	
Soil K Factor	<0.20	5	
Approach Slope Mean	<2.0%	5	
Road Approach Material	All Aggregate	5	
Upstream Rt Outlet	Vegetated	1	
Upstream Lt Outlet	Vegetated	1	
Upstream Rt Ditch	Vegetated	1	
Upstream Lt Ditch	Vegetated	1	
Downstream Rt Outlet	Vegetated	1	
Downstream Lt Outlet	Vegetated	1	Crossing Type and Quantity: Bridge

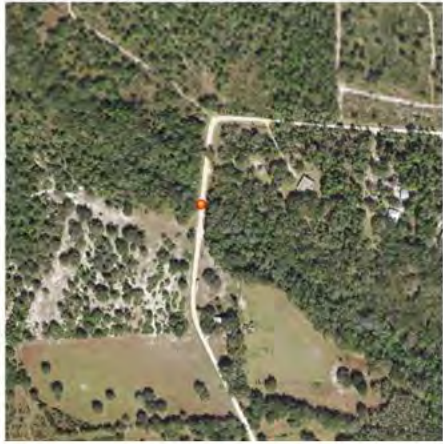
US Channel Morph	G	1		
DS Channel Morph	Ponded	1		
DS Bank Alteration	Minor/Partial	3		
Upstream Skew Angle	<5°	5		
Crossing fill condition	Good/Vegetated	5		
Inlet/Outlet Condition	Sediment/Scouring	3		
Potential Eroded Vol.	21 to 40 c.y.	3		
Soil K Factor	<0.20	5		
Approach Slope Mean	<2.0%	5		
Road Approach Material	All Aggregate	5		
Upstream Rt Outlet	Rip Rap	1		
Upstream Lt Outlet	Vegetated	1		
Upstream Rt Ditch	Vegetated	1		<b>Additional Site Features</b>

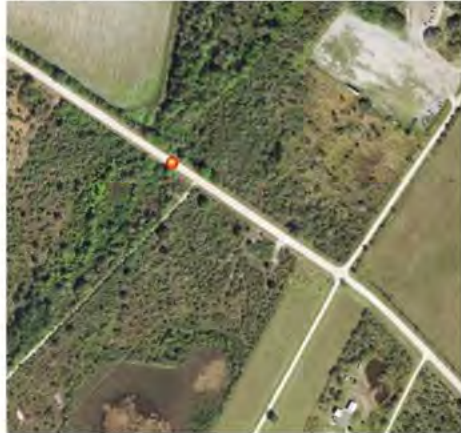
<p><b>Additional Site Features</b></p> <p>Crossing Type and Quantity: Culvert</p> <p>Crossing Material: Reinforced Concrete</p> <p>Culvert Outfall Drop: 0 in.</p> <p>Fish Passage Barrier: Not Present</p> <p>Notes: *additional landowner: Firouz Azima</p>
US Channel Morph	G	1	
DS Channel Morph	Wetland	5	
DS Bank Alteration	Natural	5	
Upstream Skew Angle	<5°	5	
Crossing fill condition	Good/Vegetated	5	
Inlet/Outlet Condition	No Impairment	5

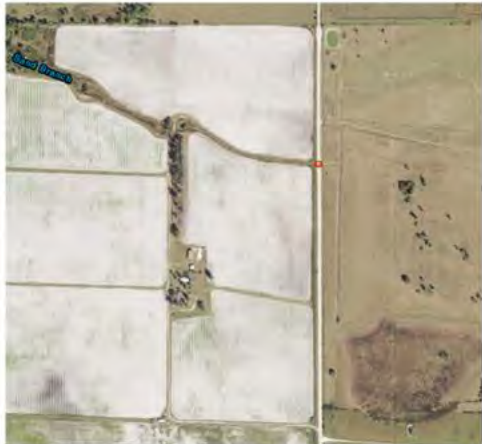
<p><b>Additional Site Features</b>                      Crossing Type and Quantity: Culvert, 1                      Crossing Material: Reinforced Concrete                      Culvert Outfall Drop: 0 in.                      Fish Passage Barrier: Not Present                      Notes: *additional landowner: LPK LLC.</p>
US Channel Morph	Wetland	5	
DS Channel Morph	F	1	
DS Bank Alteration	High	1	
Upstream Skew Angle	<5°	5	
Crossing fill condition	Good/Vegetated	5	
Inlet/Outlet Condition	Sediment/Scouring	3

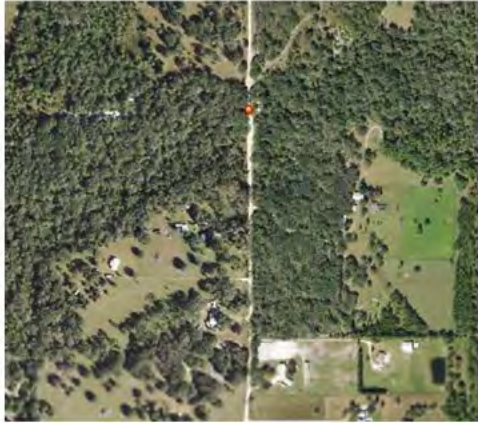
<p><b>Additional Site Features</b></p> <p>Crossing Type and Quantity: Bridge</p> <p>Crossing Material: Wood</p> <p>Culvert Outfall Drop: 0 in.</p> <p>Fish Passage Barrier: Not Present</p> <p>Notes: *additional landowners: John Falkner LLC., Kibler Agricultural Corp</p>
US Channel Morph	F	1	
DS Channel Morph	C	5	
DS Bank Alteration	High	1	
Upstream Skew Angle	<5°	5	
Crossing fill condition	Fair/RipRap	3	
Inlet/Outlet Condition	Sediment/Scouring	3

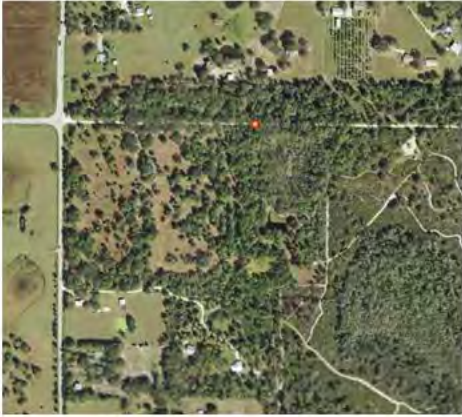
<p><b>Additional Site Features</b></p> <p>Crossing Type and Quantity: Culvert, 1</p> <p>Crossing Material: Polyvinyl Chloride</p> <p>Culvert Outfall Drop: 0 in.</p> <p>Fish Passage Barrier: Not Present</p> <p>Notes:</p>
US Channel Morph	E	5	
DS Channel Morph	E	5	
DS Bank Alteration	Natural	5	
Upstream Skew Angle	5° to 30°	3	
Crossing fill condition	Poor/Bare Soil	1	
Inlet/Outlet Condition	No Impairment	5	
Potential Eroded Vol.	21 to 40 c.y.	3

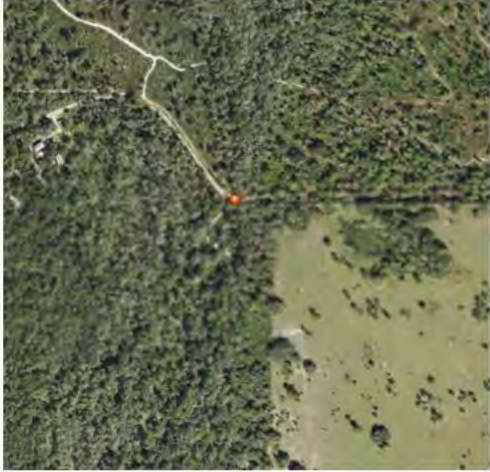
<p><b>Additional Site Features</b></p> <p>Crossing Type and Quantity: Culvert, 7</p> <p>Crossing Material: Corrugated Metal</p> <p>Culvert Outfall Drop: 0 in.</p> <p>Fish Passage Barrier: Not Present</p> <p>Notes: *additional landowners: Sarasota County, James M. Cain</p>
US Channel Morph	Ponded	1	
DS Channel Morph	Ponded	1	
DS Bank Alteration	Minor/Partial	3	
Upstream Skew Angle	<5°	5	
Crossing fill condition	Good/Vegetated	5	
Inlet/Outlet Condition	No Impairment	5

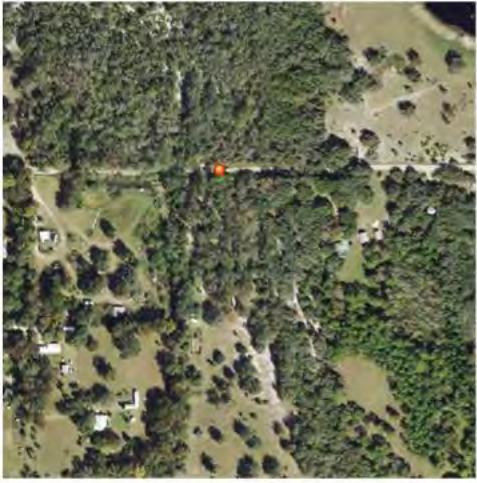
<p>Left Road Approach</p>
Risk Factor	Ranking	Score

<p><b>Additional Site Features</b>            Crossing Type and Quantity: Bridge            Crossing Material: Reinforced Concrete            Culvert Outfall Drop: 0 in.            Fish Passage Barrier: Not Present            Notes: Fish passage blockage at low flow,            *additional landowners: Sarasota County, Sandlot Boys LLC.</p>
US Channel Morph	Ponded	1	
DS Channel Morph	C	5	
DS Bank Alteration	Natural	5	
Upstream Skew Angle	<5°	5	
Crossing fill condition	Good/Vegetated	5	
Inlet/Outlet Condition	Sediment/Scouring	3

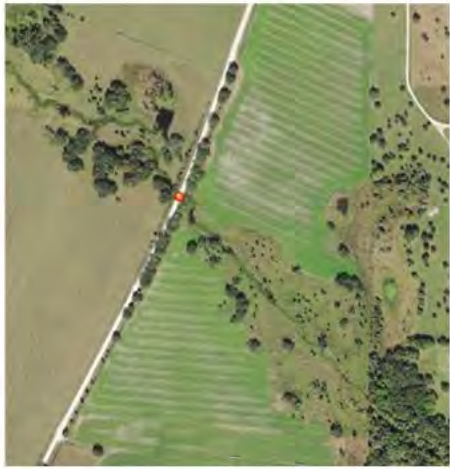
<p><b>Additional Site Features</b></p> <p>Crossing Type and Quantity: Bridge</p> <p>Crossing Material: Reinforced Concrete</p> <p>Culvert Outfall Drop: 0 in.</p> <p>Fish Passage Barrier: Not Present</p> <p>Notes: Looks channelized downstream</p>
US Channel Morph	Ponded	1	
DS Channel Morph	Ponded	1	
DS Bank Alteration	High	1	
Upstream Skew Angle	<5°	5	
Crossing fill condition	Good/Vegetated	5	
Inlet/Outlet Condition	Sediment/Scouring	3

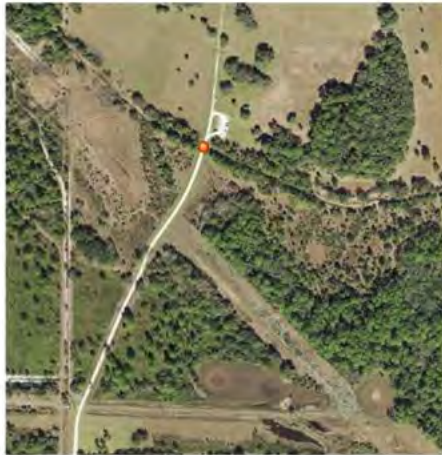
<p><b>Additional Site Features</b>            Crossing Type and Quantity: Culvert, 2            Crossing Material: Polyvinyl Chloride            Culvert Outfall Drop: 0 in.            Fish Passage Barrier: Not Present            Notes: Dry at time of survey</p>
US Channel Morph	F	1	
DS Channel Morph	Ponded	1	
DS Bank Alteration	High	1	
Upstream Skew Angle	<5°	5	
Crossing fill condition	Good/Vegetated	5	
Inlet/Outlet Condition	No Impairment	5	
Potential Eroded Vol.	<21 c.y.	5	
Soil K Factor	<0.20	5	
Approach Slope Mean	<2.0%	5

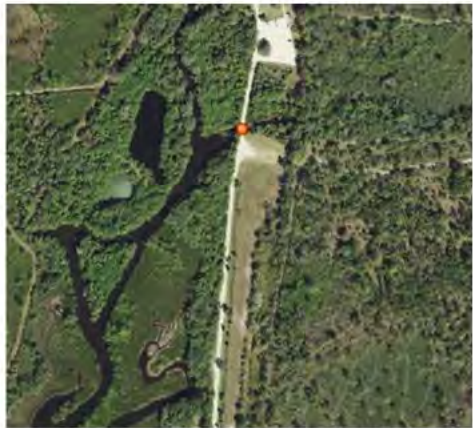
<p><b>Additional Site Features</b>            Crossing Type and Quantity: Culvert, 1            Crossing Material: Corrugated Metal            Culvert Outfall Drop: 0 in.            Fish Passage Barrier: Not Present            Notes: may be tidal</p>
US Channel Morph	C	5	
DS Channel Morph	C	5	
DS Bank Alteration	Natural	5	
Upstream Skew Angle	5° to 30°	3	
Crossing fill condition	Fair/Rip Rap	3	
Inlet/Outlet Condition	Sediment/Scouring	3

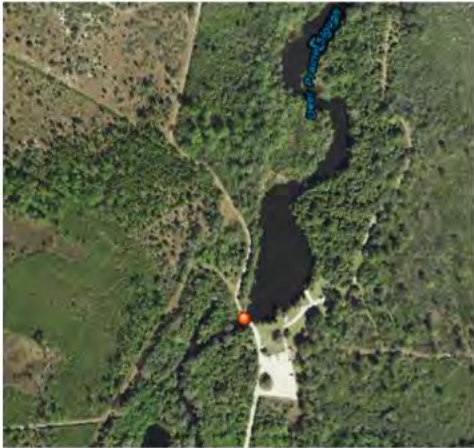
<p><b>Additional Site Features</b>                      Crossing Type and Quantity: Ford                      Crossing Material: Reinforced Concrete                      Culvert Outfall Drop: 0 in.                      Fish Passage Barrier: Not Present                      Notes: Dam present. Road mostly vegetated. Parking lot sediment may contribute to sedimentation.</p>
US Channel Morph	C	5	
DS Channel Morph	C	5	
DS Bank Alteration	Minor/Partial	3

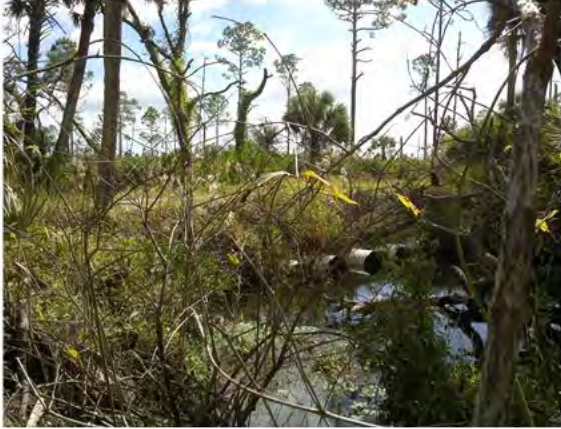
<p>Crossing Structure: Downstream</p>

<table><tr> <th>Risk Factor</th> <th>Ranking</th> <th>Score</th> </tr><tr><td>Crossing fill condition</td><td>Fair/Riprap</td><td>3</td></tr></table>

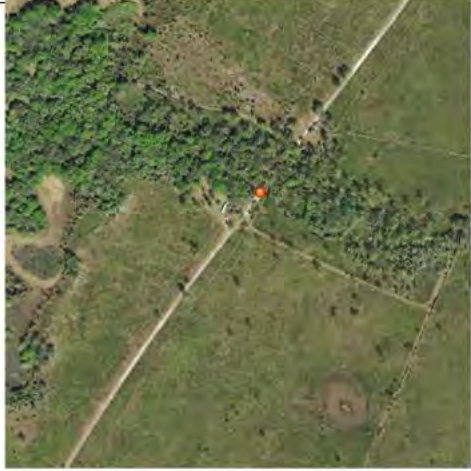
Risk Factor	Ranking	Score																																																																			
US Channel Morph	E	5																																																																			
DS Channel Morph	E	5																																																																			
DS Bank Alteration	Natural	5																																																																			
Upstream Skew Angle	>30°	1																																																																			
Crossing fill condition	Fair/Riprap	3																																																																			
Inlet/Outlet Condition	No Impairment	5																																																																			
Potential Eroded Vol.	<21 c.y.	5																																																																			
Soil K Factor	<0.20	5																																																																			
Approach Slope Mean	<2.0%	5																																																																			
Road Approach Material	All Aggregate	5																																																																			
Upstream Rt Outlet	Vegetated	1																																																																			
Upstream Lt Outlet	Rip Rap	1																																																																			
Upstream Rt Ditch	Vegetated	1																																																																			
Upstream Lt Ditch	Vegetated	1																																																																			
Downstream Rt Outlet	Rip Rap	1																																																																			
Downstream Lt Outlet	Rip Rap	1																																																																			
Downstream Rt Ditch	Vegetated	1																																																																			
Downstream Lt Ditch	Vegetated	1																																																																			
Improved Outlet Total	4	1																																																																			
Improved Ditches Total	4	1																																																																			
<b>SRI Total:</b>		<b>54</b>																																																																			
			<p><b>Additional Site Features</b></p> <p>Crossing Type and Quantity: Culvert, 5</p> <p>Crossing Material: Corrugated Metal</p> <p>Culvert Outfall Drop: 0 in.</p> <p>Fish Passage Barrier: Not Present</p> <p>Notes:</p>

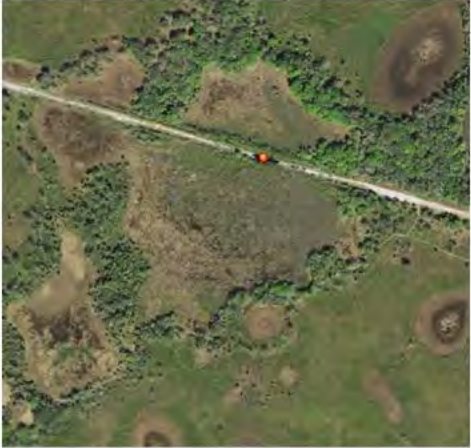
<p><b>Additional Site Features</b></p> <p>Crossing Type and Quantity: Ford</p> <p>Crossing Material: Native Soil, Rock</p> <p>Culvert Outfall Drop: 0 in.</p> <p>Fish Passage Barrier: Not Present</p> <p>Notes:</p>
US Channel Morph	Wetland	5	
DS Channel Morph	Wetland	5	
DS Bank Alteration	Natural	5	
Upstream Skew Angle	<5°	5	
Crossing fill condition	Good/Vegetated	5	
Inlet/Outlet Condition	No Impairment	5	
Potential Eroded Vol.	<21 c.y.	5	
Soil K Factor	<0.20	5	
Approach Slope Mean	>4.0%	1	
Road Approach Material	All Aggregate	5
