# Peace River Streambank Restoration and Myakka River Watershed Threats Assessment and Fish Assemblage Monitoring

Final Report 1 July 2019 – 31 March 2023  
State Wildlife Grant 2953 – PID 9100 250 2953

Submitted to Florida State Wildlife Grants Program  
1 June 2023

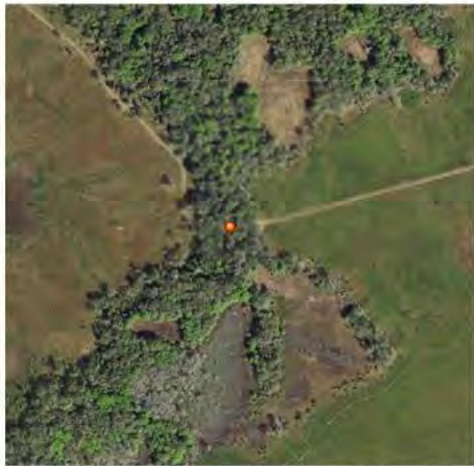
US Channel Morph	E	5	
DS Channel Morph	Wetland	5	
DS Bank Alteration	Natural	5	
Upstream Skew Angle	<5°	5	
Crossing fill condition	Poor/Bare Soil	5	
Inlet/Outlet Condition	No Impairment	5	
Potential Eroded Vol.	<21 c.y.	5	
Soil K Factor	<0.20	5	
Approach Slope Mean	>4.0%	1	
Road Approach Material	Aggregate/Native Soil	3	
Upstream Rt Outlet	Vegetated	1	
Upstream Lt Outlet	Vegetated	1	
Upstream Rt Ditch	Vegetated	1	
Upstream Lt Ditch	Vegetated	1	
Downstream Rt Outlet	Vegetated	1	
Downstream Lt Outlet	Vegetated	1	Crossing Type and Quantity: Ford

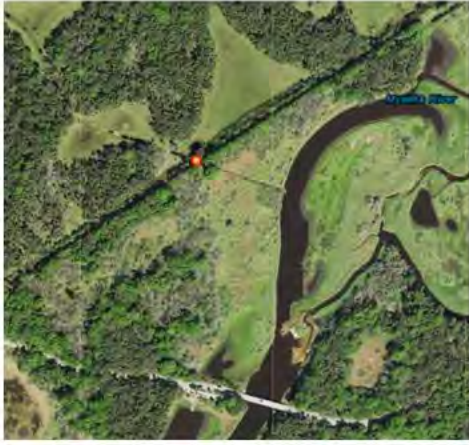
US Channel Morph	E	5		
DS Channel Morph	E	5		
DS Bank Alteration	Natural	5		
Upstream Skew Angle	5° to 30°	3		
Crossing fill condition	Good/Vegetated	5		
Inlet/Outlet Condition	No Impairment	5		
Potential Eroded Vol.	<21 c.y.	5		
Soil K Factor	<0.20	5		
Approach Slope Mean	>4.0%	1		
Road Approach Material	Aggregate/Sand/Clay	5		
Upstream Rt Outlet	Concrete	0		
Upstream Lt Outlet	Concrete	0		
Upstream Rt Ditch	Vegetated	1		<b>Additional Site Features</b>
Upstream Lt Ditch	Vegetated	1		Crossing Type and Quantity: Culvert, 2

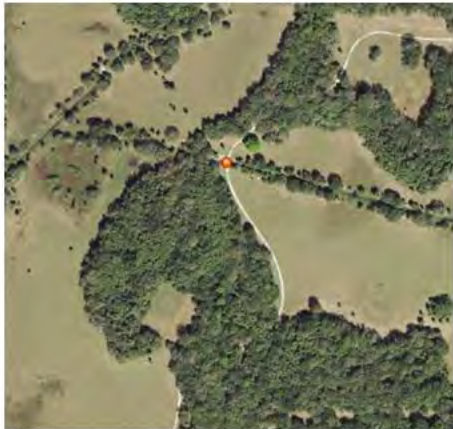
US Channel Morph	E	5	
DS Channel Morph	E	5	
DS Bank Alteration	Natural	5	
Upstream Skew Angle	<5°	5	
Crossing fill condition	Fair/Riprap	3	
Inlet/Outlet Condition	No Impairment	5	
Potential Eroded Vol.	<21 c.y.	5	
Soil K Factor	<0.20	5	
Approach Slope Mean	<2.0%	5	
Road Approach Material	All Aggregate	5	
Upstream Rt Outlet	Rip Rap	1	
Upstream Lt Outlet	Rip Rap	1	
Upstream Rt Ditch	Rip Rap	1	
Upstream Lt Ditch	Rip Rap	1	
Downstream Rt Outlet	Rip Rap	1	<b>Additional Site Features</b>
Downstream Lt Outlet	Rip Rap	1	Crossing Type and Quantity: Culvert, 1

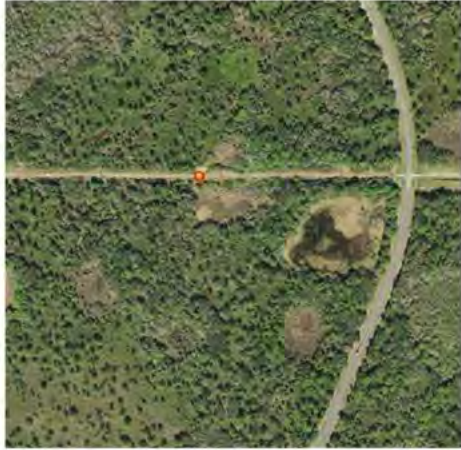
<p><b>Additional Site Features</b>            Crossing Type and Quantity: Culvert, 1            Crossing Material: Polyvinyl Chloride            Culvert Outfall Drop: 0 in.            Fish Passage Barrier: Not Present            Notes: culvert connecting ditches @ 90 degree angle</p>
US Channel Morph	Wetland	5	
DS Channel Morph	Wetland	5	
DS Bank Alteration	Natural	5	
Upstream Skew Angle	>30°	1	
Crossing fill condition	Good/Vegetated	5	
Inlet/Outlet Condition	No Impairment	5	
Potential Eroded Vol.	<21 c.y.	5	
Soil K Factor	<0.20	5

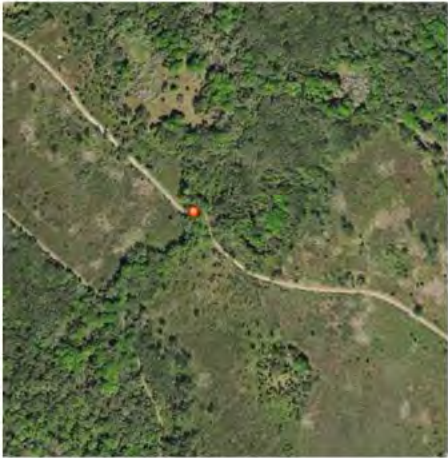
US Channel Morph	E	5		
DS Channel Morph	E	5		
DS Bank Alteration	Natural	5		
Upstream Skew Angle	5° to 30°	3		
Crossing fill condition	Fair/Riprap	3		
Inlet/Outlet Condition	No Impairment	5		
Potential Eroded Vol.	<21 c.y.	5		
Soil K Factor	<0.20	5		
Approach Slope Mean	<2.0%	5		
Road Approach Material	All Aggregate	5		
Upstream Rt Outlet	Rip Rap	1		
Upstream Lt Outlet	Bare Soil	0		
Upstream Rt Ditch	Vegetated	1		
Upstream Lt Ditch	Vegetated	1		
Downstream Rt Outlet	Rip Rap	1		<b>Additional Site Features</b>
Downstream Lt Outlet	Rip Rap	1		Crossing Type and Quantity: Culvert, 1

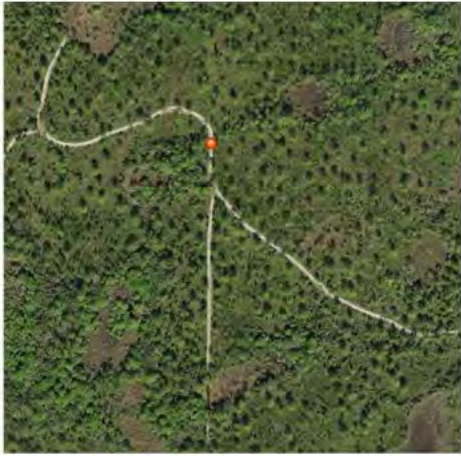
US Channel Morph	E	5	
DS Channel Morph	E	5	
DS Bank Alteration	Natural	5	
Upstream Skew Angle	<5°	5	
Crossing fill condition	Good/Vegetated	5	
Inlet/Outlet Condition	No Impairment	5	
Potential Eroded Vol.	<21 c.y.	5	
Soil K Factor	<0.20	5	
Approach Slope Mean	<2.0%	5	
Road Approach Material	All Native Soil	1	
Upstream Rt Outlet	Vegetated	1	
Upstream Lt Outlet	Vegetated	1	
Upstream Rt Ditch	Bare Soil	0	
Upstream Lt Ditch	Bare Soil	0	Crossing Type and Quantity: Ford
Downstream Rt Outlet	Vegetated	1	Crossing Material: Native Soil
Downstream Lt Outlet	Vegetated	1	Culvert Outfall Drop: 0 in.

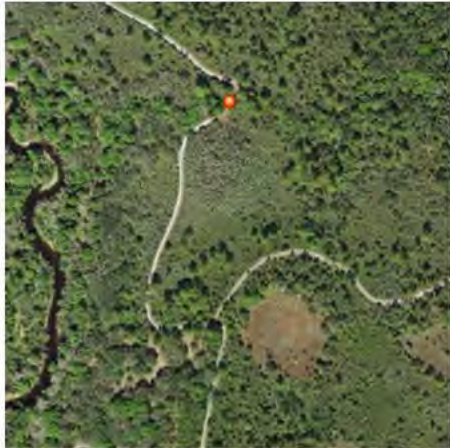
<p><b>Additional Site Features</b></p> <p>Crossing Type and Quantity: Culvert, 1</p> <p>Crossing Material: Corrugated Metal</p> <p>Culvert Outfall Drop: 0 in.</p> <p>Fish Passage Barrier: Not Present</p> <p>Notes:</p>
US Channel Morph	E	5	
DS Channel Morph	E	5	
DS Bank Alteration	Natural	5	
Upstream Skew Angle	>30°	1	
Crossing fill condition	Good/Vegetated	5	
Inlet/Outlet Condition	No Impairment	5	
Potential Eroded Vol.	<21 c.y.	5	
Soil K Factor	<0.20	5	
Approach Slope Mean	<2.0%	5	
Road Approach Material	All Native Soil	1

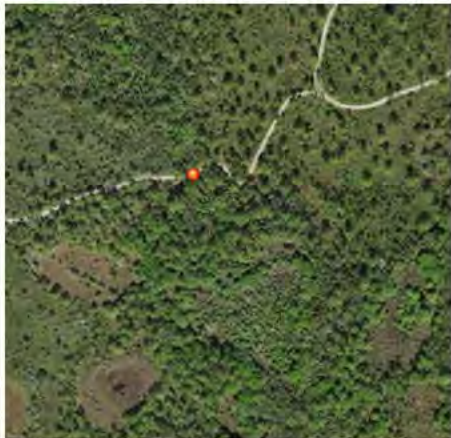
<p><b>Additional Site Features</b></p> <p>Crossing Type and Quantity: Culvert, 1</p> <p>Crossing Material: Polyvinyl Chloride</p> <p>Culvert Outfall Drop: 0.35 in.</p> <p>Fish Passage Barrier: Present</p> <p>Notes:</p>
US Channel Morph	E	5	
DS Channel Morph	E	5	
DS Bank Alteration	Natural	5	
Upstream Skew Angle	5° to 30°	3	
Crossing fill condition	Good/Vegetated	5	
Inlet/Outlet Condition	No Impairment	5	
Potential Eroded Vol.	<21 c.y.	5	
Soil K Factor	<0.20	5	
Approach Slope Mean	<2.0%	5	
Road Approach Material	All Native Soil	1

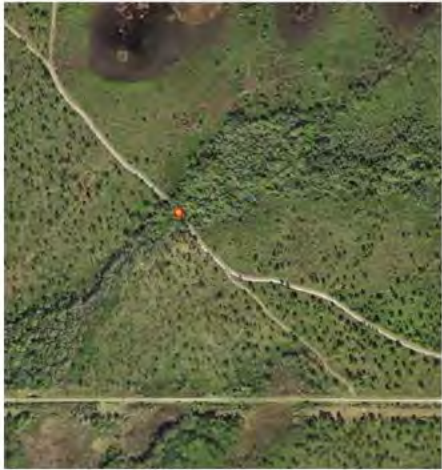
US Channel Morph	E	5	
DS Channel Morph	Wetland	5	
DS Bank Alteration	Natural	5	
Upstream Skew Angle	<5°	5	
Crossing fill condition	Good/Vegetated	5	
Inlet/Outlet Condition	No Impairment	5	
Potential Eroded Vol.	<21 c.y.	5	
Soil K Factor	<0.20	5	
Approach Slope Mean	<2.0%	5	
Road Approach Material	Native Soil/Sand/Clay	1	
Upstream Rt Outlet	Vegetated	1	
Upstream Lt Outlet	Vegetated	1	
Upstream Rt Ditch	Vegetated	1	
Upstream Lt Ditch	Vegetated	1	
Downstream Rt Outlet	Vegetated	1

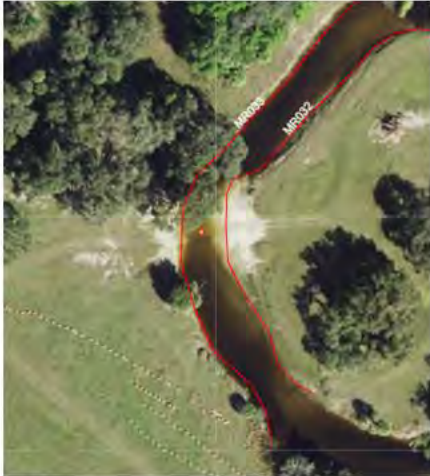
<p><b>Additional Site Features</b></p> <p>Crossing Type and Quantity: Ford</p> <p>Crossing Material: Native Soil/Sand</p> <p>Culvert Outfall Drop: 0 in.</p> <p>Fish Passage Barrier: Not Present</p> <p>Notes:</p>
US Channel Morph	C	5	
DS Channel Morph	C	5	
DS Bank Alteration	Minor/Partial	3	
Upstream Skew Angle	<5°	5	
Crossing fill condition	Good/Vegetated	5	
Inlet/Outlet Condition	No Impairment	5	
Potential Eroded Vol.	<21 c.y.	5	
Soil K Factor	<0.20	5	
Approach Slope Mean	>4.0%	1	
Road Approach Material	Native Soil/Sand/Clay	1

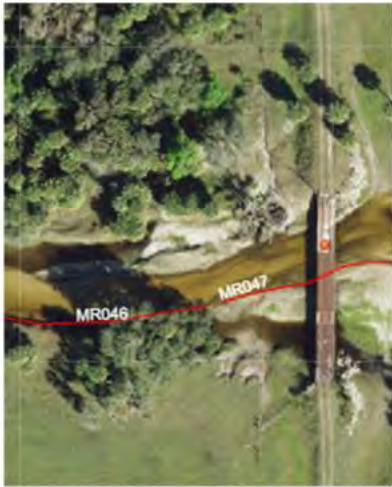
<p><b>Additional Site Features</b></p> <p>Crossing Type and Quantity: Bridge</p> <p>Crossing Material: Iron/Steel, Wood</p> <p>Culvert Outfall Drop: 0 in.</p> <p>Fish Passage Barrier: Not Present</p> <p>Notes: **Upland Hardwood-Coniferous Mix</p>
US Channel Morph	C	5	
DS Channel Morph	C	5	
DS Bank Alteration	Minor/Partial	3	
Upstream Skew Angle	<5°	5	
Crossing fill condition	Good/Vegetated	5	
Inlet/Outlet Condition	Sediment Scouring	3
