Fish Kill on the Myakka River August 16, 2024

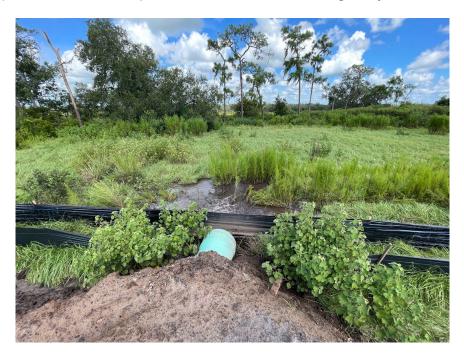
Discharge point from Miakka North into a wetland:

++++ (above meter limit) NTUs reading taken on 8/30 472 NTUs reading taken on 9/9

Background sample taken upstream at the overpass on SR-70 between Singletary and MJ Rds read 2.39 NTUs*.

*Turbidity of any water that leaves the site and impacts the water systems cannot be higher than 29 NTUs above background.

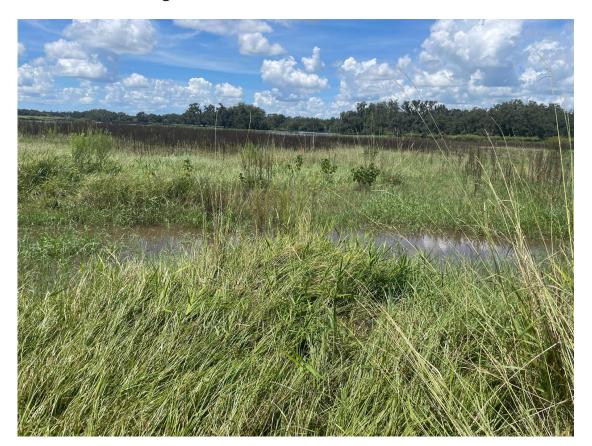
Where this discharge is leading: Wetland, off-site, near the Myakka River 806 and 778 NTU readings taken on 8/30

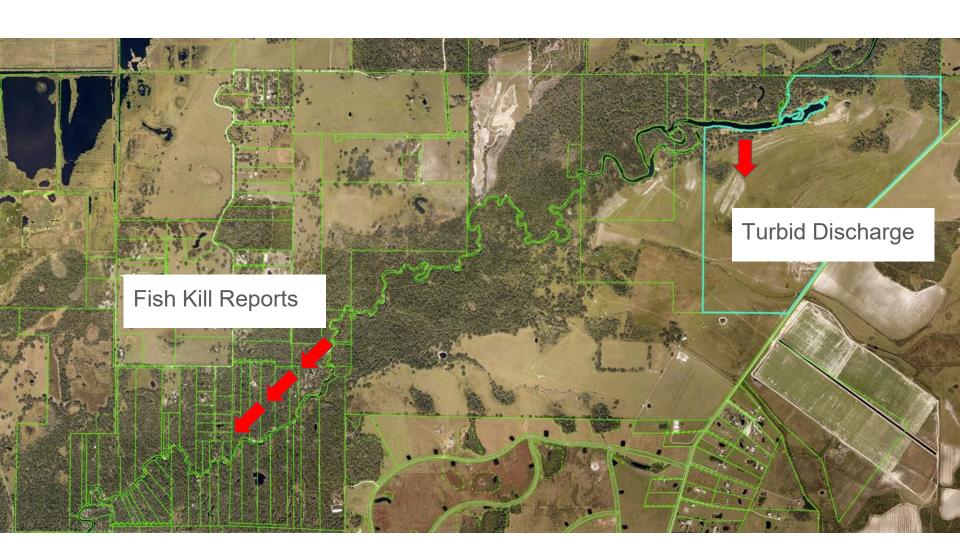
"BMPs that are currently in place for their dewatering is what was in their plans, and it is nowhere near sufficient for the water flow rate being pushed through.

I did recommend that they seek the input of a third-party environmental consultant at this point, due to the severity of the violation(s).

This isn't something that some riprap or hay bales will bring back into compliance."

- Confirm that all required permits have been obtained for both golf developments and alert relevant regulatory agencies of concerns
- Recommend inspections to assure compliant
 - wetland delineation
 - setbacks from the river
 - nutrient allowance in discharges
- Leverage council members to prevent further impact to the river through regular water quality testing
- Invite collaboration by the two golf development owners to seek solutions that minimize further impact to the river and watershed.
