Myakka Wild and Scenic River Program 2021 Annual Report

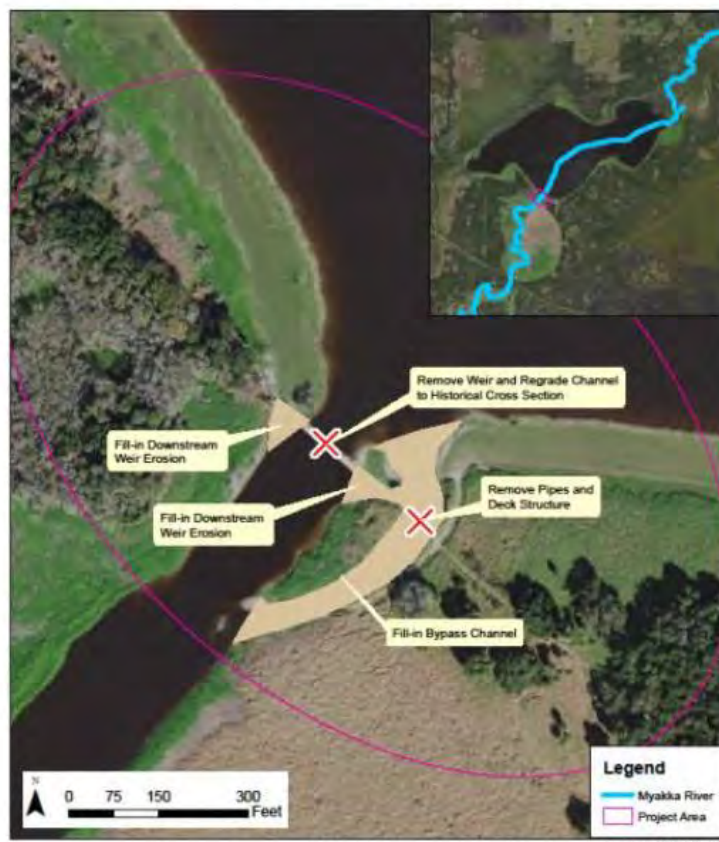
Exhibit 5.1a - Alternative 1 Conceptual Plan

Conceptual design for restoration from Wood UML Feasibility Study 2020, from page 42.

1. The FPS District IV continues the effort to restore the Upper Myakka Lake (UML) Bypass/Weir Area as directed in the adopted Myakka Wild and Scenic River (MWSR) Management Plan, under Action 2.4. In October 2017 an application was submitted to request funding through the SWFWMD Cooperative Funding Initiative (CFI) to conduct modeling to identifying the best solution to this long-standing issue. In October 2018 SWFWMD approved matching funding. Wood Environment & Infrastructure Solutions, Inc. (Wood) was contracted to produce a feasibility study. In summer 2020 Wood provided a final study and their recommendation for restoration the area to the pre-alteration condition. The FPS, SWFWMD, FWC's Aquatic Habitat Restoration Enhancement (AHRE) Program, and U.S. Fish and Wildlife Service (FWS) agreed to partner in this effort. Wood provided additional work from the conceptual design toward formal construction plans and applied for the necessary restoration permitting with SWFWMD and ACOE in late 2020. Permits were received in 2021 but procurement issues stalled the planned FWS demolition of the structures targeted for the dry season in 2021. The FPS regrouped and are now aiming for a 2022 restoration.

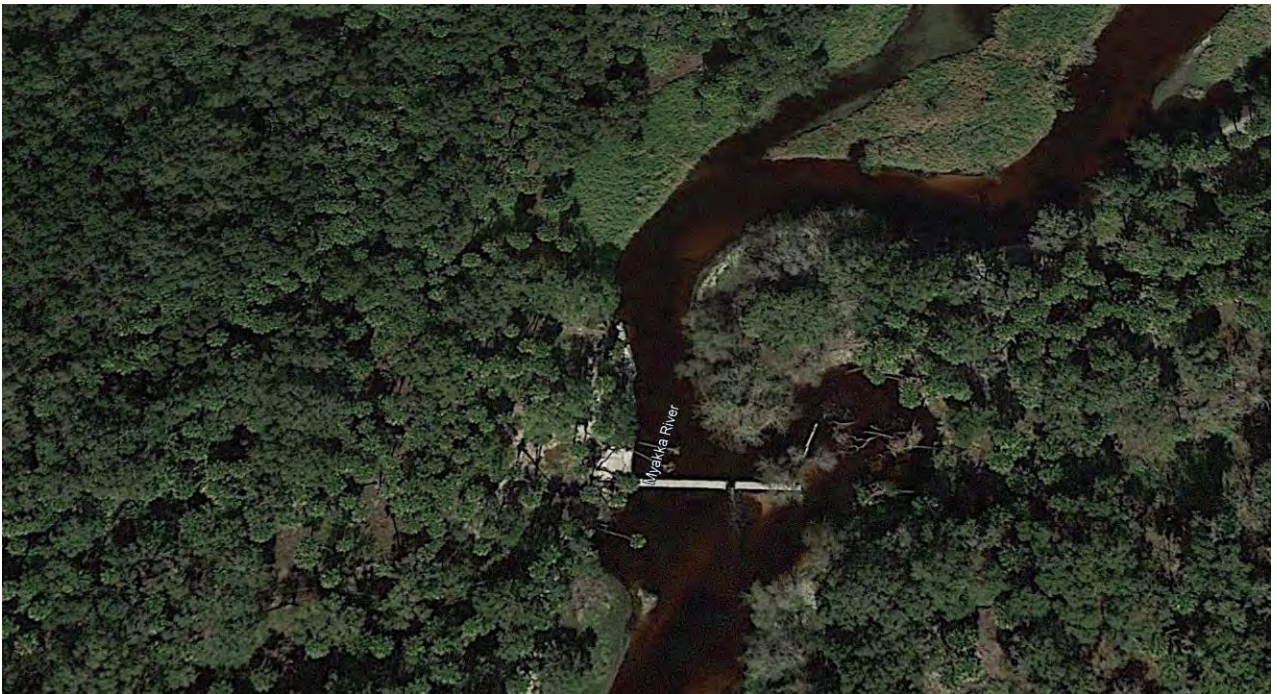
Aerial image showing river bypassing the structure of Downs' Dam where erosion is cutting into hydric hammock from MRSP.

2. The FPS District IV continues the effort for the restoration of the Downs' Dam area as directed in the adopted MWSR Management Plan, under Action 2.4. In October 2018 an application was submitted to request funding through the SWFWMD CFI to conduct modeling to identifying the best solution to this long-standing issue. In October 2019 SWFWMD approved matching funding for the project and in early 2020 a contract with Wood was secured for a study. The O Bar O Ranch hosted the consultants and agency staff for a February 2020 kick-off meeting for this project. The FPS, SWFWMD, FWC's AHRE Program, and FWS have agreed to partner in this effort. The consultant has completed survey, modeling, and a cost and benefit analysis and produce the requested Feasibility study that recommended removal of the dam and restoration of both banks. Pending an agreement with adjacent Ranch and required permitting, this restoration project could occur in Spring 2023 or 2024.

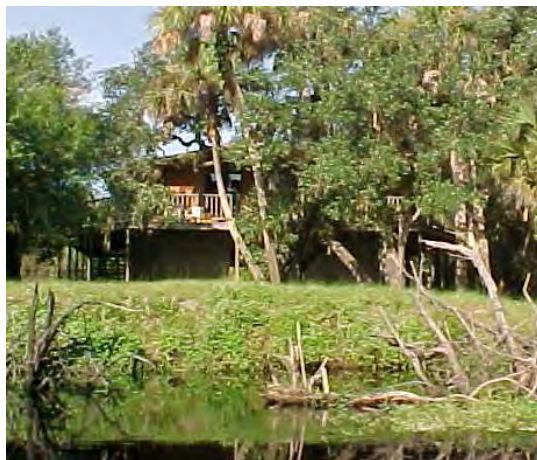
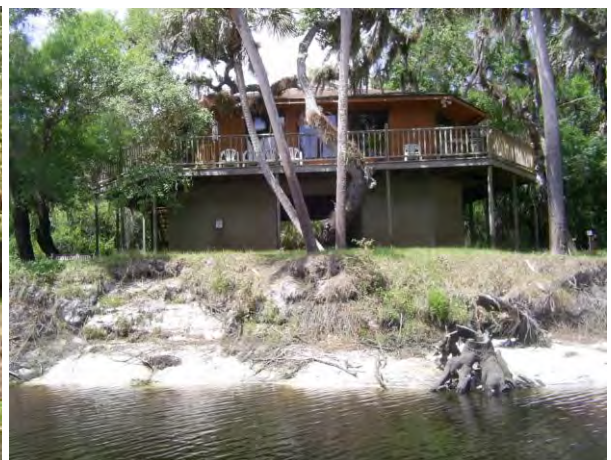
2000 (left) and April 2016 (right) pre-installation views of the project area.

- Structure off North Jackson Road. In 2019 permitting issues arose related to shoreline wall adjacent to a structure constructed in the river area off North Jackson Road. The project was initially submitted as exempt and fully in uplands (i.e. not in the river area, and thus not regulated under 62D-15). Initially, a Safe Upland Line (SUL) was established well below the ‘top of bank’ making the project exempt. Conversations and site visits occurred to address regulatory issues related to the location of river area. After a site visit, the limit of surface waters was determined by the present Ordinary High Water Mark (OHW). The South District Regulatory Office (SDO) found that the entire project was below the OHWM and therefore, in the river area. On October 31st, 2019 SDO issued a permit stating, “the permittee is authorized to stabilize an eroding shoreline through the installation of a 117-linear foot retaining wall and vegetative plantings within the landward extent of the Myakka River, a Wild and Scenic River, Class III Outstanding Florida Waters. Those activities include the restoration of an eroding shoreline through the installation of vegetative plantings on state-owned sovereignty submerged lands.” The physical wall was installed in early 2020. The permit required plantings including in front of the wall to mitigate impact to the view but were viewed as very unlikely to establish. Plantings were installed at the top of the structure in late 2020. See photos.

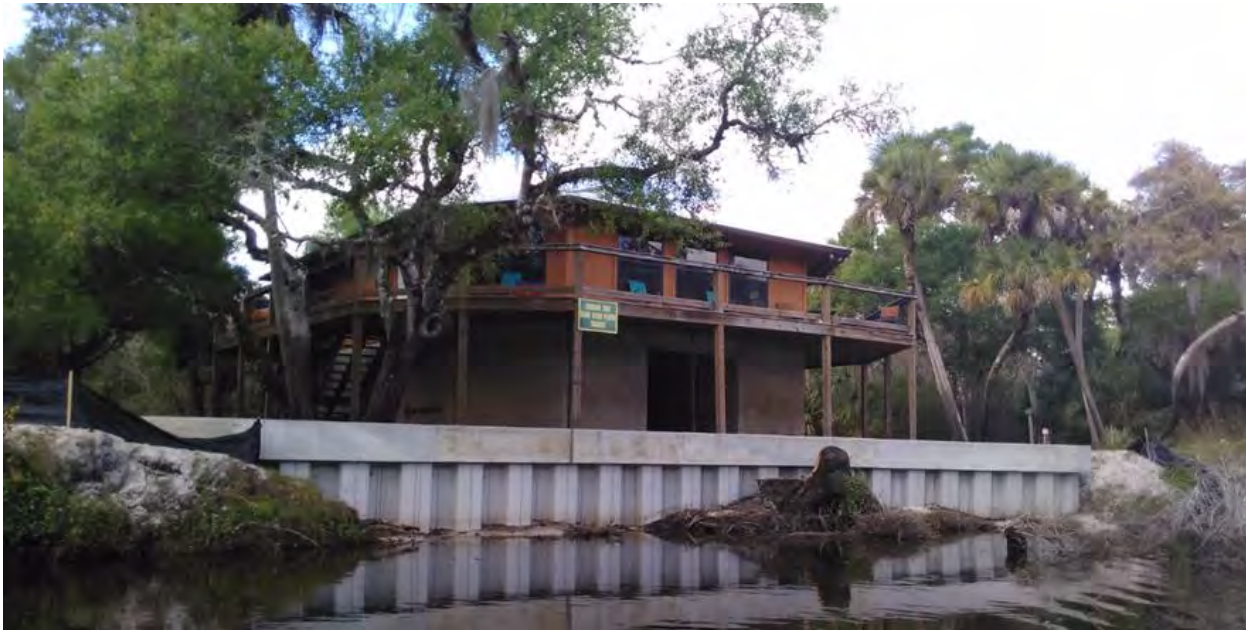
2020 post-installation of wall.

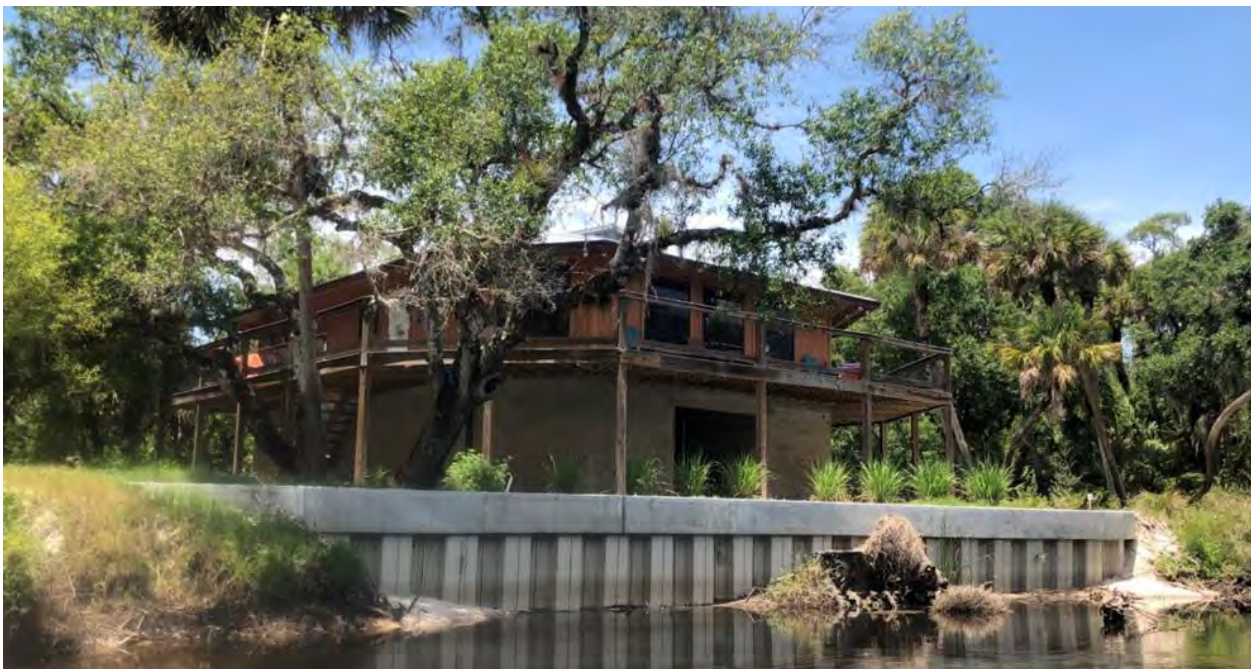
May 2021 post-installation of vegetation required as mitigation in permit for the shoreline protection wall.

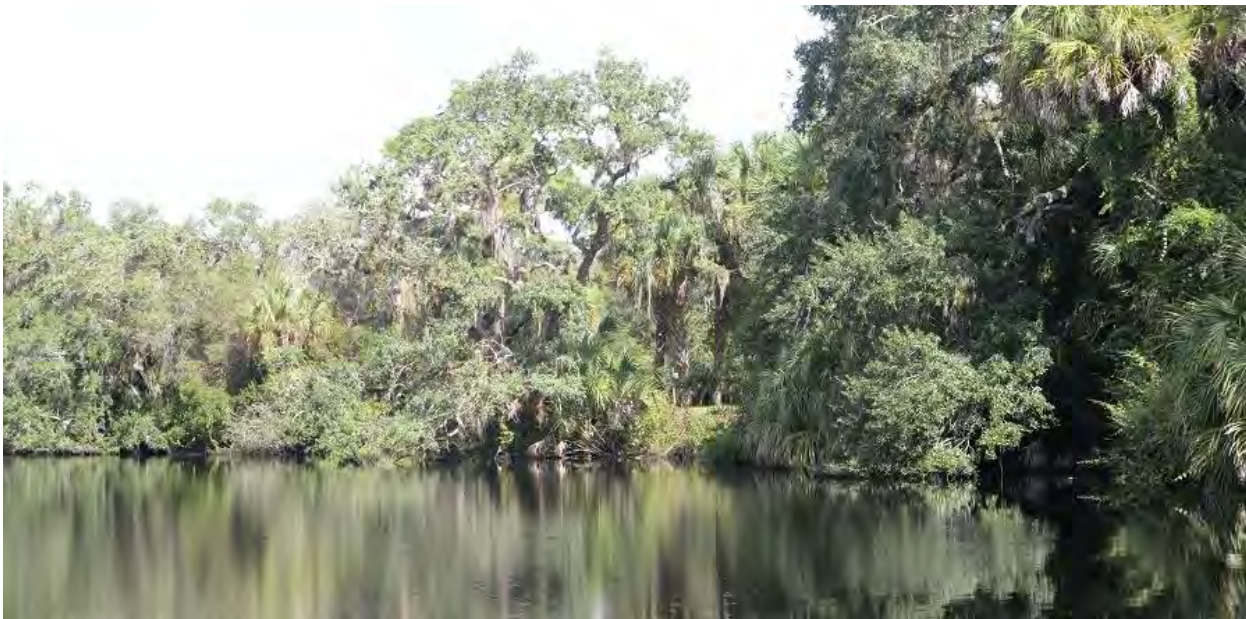
Location area one for the 135-foot proposed wall (not far above Snook Haven Park).

- Proposed structure off South Moon Drive. In March 2021 an application was received by SDO for two proposed shoreline walls in the river area. On December 10th, 2021 a permit was issued “To install approximately 135 linear feet of

seawall and 83 linear feet of seawall landward of mean high water to be faced with riprap that has a maximum slope of 2 to 1 and located landward of mean high water to stabilize the shoreline and protect the existing road and wastewater utilities...” See photos.

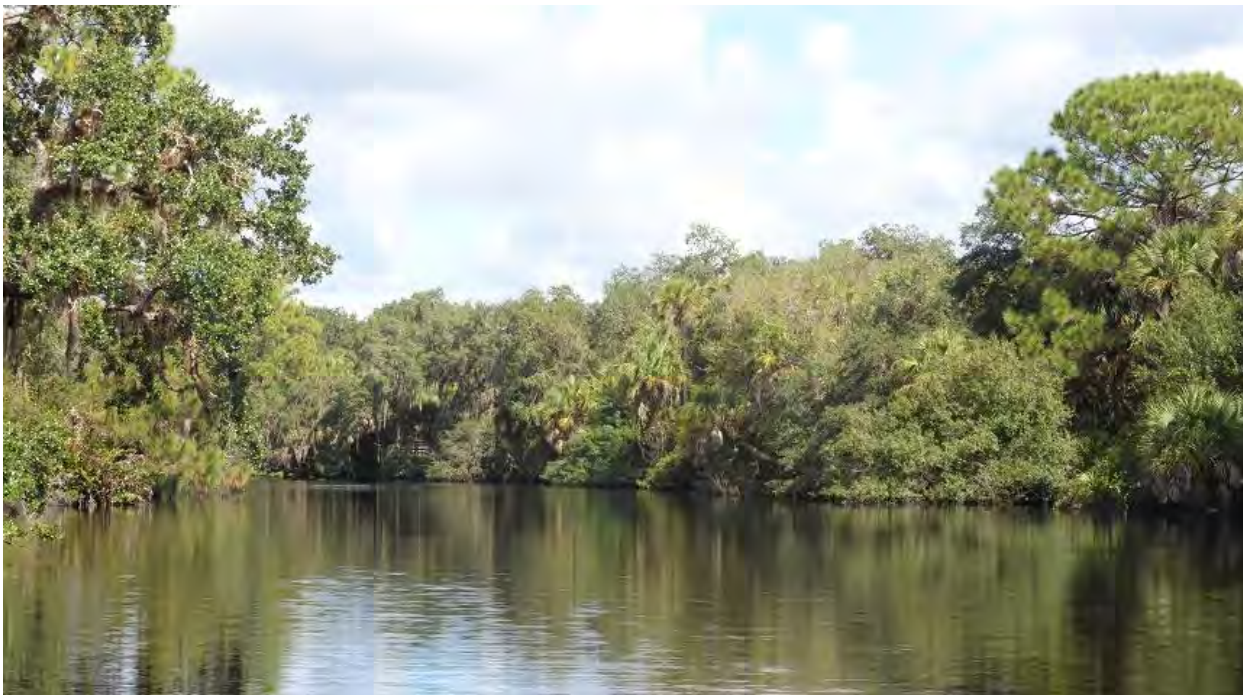
Location area two for the 83-foot proposed wall (not far above Snook Haven Park).

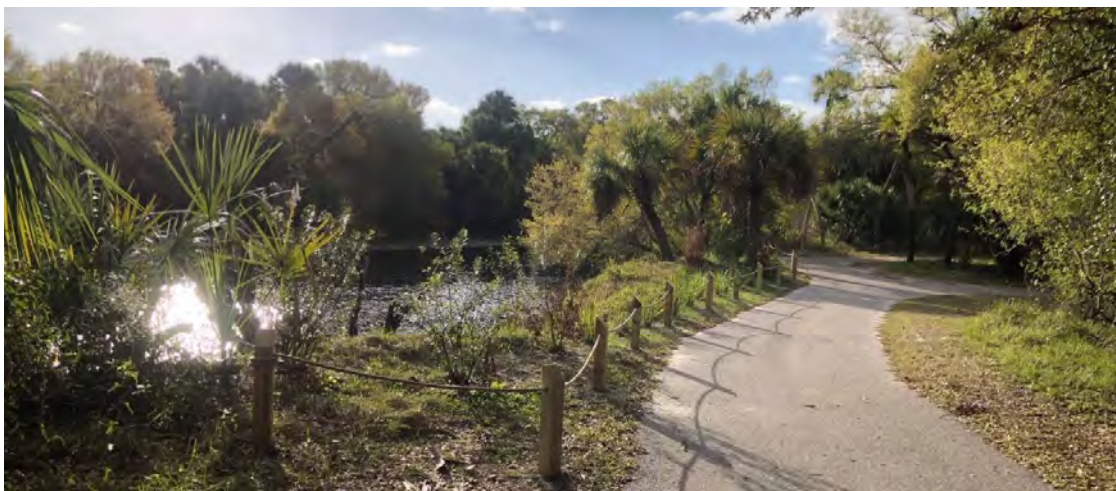
Looking south after fence and native plantings to slow erosion (VMRP, February 2, 2021).

- Discussions about slowing the erosion or using structural stabilization occurred related to the Venice Myakka River Park (VMRP). Over the past three or four years several trees have collapsed, and the river is now closer to paved foot path. See photos.

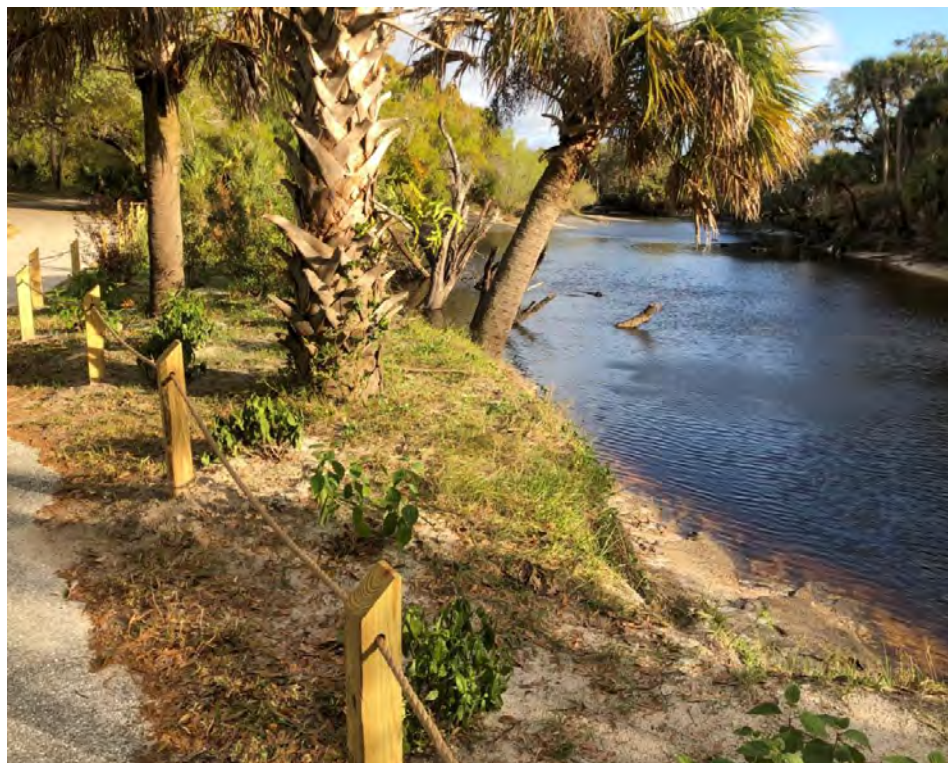
Looking north after fence and native plantings intended to slow erosion (VMRP, February 2, 2021).

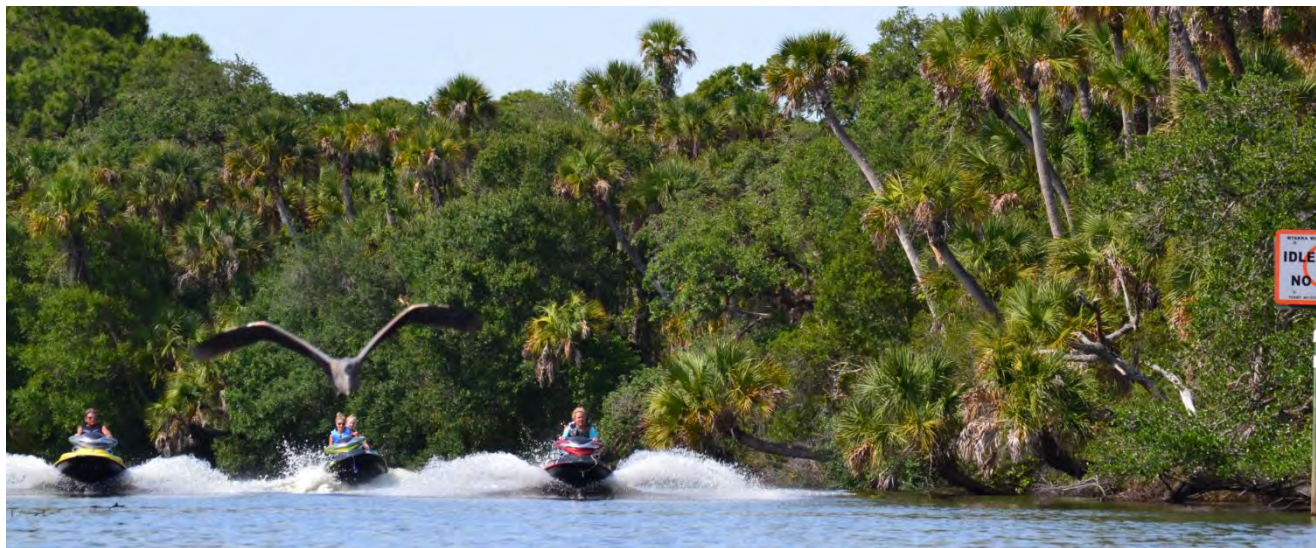
Group of speeding jet ski operators within the IDLE zone at Snook Haven (reported to this office in April 2021).

- Speeding jet skis appears to be an emerging issue with several occurrences of unsafe operations seen during surveys and reported to this office. This includes jet skis in ISNW zones and entering the MRSP Wildlife Preserve (without permits) and causing unsafe situations with paddle craft.

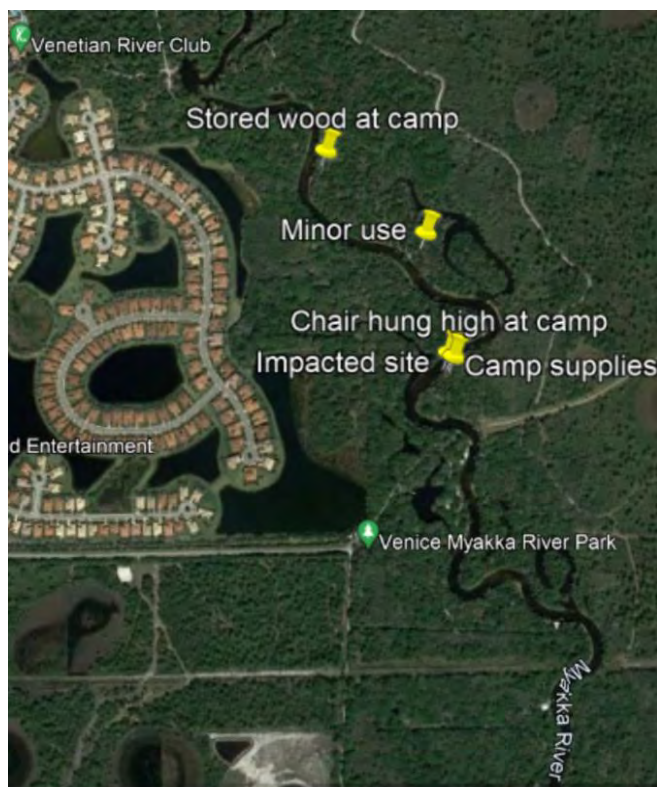
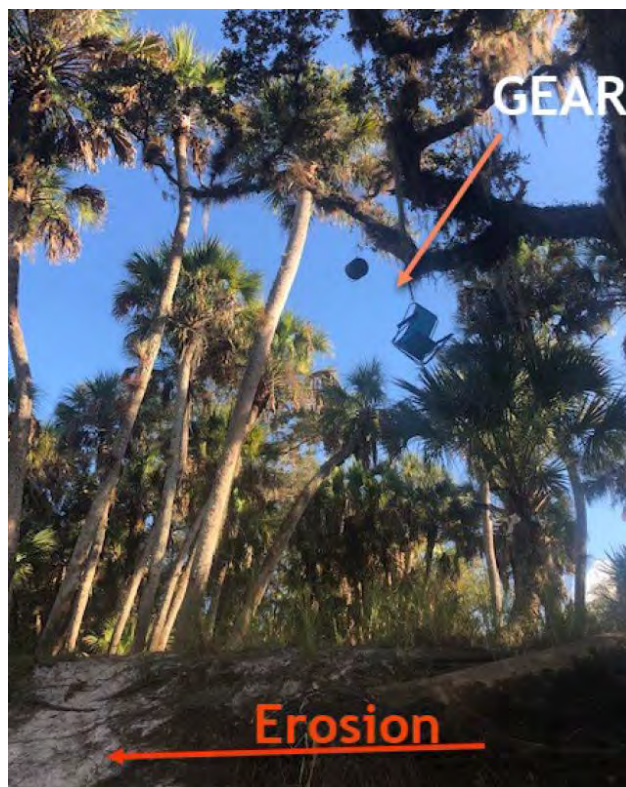
Examples from December 2021 report, showing a hot spot for unpermitted camping, note the chair hung from a tree to and the erosion above.

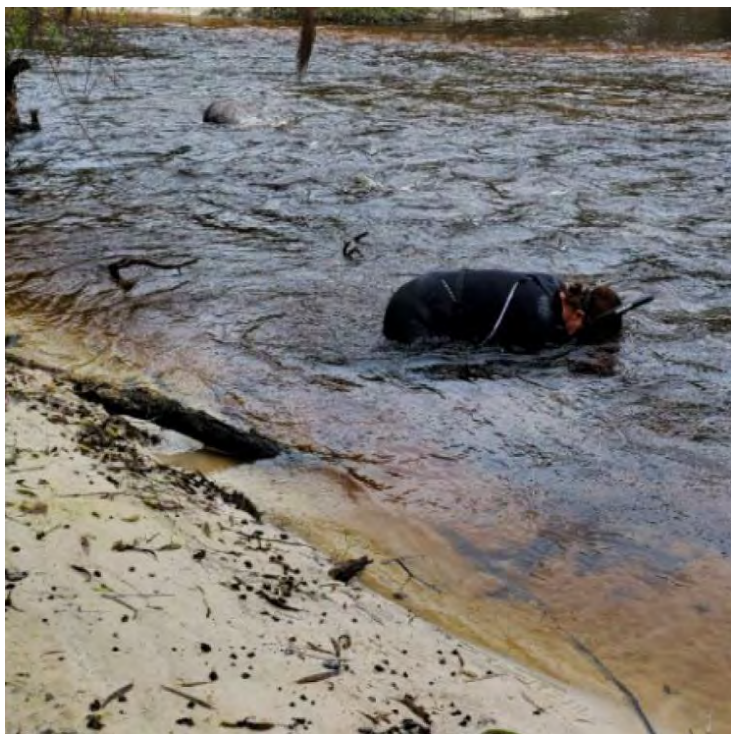
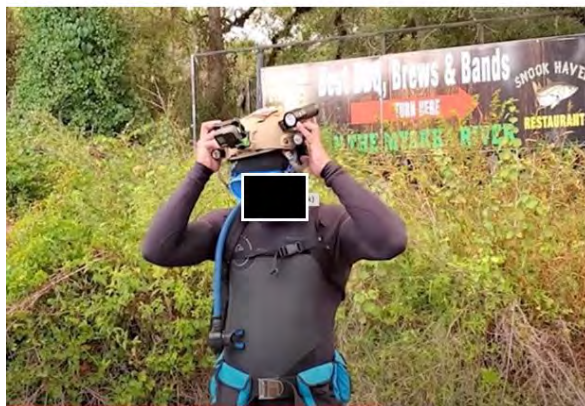
Snorkelers with hand tools within MRSP (left, 12-2021). Note to the right, a second commercial fossil hunter using scuba equipment to dive for a lost Go-Pro (from May alligator incident) in front signage for Snook Haven Park, above same diver with a metal scraping tool.

- The majority of fossil collection activities occurs in the ‘dry season’ with low water levels where fossil hunters wade in the shallows (typically above Laurel Road). However, fossiling while snorkeling in the shallows, or free diving in deeper water or using scuba equipment is being more commonly seen and allows for fossiling at more water levels. Scuba activities appear to be focused around Border Road, near SHP downriver to the inlet of Deer Prairie Creek. According to media reports, a Tampa-based commercial fossil hunter was bitten by an alligator just after he entered the river immediately off SHP.

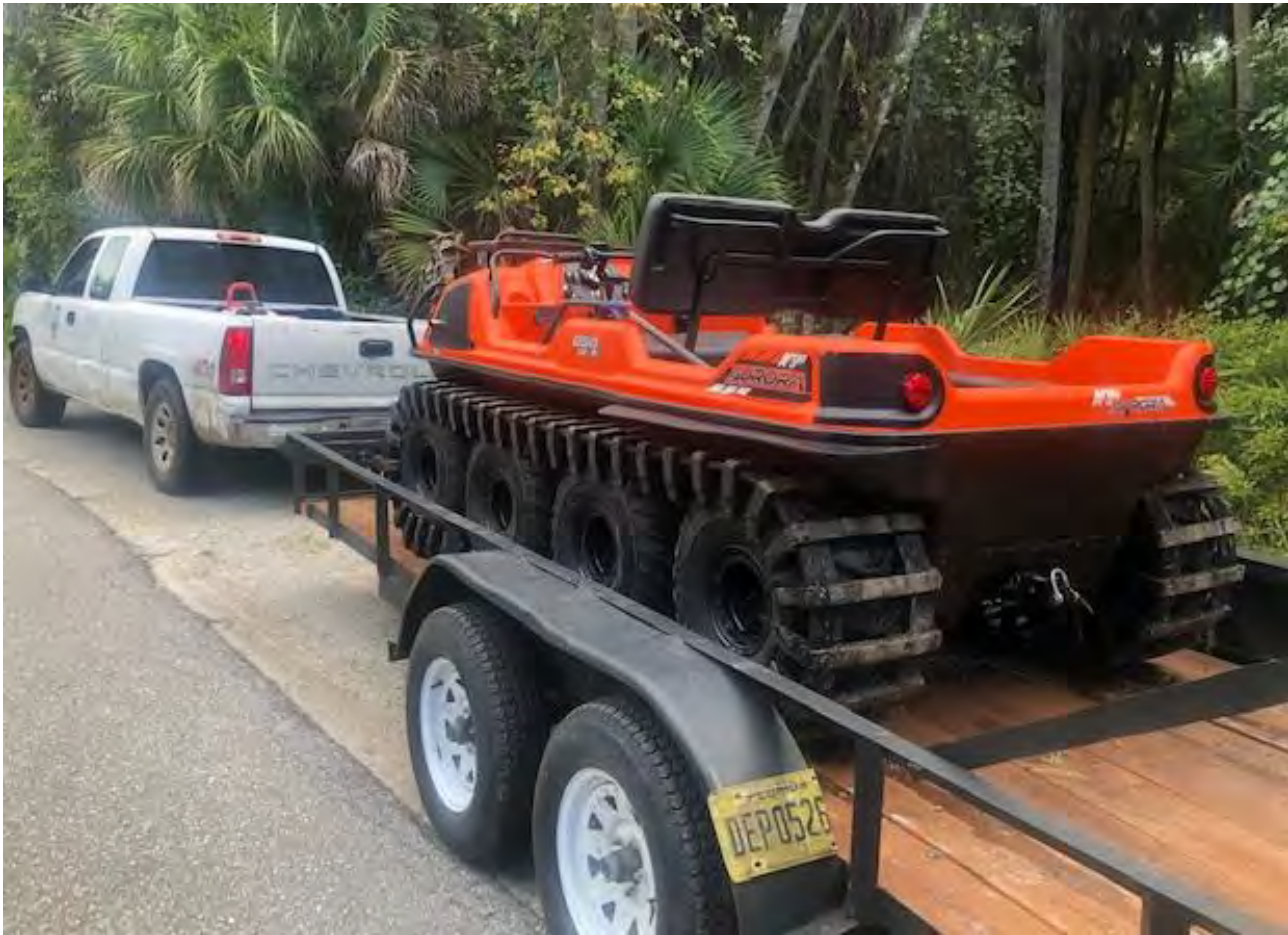
MRSP purchased and began using the above Argo (amphibious UTV) to assist the effort to reduce paragrass while also minimizing impact (July 2021).

3. Expanded efforts to reduce large monoculture areas of paragrass (*Urochloa mutica*) and West Indian Marsh Grass (WIMG, *Hymenachne amplexicaulis*) were undertaken in 2021. This included one aerial herbicide treatment of about 160 acres which was conducted targeting parts of Big Flats Marsh (BFM) down to Fisherman's Loop and the eastern floodplain marsh down to S.R.72. When water levels allowed, additional treatments were conducted by both staff and FWC IPM contractors in MRSP. The Conservation Foundation of the Gulf Coast (CFGC) contractor continues to work areas of paragrass above MRSP.

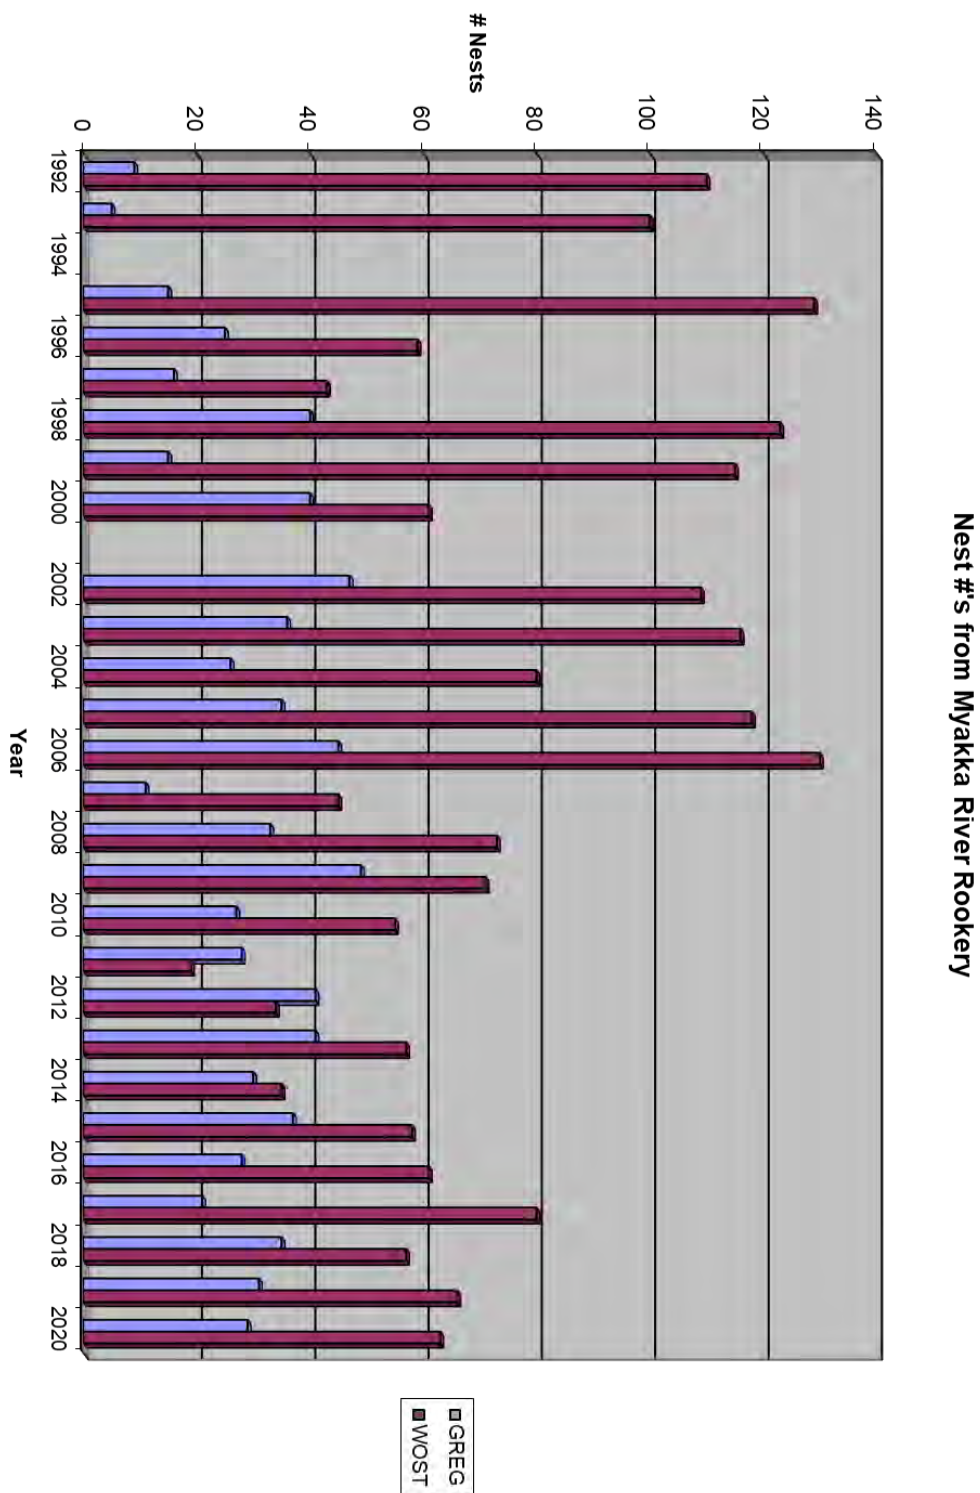
As in previous years, the CWA (Myakka Rookery) was monitored during monthly wildlife surveys. (See graph of estimated nesting by MWSR Program on the following page.)
