# Peace River Streambank Restoration and Myakka River Watershed Threats Assessment and Fish Assemblage Monitoring

Final Report 1 July 2019 – 31 March 2023  
State Wildlife Grant 2953 – PID 9100 250 2953

Submitted to Florida State Wildlife Grants Program  
1 June 2023

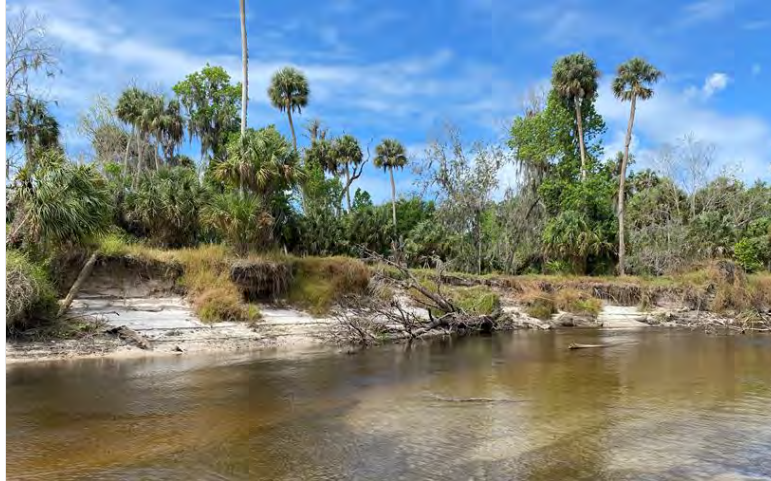
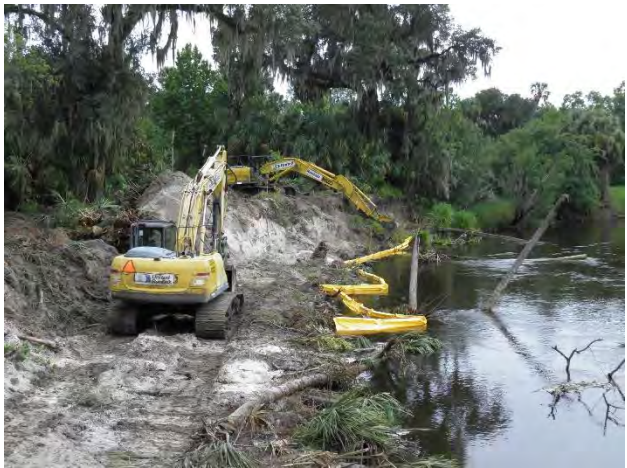
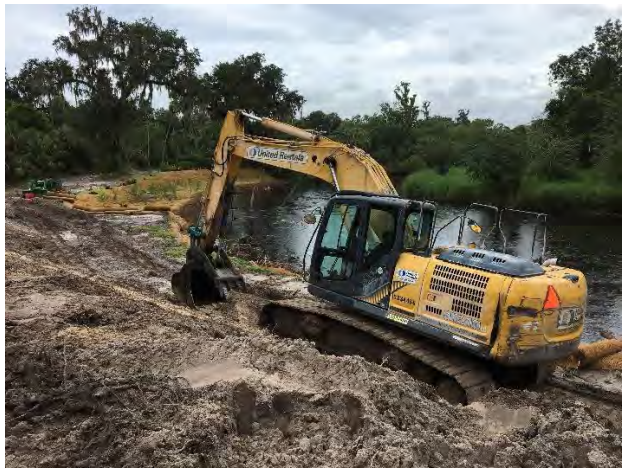
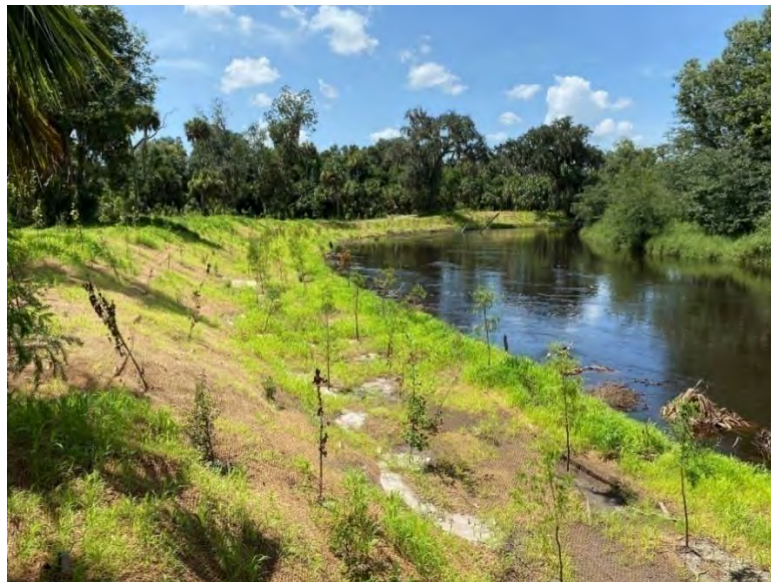
Figure 8. Field photos before (top), during (middle), and after (bottom) restoration at the 450-ft streambank on the Peace River near Zolfo Springs, FL.

***Objective 2: Restore 2 degraded Peace River streambanks by the end of the second fiscal year.*** Construction and planting at the 450-ft restoration site near Zolfo Springs was completed in June 2020 (Figure 8) at a cost of \$138,995.46 (\$308.88/ft). Revegetation included installation of 1,065 plants and 100 pounds of native plant seed mix (Table 4). During spring 2021, site inspection revealed some loss of woody plantings. In May 2021, supplemental planting was funded by AHRE (\$2,496.00) and included installation of 160 plants consisting of bald cypress (*Taxodium distichum*), red maple (*Acer rubrum*), wax myrtle (*Myrica cerifera*), and pop ash (*Fraxinus caroliniana*). Construction and planting at the 1,000-ft restoration site near Arcadia was completed in February 2021 (Figure 9) at a cost of \$305,000.00 (\$305.00/ft). Revegetation included installation of 1,860 plants and 200 pounds of native plant seed mix (Table 5).

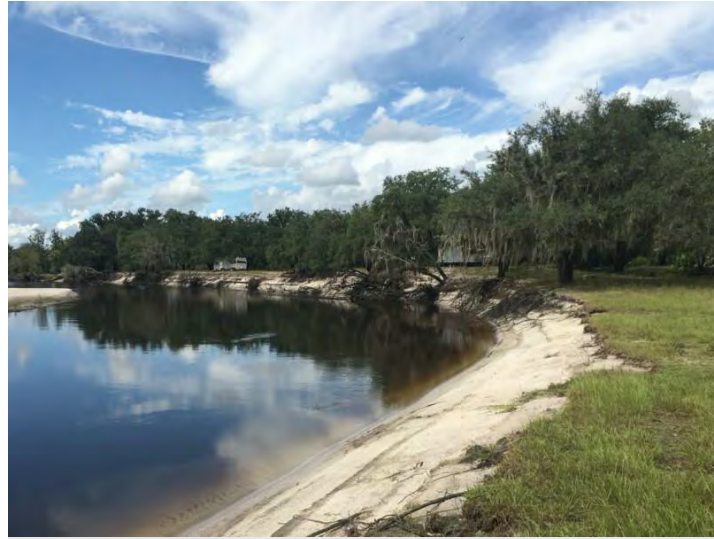
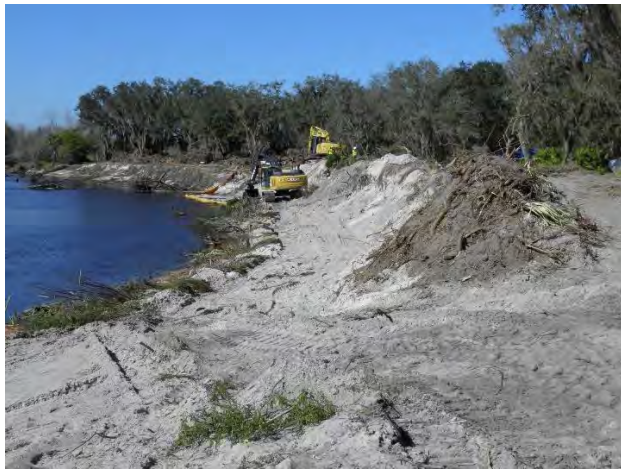
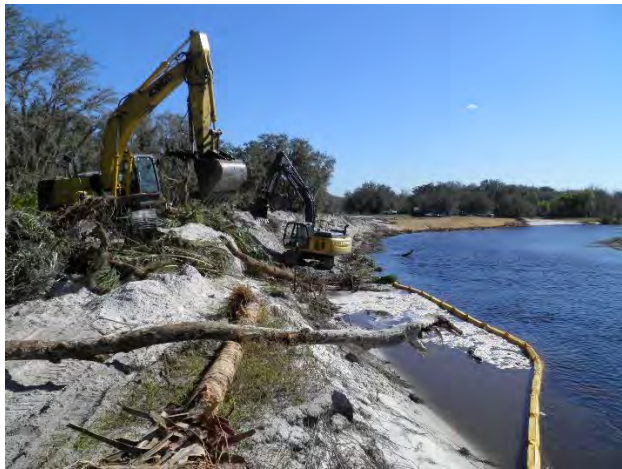
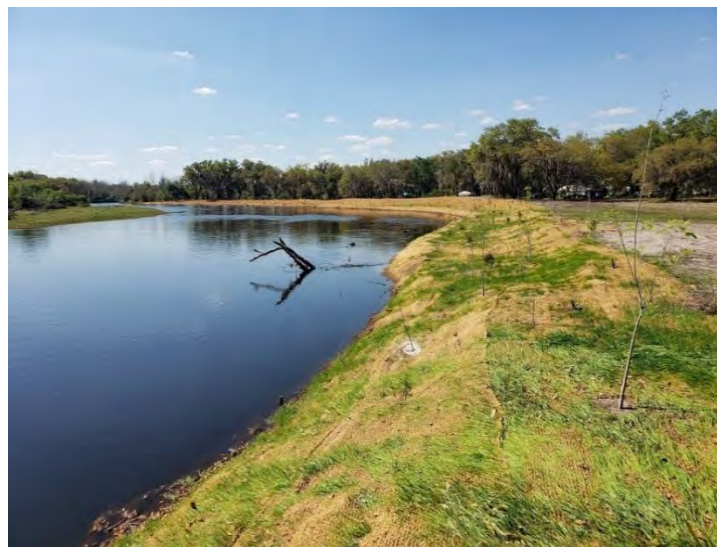
Figure 9. Field photos before (top), during (middle), and after (bottom) restoration at the 1,000-ft streambank on the Peace River near Arcadia, FL.

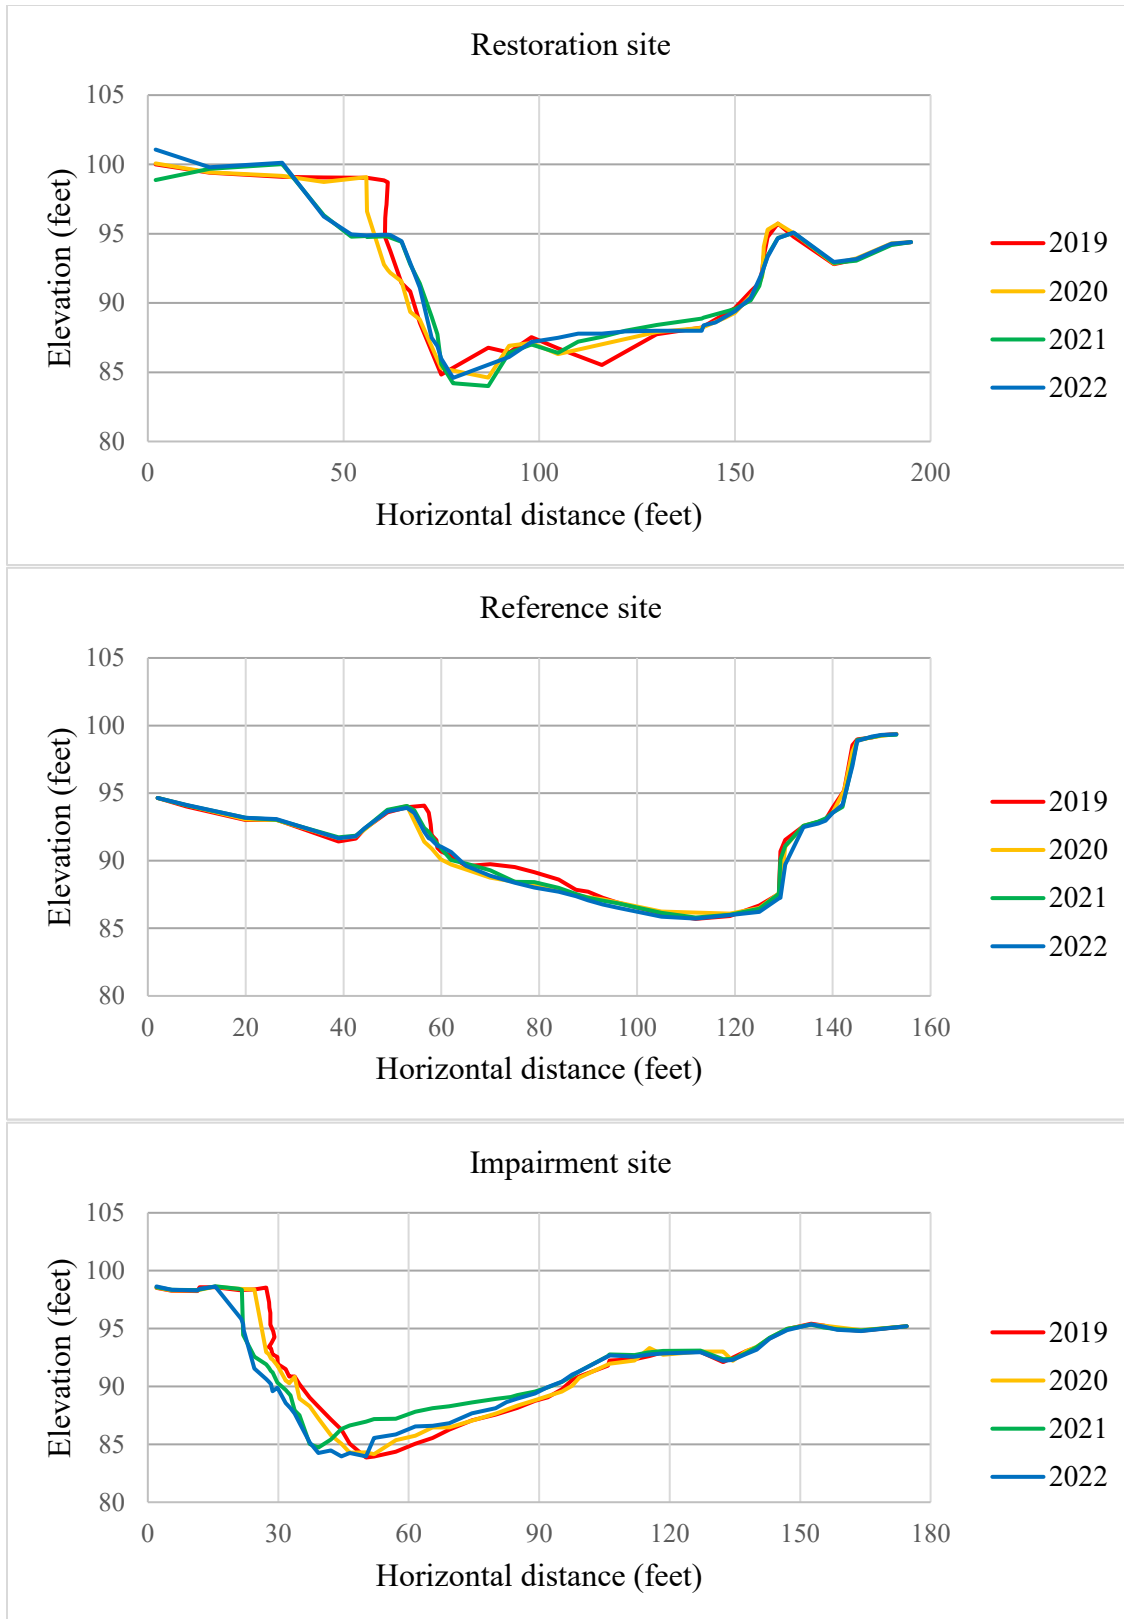
Annual monitoring captured 2 permanent cross section surveys before and 2 surveys after restoration at treatment sites near Zolfo Springs (Figure 10). At the 450-ft restoration site, the bank profile receded horizontally by 5.5 ft during the year before restoration and did not change during the year after restoration. In comparison, bank profile measurements revealed no change at the reference site but receded by 3.8 ft/yr at the impairment site. Erosion rates based on bank profile data averaged 0.3 ft/yr at

the impairment site and 0.1 ft/yr at the reference site (Table 15). The erosion rate at the restoration site resembled that of the impairment site before restoration and that of the reference site after restoration. Prior to restoration, the total erosion rate along the entire length of the restoration site (102 tons/yr) was similar to that of the impairment site (108 tons/yr). After restoration, the total erosion rate along the entire length of the restoration site declined by 87% to 14 tons/yr and was similar to that of the reference site (17 tons/yr). Annual photo points illustrated conditions over time at each of the treatment sites (Figure 11, restoration site; Figure 12, reference site; and Figure 13, impairment site).

Figure 10. Cross section surveys of the restoration, reference, and impairment sites on the Peace River near Zolfo Springs, 2019 to 2022.

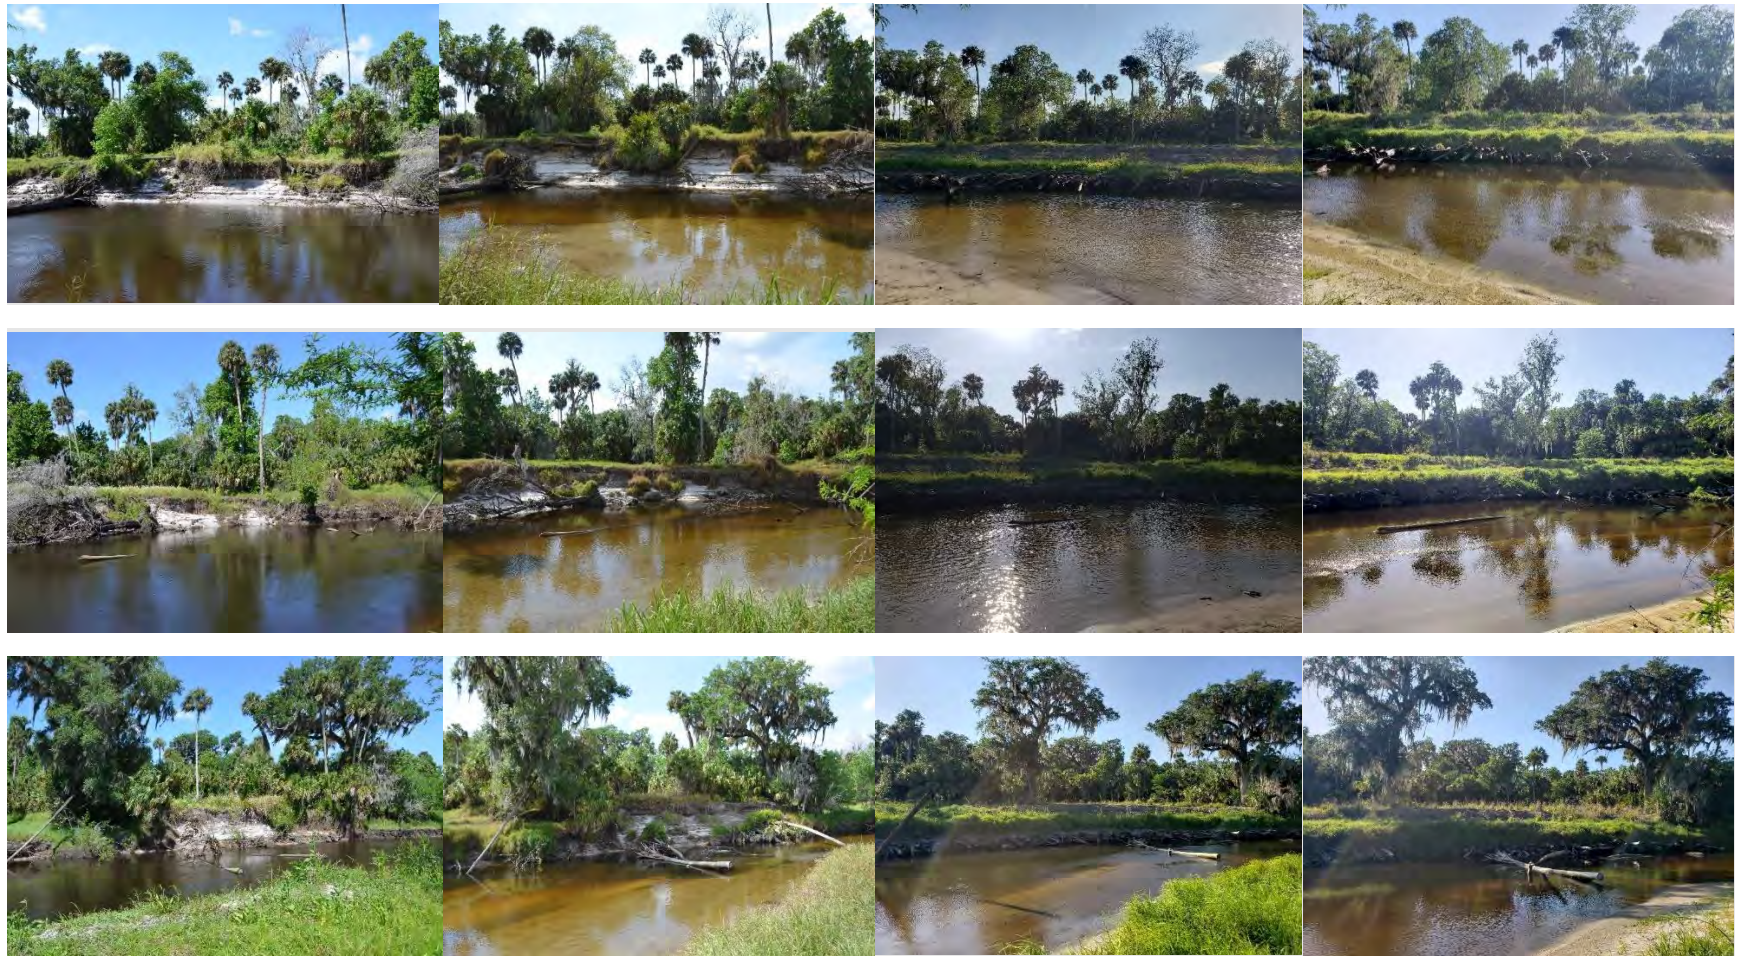
Figure 11. Field photos from photo points REST\_B1 (top), REST\_B2 (middle), and REST\_C1 (bottom) at the restoration site on the Peace River near Zolfo Springs during 2019 to 2022.

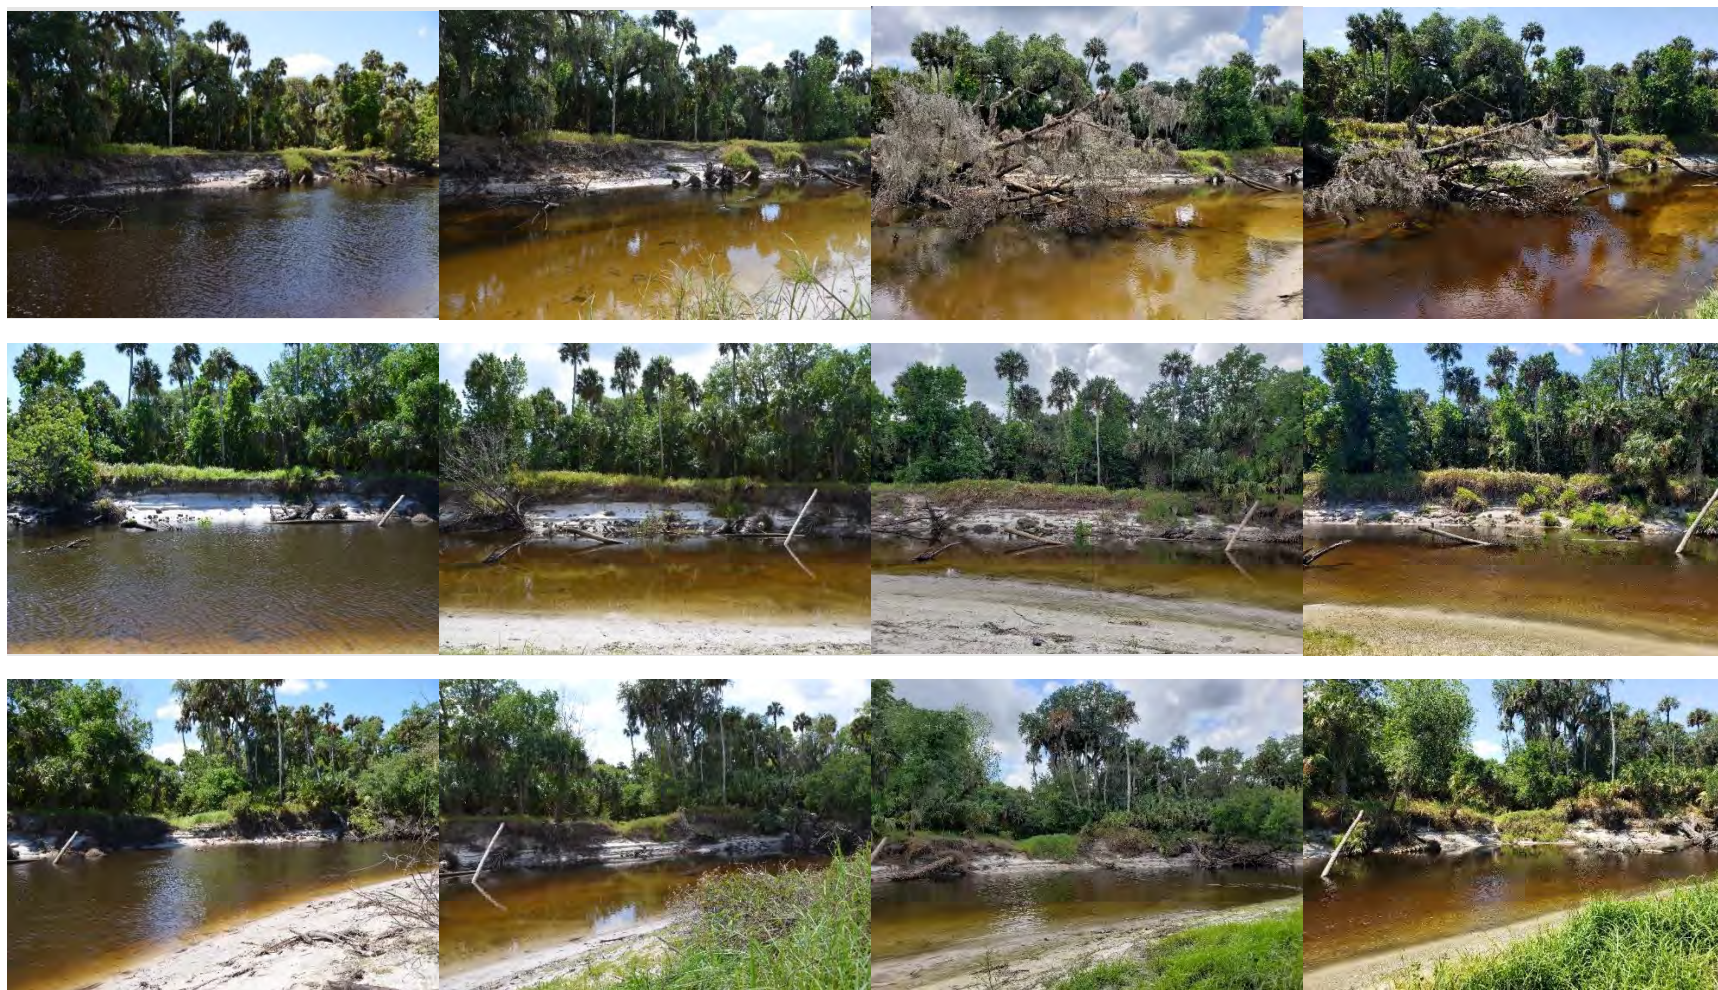
Figure 13. Field photos from photo points IMP\_A2 (top), IMP\_B1 (middle), and IMP\_B2 (bottom) at the impairment site on the Peace River near Zolfo Springs during 2019 to 2022.

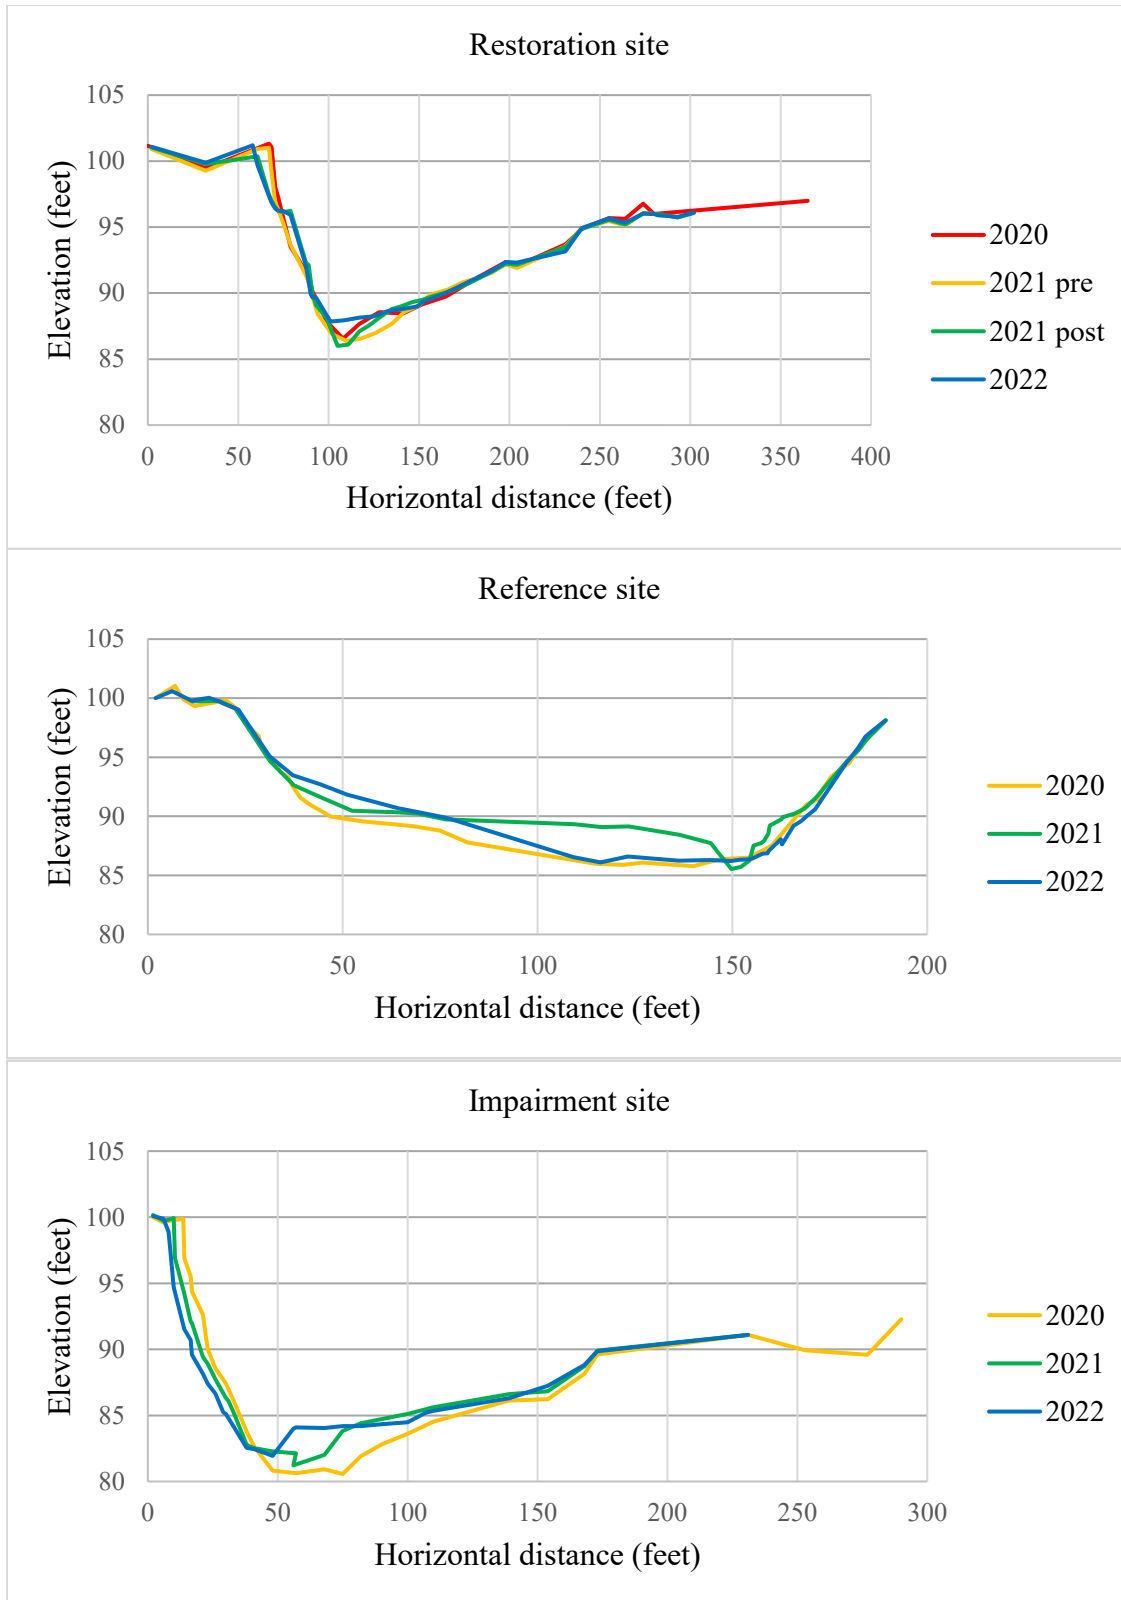
Annual monitoring captured 1 permanent cross section survey before and 2 surveys after restoration at treatment sites near Arcadia, with an additional survey at the restoration site prior to construction (Figure 14). At the 1,000-ft restoration site, the bank profile receded horizontally by 1.6 ft/yr prior to restoration and did not change after restoration. In comparison, bank profile measurements revealed no change at the reference site but receded by 2.6 ft/yr at the impairment site. Erosion rates based on bank profile data averaged 0.5 ft/yr at the impairment site and -0.1 ft/yr (demonstrated aggradation) at the reference site (Table 16). Prior to restoration, erosion at the restoration site (0.4 ft/yr) resembled that of the impairment site. After restoration, the erosion rate declined to 0.1 ft/yr. Prior to restoration, the total erosion rate along the entire length of the restoration site (286 tons/yr) was most like that of the impairment site (385 tons/yr). After restoration, the total erosion rate along the entire length of the restoration site declined by 89% to 32 tons/yr. Annual photo points illustrated conditions over time at each of the treatment sites (Figure 15, restoration site; Figure 16, reference site; and Figure 17, impairment site).

Figure 14. Cross section surveys of the restoration, reference, and impairment sites on the Peace River near Arcadia during 2020 to 2022. Pre = before restoration, post = after restoration.

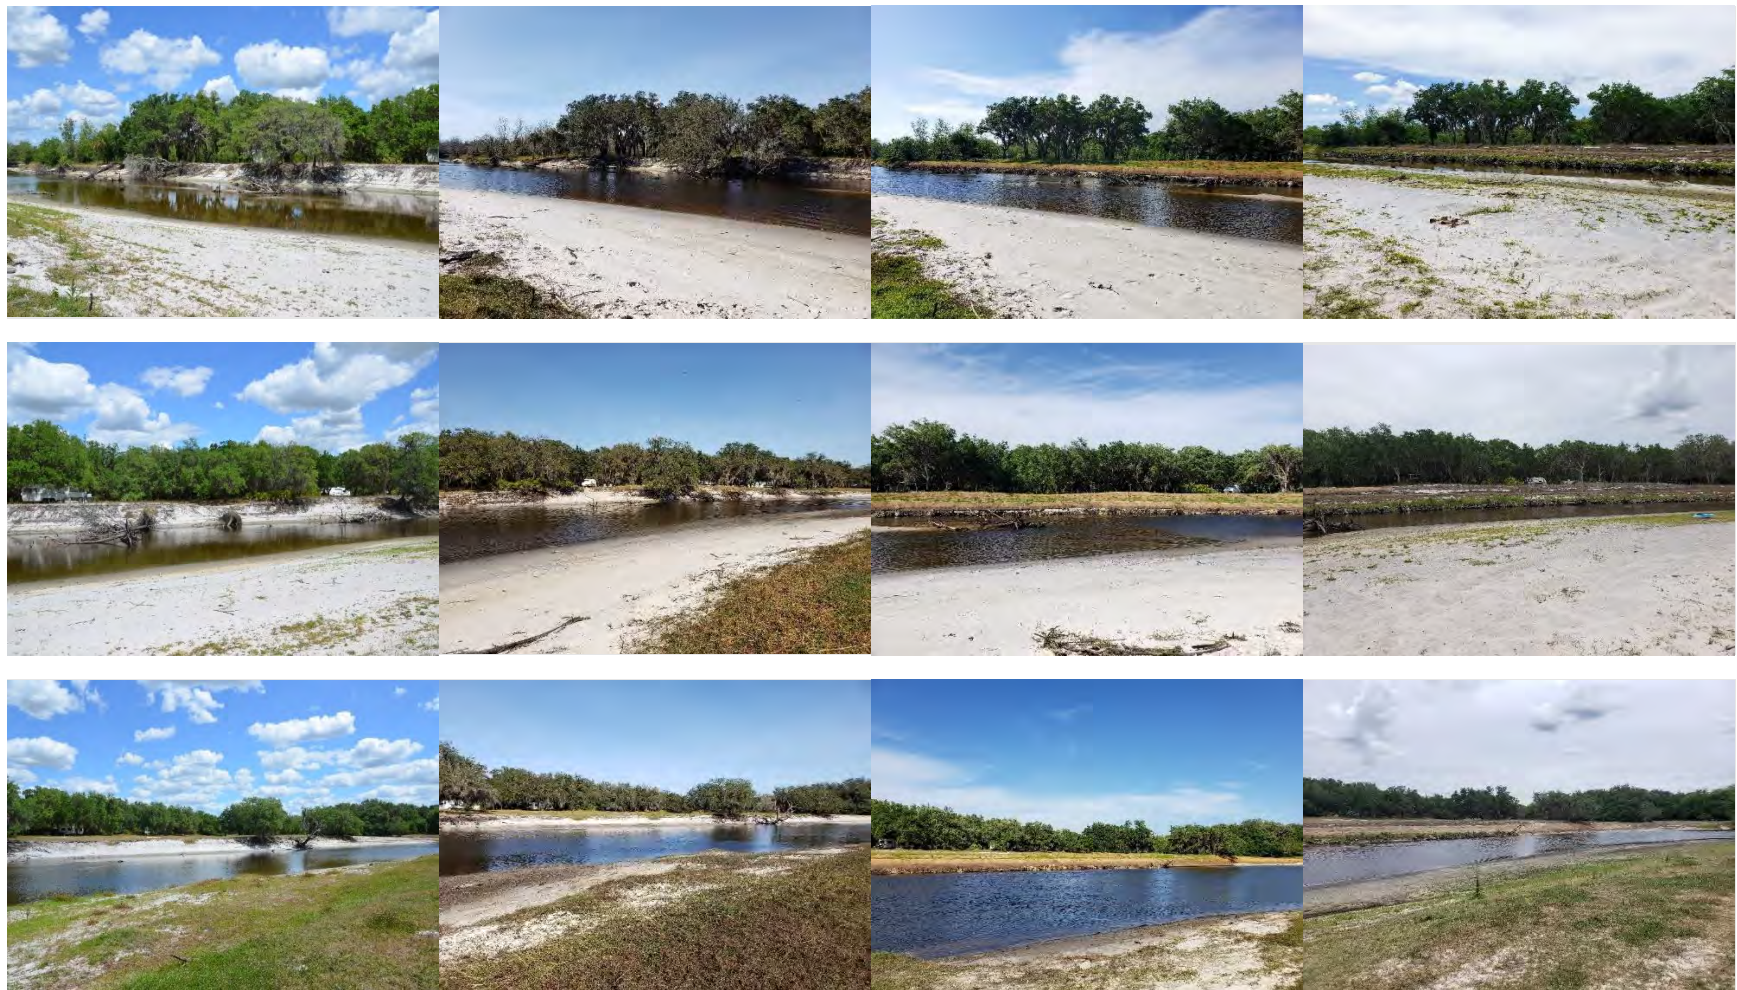
Figure 15. Field photos from photo points REST\_A1 (top), REST\_A2 (middle), and REST\_B2 (bottom) at the restoration site on the Peace River near Arcadia during 2020 to 2022.

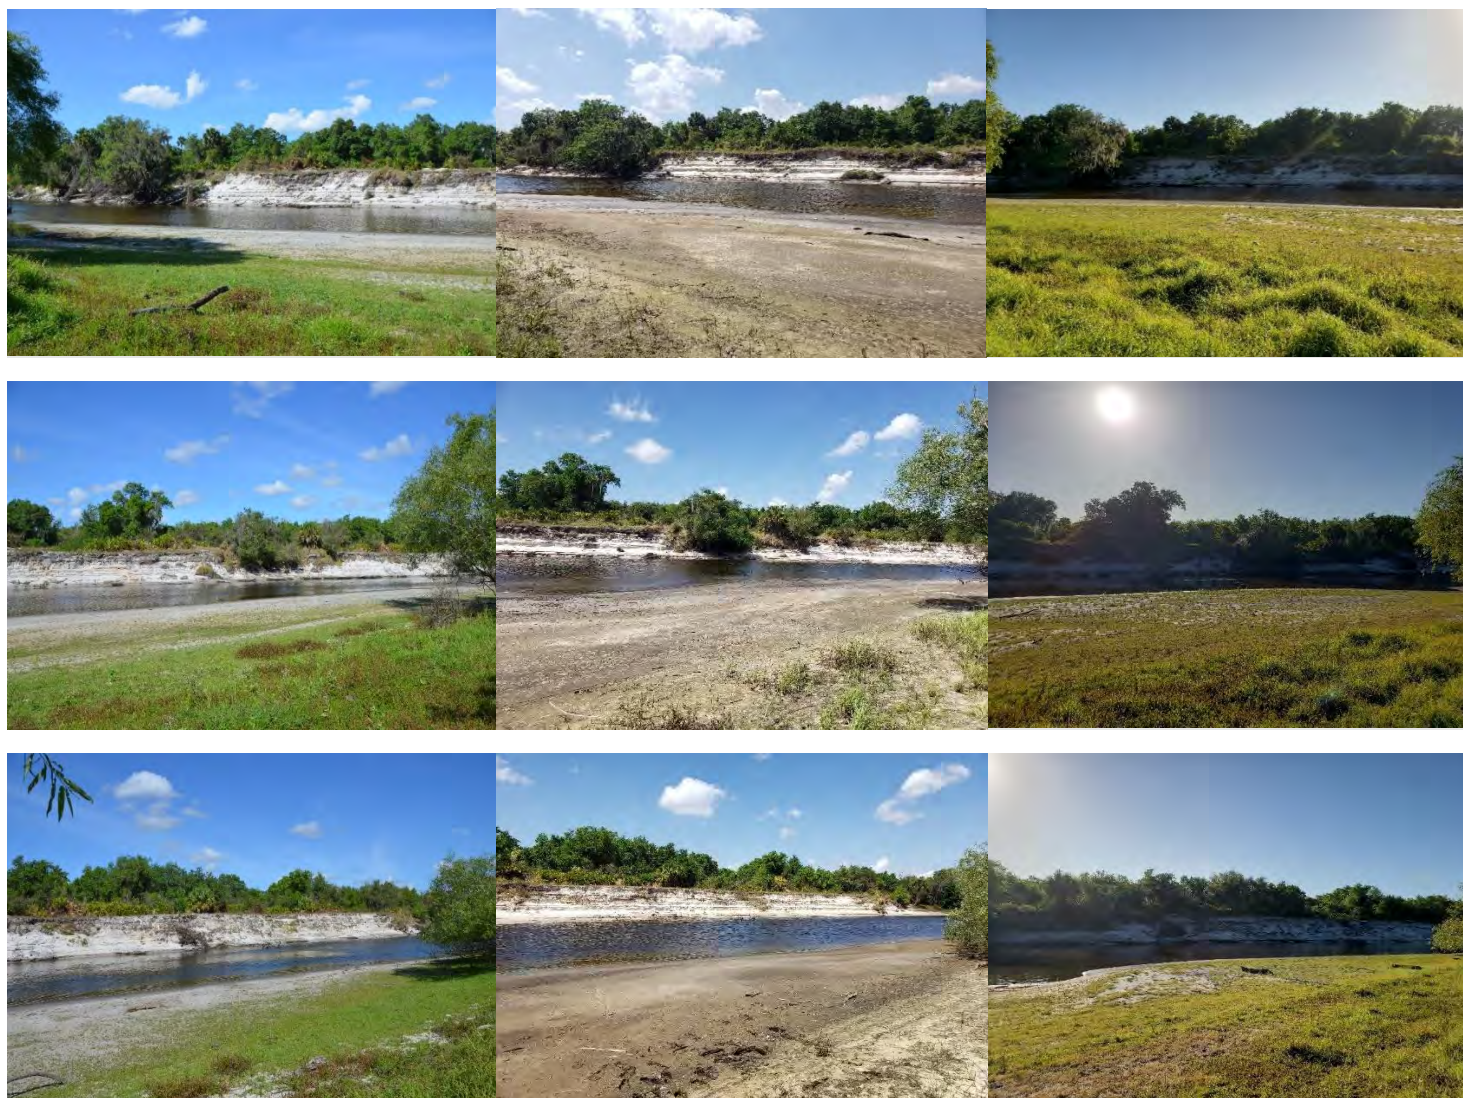
Figure 17. Field photos from photo points IMP\_A1 (top), IMP\_B1 (middle), and IMP\_C1 (bottom) at the impairment site on the Peace River near Arcadia during 2020 to 2022.

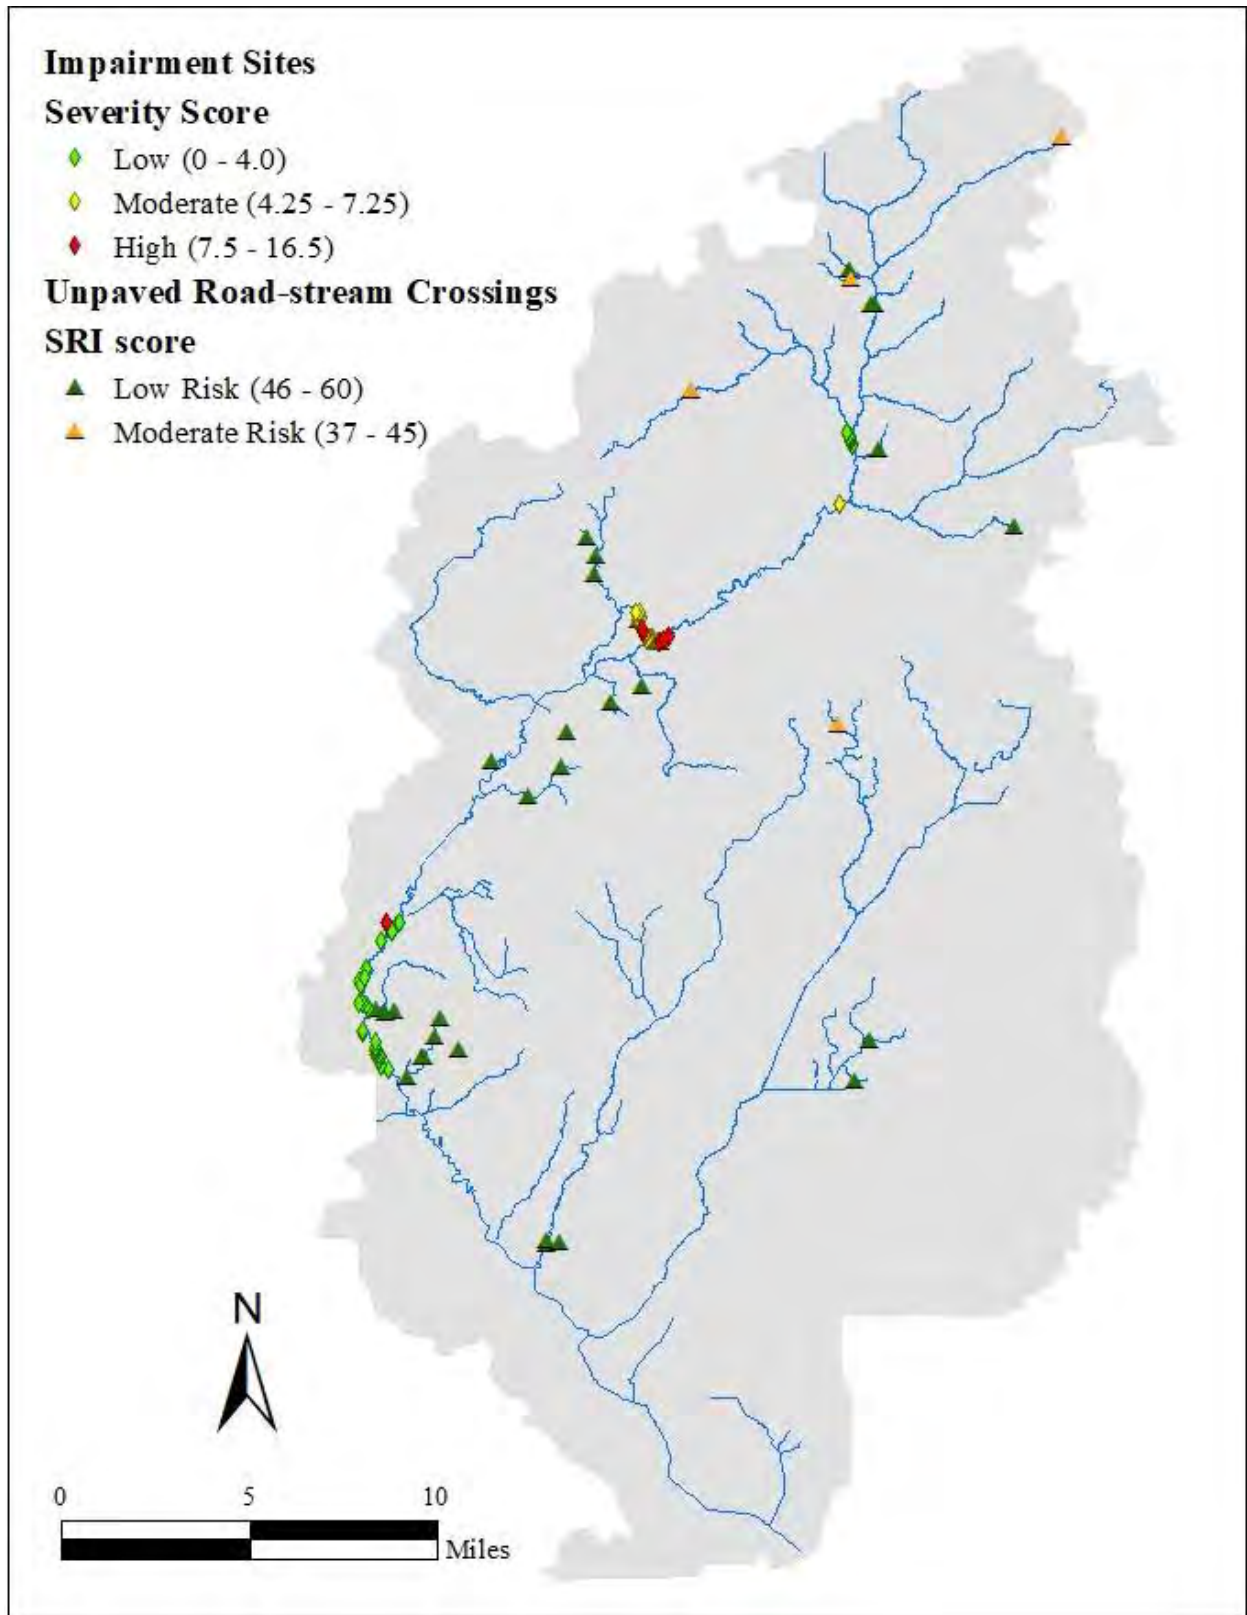
where permission to access was granted (Figure 18). A total of 67 impairment sites were identified, including 41 (61%) ranked “Low Severity,” 20 (30%) ranked “Moderate Severity,” and 6 (9%) ranked “High Severity” (Figure 19). Impairment sites totaled 16,331 ft in length, which included 8,059 ft ranked “Low Severity,” 6,735 ft ranked “Moderate Severity,” and 1,537 ft ranked “High Severity.” Individual site summaries with restoration recommendations were completed for the 67 assessed impairment sites (Appendix C).

Figure 19. Location and ranking of all scored impairment sites and unpaved road-stream crossing sites in the Myakka River Watershed during 2019 to 2022. SRI = Sediment Risk Index.

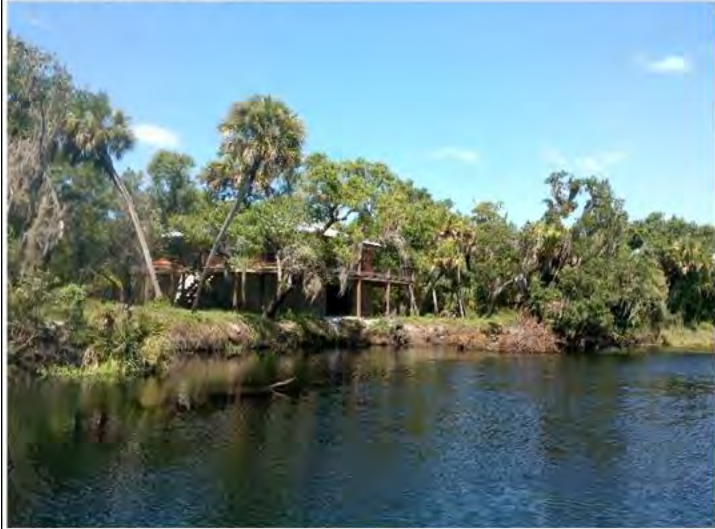
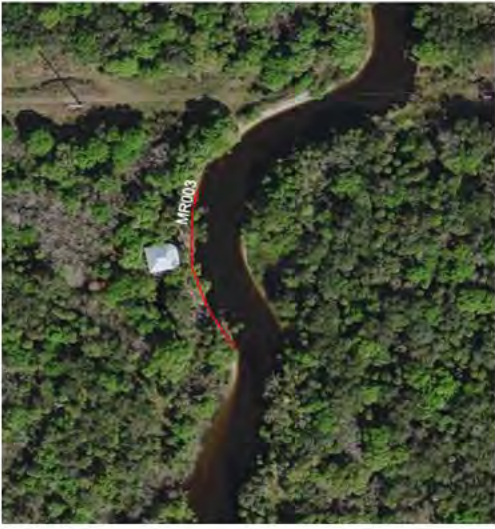
Myakka River			Severity Scale: 2.0 (Low)
Watershed: Myakka River Subwatershed: Harris Camp Latitude: 27.13434 Longitude: -82.35838			County: Sarasota Site Number: MR003 Reach Length: 285 ft. Landowner: *Sarasota County

Risk Factor	Ranking	Score	Restoration Option 2
Pfankuch-Channel Stability:	Good	0	
Channel Alteration:	None	0	
Bank Erosion:	Active Erosion	1	
BEHI:	Moderate (27.0)	0.5	
Local NPSP:	No Evidence	0	
Shoring Structures:	None	0	
Pipe Discharge:	Not Present	0	Additional Site Features
Water Odor:	Normal	0	Stream Channel Woody Material: Numerous
Fish Passage Barrier:	None	0	Impoundments: None
RB: Riparian Buffer (ft.):	40	0.5	Substrate Composition: Medium Sand
LB: Riparian Buffer (ft.):	100	0	Bank Material: Sand
RB: Floodplain Access:	Full	0	Near Bank Stress: Low
LB: Floodplain Access:	Full	0	RB Landuse: Residential, Natural Forest
<b>Severity Scale:</b>		<b>2.0</b>	LB Landuse: Natural Forest

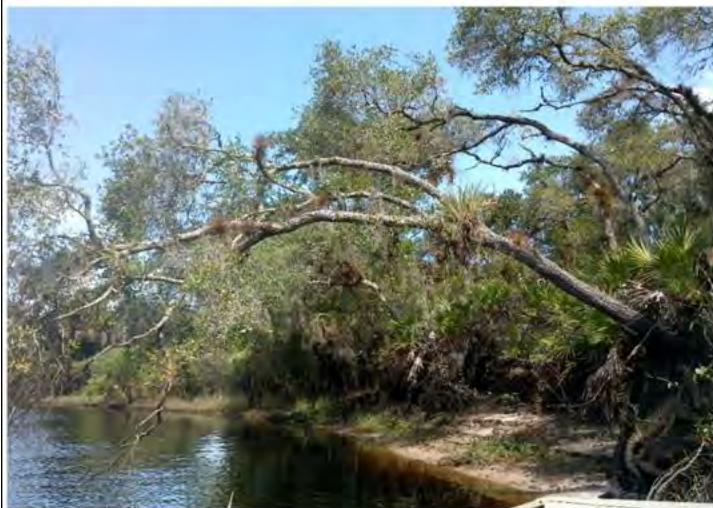
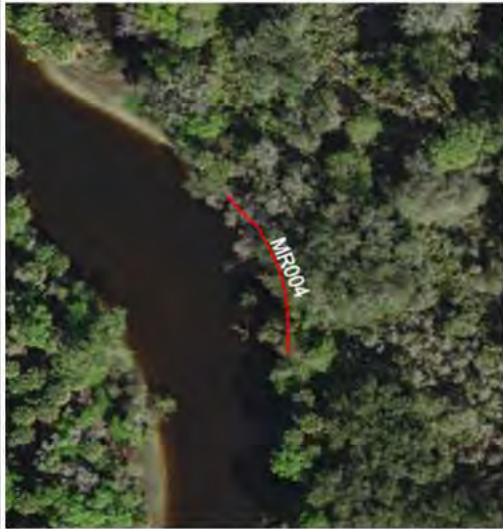
Myakka River			Severity Scale: 1.75 (Low)
Watershed: Myakka River Subwatershed: Harris Camp Latitude: 27.13579 Longitude: -82.35738			County: Sarasota Site Number: MR004 Reach Length: 102 ft. Landowner: Sarasota County

Risk Factor	Ranking	Score	Restoration Option 2
Pfankuch-Channel Stability:	Good	0	
Channel Alteration:	None	0	
Bank Erosion:	Active Erosion	1	
BEHI:	Moderate (24.2)	0.5	
Local NPSP:	No Evidence	0	
Shoring Structures:	None	0	
Pipe Discharge:	Not Present	0	Additional Site Features
Water Odor:	Normal	0	Stream Channel Woody Material: Moderate
Fish Passage Barrier:	None	0	Impoundments: None
RB: Riparian Buffer (ft.):	100	0	Substrate Composition: Medium Sand
LB: Riparian Buffer (ft.):	100	0	Bank Material: Sandy Clay
RB: Floodplain Access:	Full	0	Near Bank Stress: High
LB: Floodplain Access:	Partial	0.25	RB Landuse: Natural Forest
<b>Severity Scale:</b>		<b>1.75</b>	LB Landuse: Natural Forest

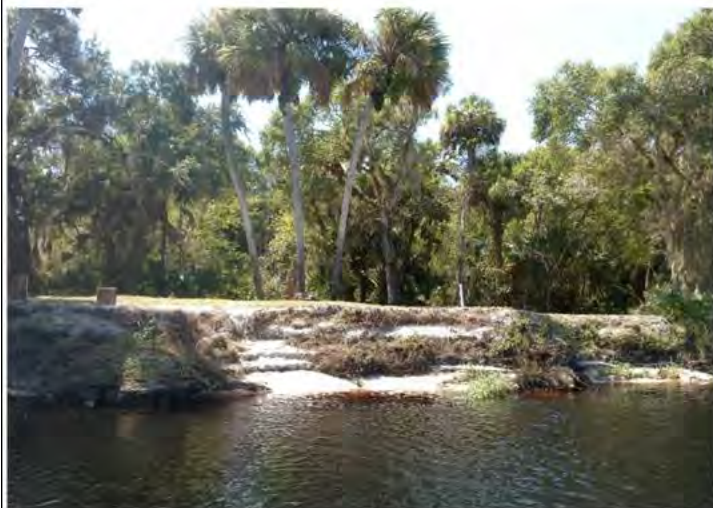
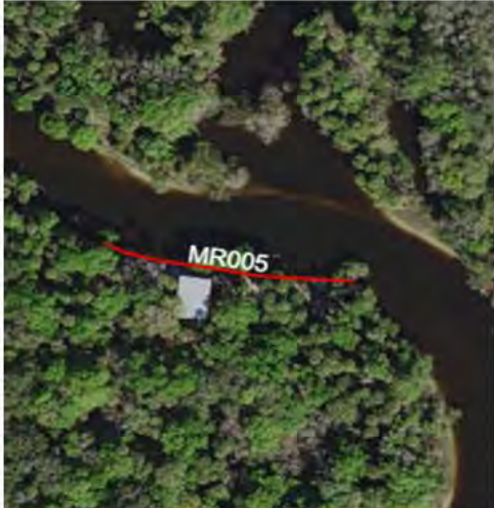
Myakka River			Severity Scale: 2.75 (Low)
Watershed: Myakka River Subwatershed: Harris Camp Latitude: 27.13595 Longitude: -82.35822			County: Sarasota Site Number: MR005 Reach Length: 223 ft. Landowner: Fourtoads LLC

Risk Factor	Ranking	Score	<b>Restoration Option 2</b>  <b>Additional Site Features</b> Stream Channel Woody Material: Moderate Impoundments: None Substrate Composition: Medium Sand Bank Material: Sand Near Bank Stress: Very Low RB Landuse: Residential, Natural Forest LB Landuse: Natural Forest
Pfankuch-Channel Stability:	Good	0	
Channel Alteration:	None	0	
Bank Erosion:	Active Erosion	1	
BEHI:	High (34.0)	1	
Local NPSP:	No Evidence	0	
Shoring Structures:	None	0	
Pipe Discharge:	Not Present	0	
Water Odor:	Normal	0	
Fish Passage Barrier:	None	0	
RB: Riparian Buffer (ft.):	0	0.75	
LB: Riparian Buffer (ft.):	100	0	
RB: Floodplain Access:	Full	0	
LB: Floodplain Access:	Full	0	
<b>Severity Scale:</b>		<b>2.75</b>

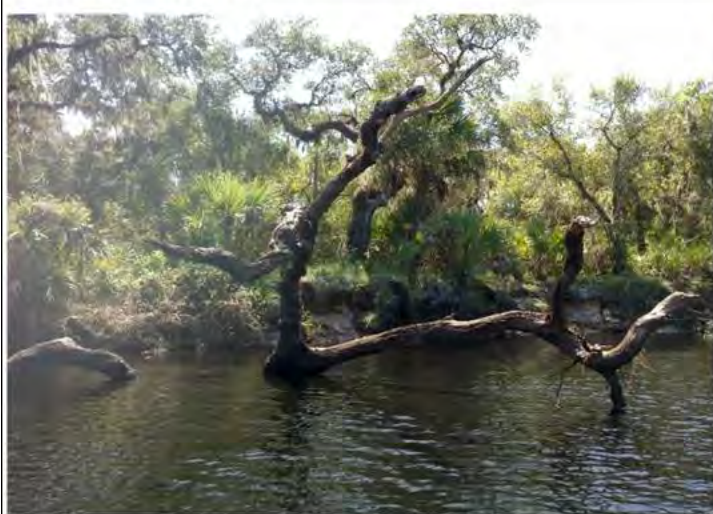
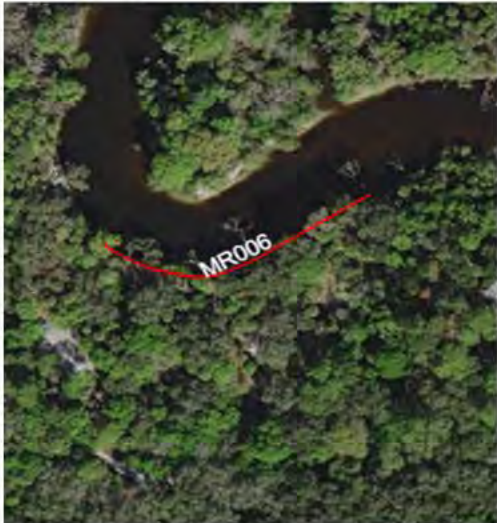
Myakka River			Severity Scale: 1.75 (Low)
Watershed: Myakka River Subwatershed: Harris Camp Latitude: 27.13633 Longitude: -82.35992			County: Sarasota Site Number: MR006 Reach Length: 271 ft. Landowner: David B. Shroyer

Risk Factor	Ranking	Score	Restoration Option 2
Pfankuch-Channel Stability:	Good	0	
Channel Alteration:	None	0	
Bank Erosion:	Active Erosion	1	
BEHI:	Moderate (27.8)	0.5	
Local NPSP:	No Evidence	0	
Shoring Structures:	None	0	
Pipe Discharge:	Not Present	0	
			Additional Site Features
Water Odor:	Normal	0	Stream Channel Woody Material: Extensive
Fish Passage Barrier:	None	0	Impoundments: None
RB: Riparian Buffer (ft.):	70	0.25	Substrate Composition: Medium Sand
LB: Riparian Buffer (ft.):	100	0	Bank Material: Sandy Stone
RB: Floodplain Access:	Full	0	Near Bank Stress: Low
LB: Floodplain Access:	Full	0	RB Landuse: Natural Forest, Historic Pasture
		<b>Severity Scale:</b>	LB Landuse: Natural Forest

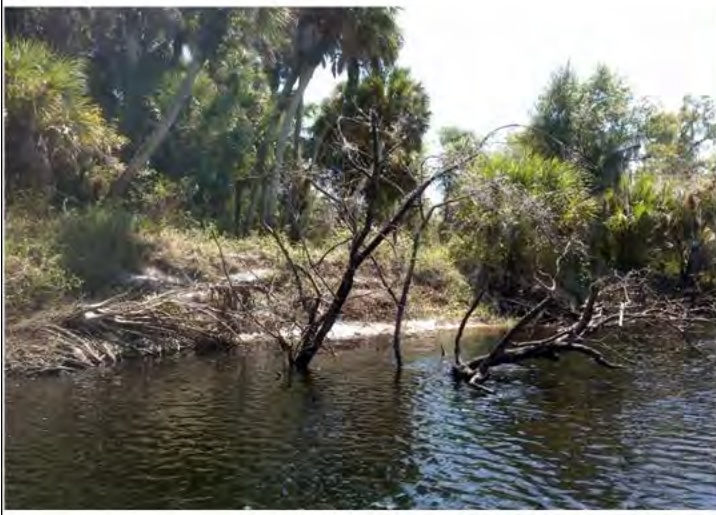
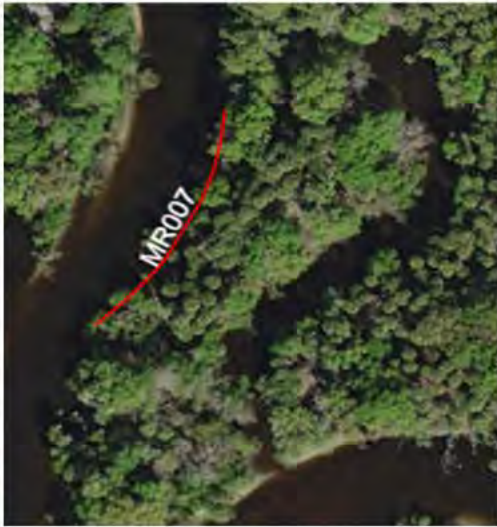
Myakka River			Severity Scale: 2.0 (Low)
Watershed: Myakka River Subwatershed: Harris Camp Latitude: 27.13738 Longitude: -82.35988			County: Sarasota Site Number: MR007 Reach Length: 230 ft. Landowner: Sarasota County

Risk Factor	Ranking	Score	Restoration Option 2
Pfankuch-Channel Stability:	Good	0	
Channel Alteration:	None	0	
Bank Erosion:	Active Erosion	1	
BEHI:	High (32.9)	1	
Local NPSP:	No Evidence	0	
Shoring Structures:	None	0	
Pipe Discharge:	Not Present	0	Additional Site Features
Water Odor:	Normal	0	Stream Channel Woody Material: Moderate
Fish Passage Barrier:	None	0	Impoundments: None
RB: Riparian Buffer (ft.):	100	0	Substrate Composition: Medium Sand
LB: Riparian Buffer (ft.):	100	0	Bank Material: Sand
RB: Floodplain Access:	Full	0	Near Bank Stress: Low
LB: Floodplain Access:	Full	0	RB Landuse: Natural Forest
<b>Severity Scale:</b>		<b>2.0</b>	LB Landuse: Natural Forest
Notes:

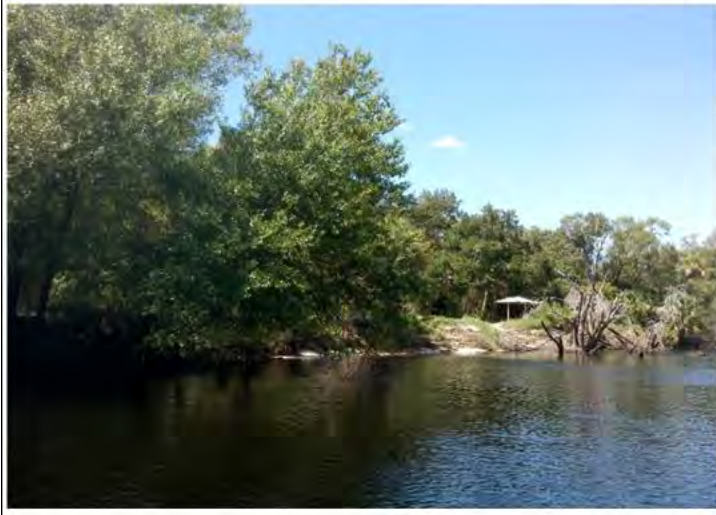
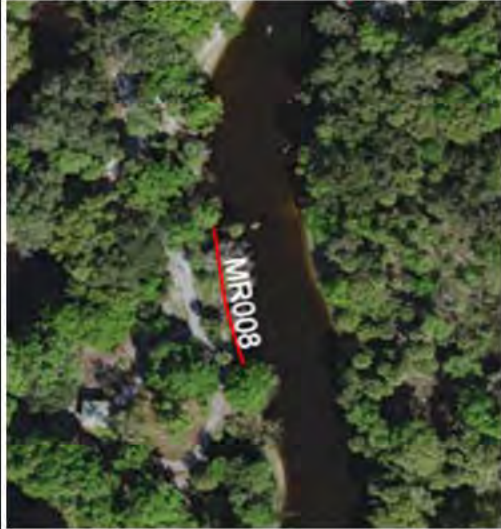
Myakka River			Severity Scale: 2.75 (Low)
Watershed: Myakka River Subwatershed: Harris Camp Latitude: 27.13825 Longitude: -82.36015			County: Sarasota Site Number: MR008 Reach Length: 105 ft. Landowner: City of Venice

Risk Factor	Ranking	Score	<b>Restoration Option 2</b>           <b>Additional Site Features</b> Stream Channel Woody Material: Moderate Impoundments: None Substrate Composition: Medium Sand Bank Material: Sand Near Bank Stress: Low RB Landuse: Recreational, Natural Forest LB Landuse: Natural Forest
Pfankuch-Channel Stability:	Good	0	
Channel Alteration:	None	0	
Bank Erosion:	Active Erosion	1	
BEHI:	High (35.0)	1	
Local NPSP:	No Evidence	0	
Shoring Structures:	None	0	
Pipe Discharge:	Not Present	0	
Water Odor:	Normal	0	
Fish Passage Barrier:	None	0	
RB: Riparian Buffer (ft.):	0	0.75	
LB: Riparian Buffer (ft.):	100	0	
RB: Floodplain Access:	Full	0	
LB: Floodplain Access:	Full	0	
<b>Severity Scale:</b>		<b>2.75</b>

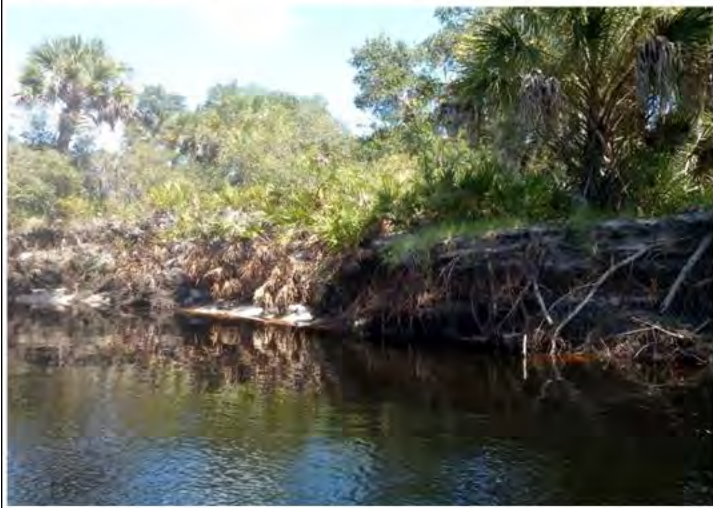
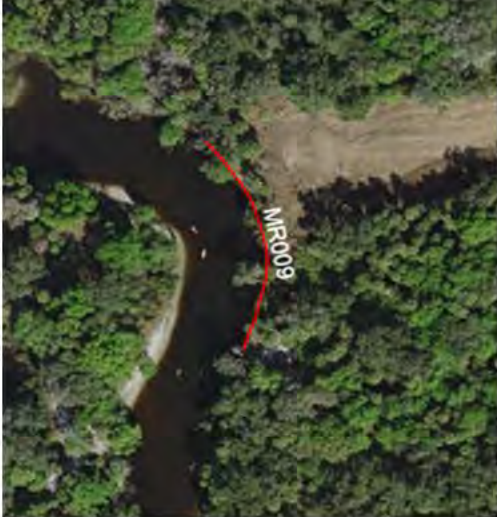
Myakka River			Severity Scale: 2.25 (Low)
Watershed: Myakka River Subwatershed: Harris Camp Latitude: 27.13920 Longitude: -82.35979			County: Sarasota Site Number: MR009 Reach Length: 225 ft. Landowner: Sarasota County

Risk Factor	Ranking	Score	Restoration Option 2
Pfankuch-Channel Stability:	Good	0	
Channel Alteration:	None	0	
Bank Erosion:	Active Erosion	1	
BEHI:	Moderate (23.4)	0.5	
Local NPSP:	No Evidence	0	
Shoring Structures:	None	0	
Pipe Discharge:	Not Present	0	Additional Site Features
Water Odor:	Normal	0	Stream Channel Woody Material: Moderate
Fish Passage Barrier:	None	0	Impoundments: None
RB: Riparian Buffer (ft.):	100	0	Substrate Composition: Medium Sand
LB: Riparian Buffer (ft.):	40	0.5	Bank Material: Sandy Clay
RB: Floodplain Access:	Full	0	Near Bank Stress: Low
LB: Floodplain Access:	Partial	0.25	RB Landuse: Natural Forest
<b>Severity Scale:</b>		<b>2.25</b>	LB Landuse: Utility, Natural Forest
