# Peace River Streambank Restoration and Myakka River Watershed Threats Assessment and Fish Assemblage Monitoring

Final Report 1 July 2019 – 31 March 2023  
State Wildlife Grant 2953 – PID 9100 250 2953

Submitted to Florida State Wildlife Grants Program  
1 June 2023

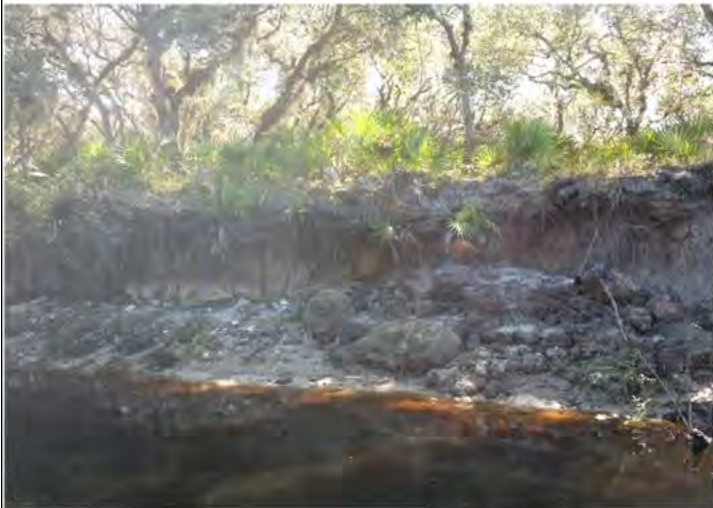
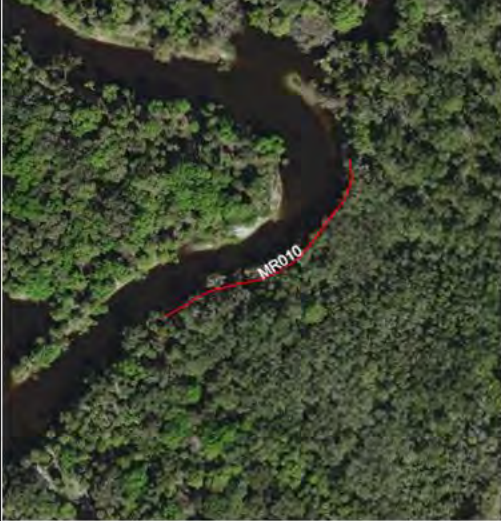
Myakka River			Severity Scale: 2.25 (Low)
Watershed: Myakka River Subwatershed: Harris Camp Latitude: 27.14094 Longitude: -82.35960			County: Sarasota Site Number: MR010 Reach Length: 400 ft. Landowner: Sarasota County

Risk Factor	Ranking	Score	Restoration Option 1
Pfankuch-Channel Stability:	Good	0	
Channel Alteration:	None	0	
Bank Erosion:	Active Erosion	1	
BEHI:	High (32.2)	1	
Local NPSP:	No Evidence	0	
Shoring Structures:	None	0	
Pipe Discharge:	Not Present	0	Additional Site Features
Water Odor:	Normal	0	Stream Channel Woody Material: Moderate
Fish Passage Barrier:	None	0	Impoundments: None
RB: Riparian Buffer (ft.):	100	0	Substrate Composition: Medium Sand
LB: Riparian Buffer (ft.):	100	0	Bank Material: Sandy Clay
RB: Floodplain Access:	Full	0	Near Bank Stress: Low
LB: Floodplain Access:	Partial	0.25	RB Landuse: Natural Forest
<b>Severity Scale:</b>		<b>2.25</b>	LB Landuse: Natural Forest

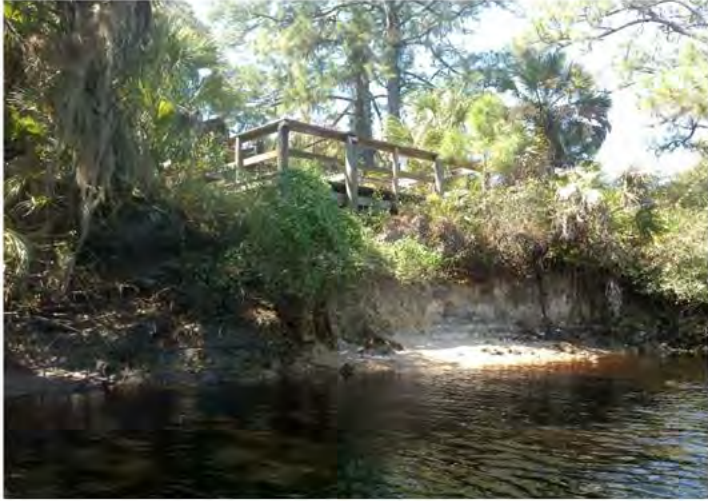
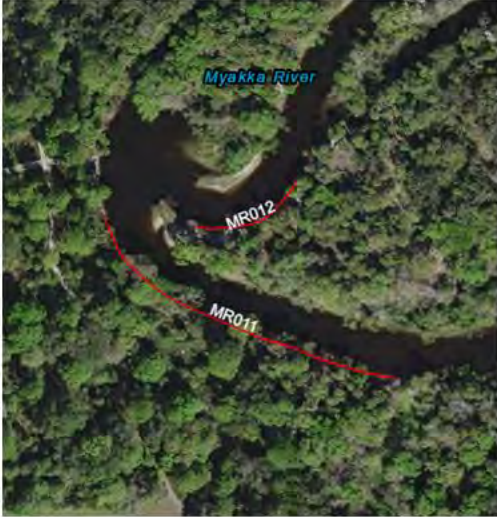
Myakka River			Severity Scale: 2.5 (Low)
Watershed: Myakka River Subwatershed: Harris Camp Latitude: 27.14523 Longitude: -82.36528			County: Sarasota Site Number: MR011 Reach Length: 500 ft. Landowner: Property owner assn. inc.

Risk Factor	Ranking	Score	Restoration Option 1
Pfankuch-Channel Stability:	Good	0	
Channel Alteration:	None	0	
Bank Erosion:	Active Erosion	1	
BEHI:	High (35.6)	1	
Local NPSP:	No Evidence	0	
Shoring Structures:	None	0	
Pipe Discharge:	Not Present	0	Additional Site Features
Water Odor:	Normal	0	Stream Channel Woody Material: Numerous
Fish Passage Barrier:	None	0	Impoundments: None
RB: Riparian Buffer (ft.):	70	0.25	Substrate Composition: Medium Sand
LB: Riparian Buffer (ft.):	100	0	Bank Material: Sandy Stone
RB: Floodplain Access:	Partial	0.25	Near Bank Stress: High
LB: Floodplain Access:	Full	0	RB Landuse: Natural Forest, Residential
<b>Severity Scale:</b>		<b>2.5</b>	LB Landuse: Natural Forest

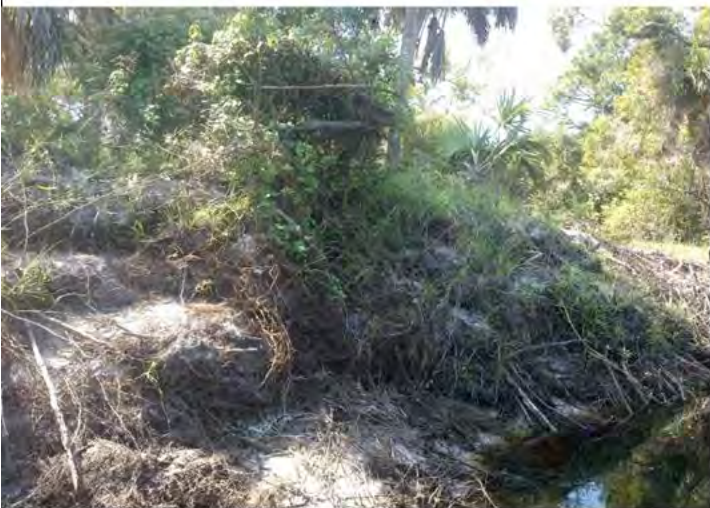
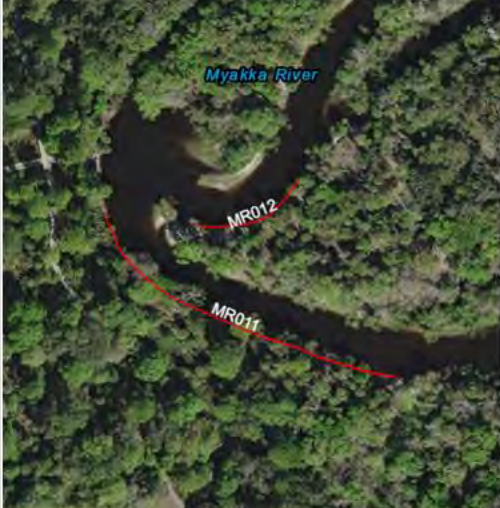
Myakka River			Severity Scale: 2.0 (Low)
Watershed: Myakka River Subwatershed: Harris Camp Latitude: 27.14561 Longitude: -82.36510			County: Sarasota Site Number: MR012 Reach Length: 175 ft. Landowner: Sarasota County

Risk Factor	Ranking	Score	<b>Restoration Option 2</b>  <b>Additional Site Features</b> Stream Channel Woody Material: Infrequent Impoundments: None Substrate Composition: Medium Sand Bank Material: Sand Near Bank Stress: Low RB Landuse: Natural Forest LB Landuse: Natural Forest
Pfankuch-Channel Stability:	Good	0	
Channel Alteration:	None	0	
Bank Erosion:	Active Erosion	1	
BEHI:	High (31.2)	1	
Local NPSP:	No Evidence	0	
Shoring Structures:	None	0	
Pipe Discharge:	Not Present	0	
Water Odor:	Normal	0	
Fish Passage Barrier:	None	0	
RB: Riparian Buffer (ft.):	100	0	
LB: Riparian Buffer (ft.):	100	0	
RB: Floodplain Access:	Full	0	
LB: Floodplain Access:	Full	0	
<b>Severity Scale:</b>		<b>2</b>

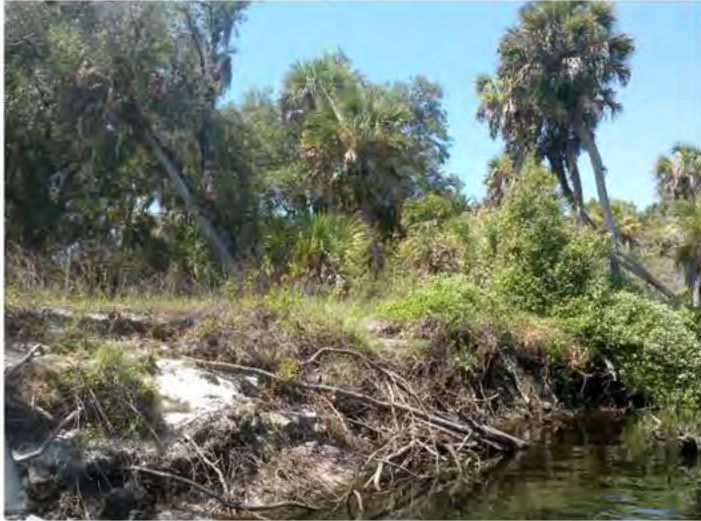
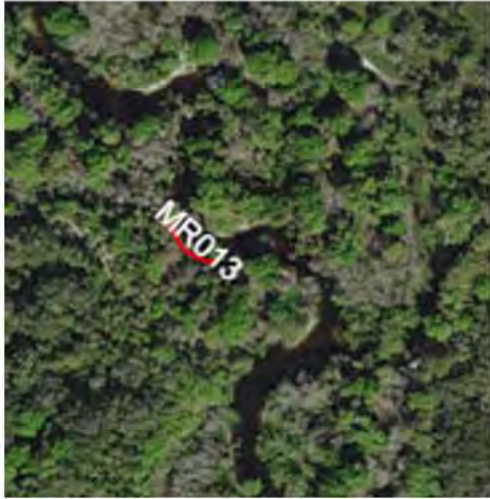
Myakka River			Severity Scale: 1.5 (Low)
Watershed: Myakka River Subwatershed: Harris Camp Latitude: 27.15365 Longitude: -82.36247			County: Sarasota Site Number: MR013 Reach Length: 95 ft. Landowner: Sarasota County

Risk Factor	Ranking	Score	Restoration Option 3
Pfankuch-Channel Stability:	Good	0	
Channel Alteration:	None	0	
Bank Erosion:	Active Erosion	1	
BEHI:	Moderate (25.3)	0.5	
Local NPSP:	No Evidence	0	
Shoring Structures:	None	0	
Pipe Discharge:	Not Present	0	Additional Site Features
Water Odor:	Normal	0	Stream Channel Woody Material: Numerous
Fish Passage Barrier:	None	0	Impoundments: None
RB: Riparian Buffer (ft.):	100	0	Substrate Composition: Medium Sand
LB: Riparian Buffer (ft.):	100	0	Bank Material: Sand
RB: Floodplain Access:	Full	0	Near Bank Stress: Low
LB: Floodplain Access:	Full	0	RB Landuse: Natural Forest
<b>Severity Scale:</b>		<b>1.5</b>	LB Landuse: Natural Forest
Notes:

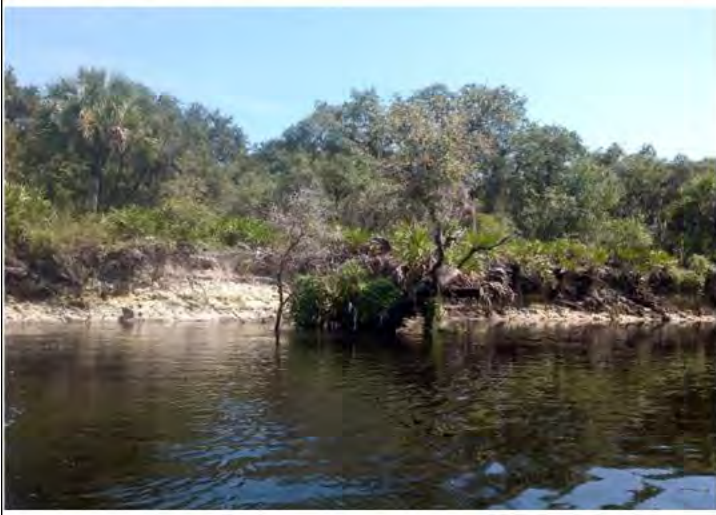
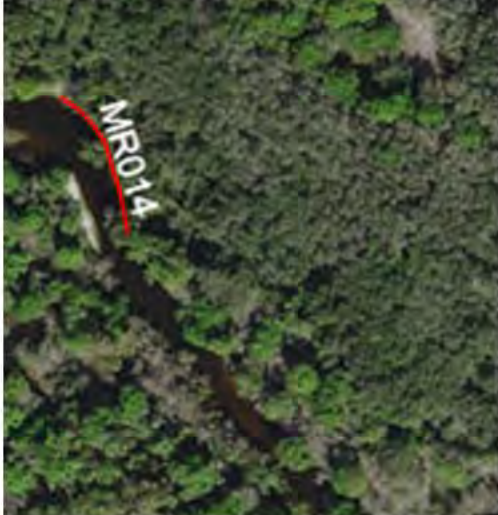
Myakka River			Severity Scale: 1.75 (Low)
Watershed: Myakka River Subwatershed: Harris Camp Latitude: 27.15572 Longitude: -82.36391			County: Sarasota Site Number: MR014 Reach Length: 200 ft. Landowner: Sarasota County

Risk Factor	Ranking	Score	Restoration Option 2
Pfankuch-Channel Stability:	Good	0	
Channel Alteration:	None	0	
Bank Erosion:	Active Erosion	1	
BEHI:	Moderate (28.3)	0.5	
Local NPSP:	No Evidence	0	
Shoring Structures:	None	0	
			Additional Site Features
Pipe Discharge:	Not Present	0	Stream Channel Woody Material: Moderate
Water Odor:	Normal	0	Impoundments: None
Fish Passage Barrier:	None	0	Substrate Composition: Medium Sand
RB: Riparian Buffer (ft.):	100	0	Bank Material: Sandy Clay
LB: Riparian Buffer (ft.):	100	0	Near Bank Stress: Very Low
RB: Floodplain Access:	Full	0	RB Landuse: Natural Forest
LB: Floodplain Access:	Partial	0.25	LB Landuse: Natural Forest
		<b>Severity Scale:</b>	<b>1.75</b>

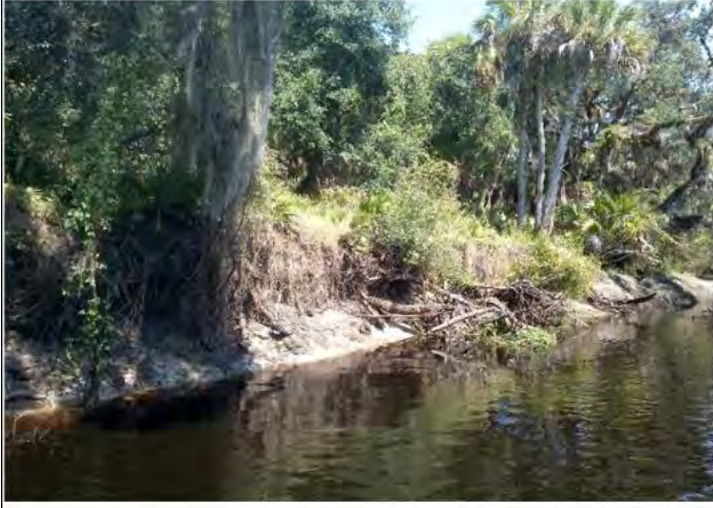
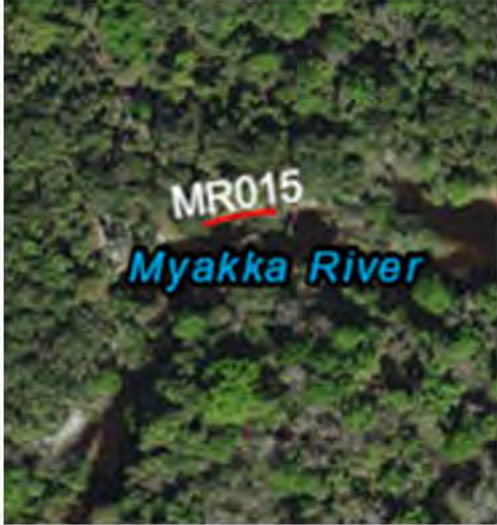
Myakka River			Severity Scale: 2.25 (Low)
Watershed: Myakka River Subwatershed: Harris Camp Latitude: 27.15588 Longitude: -82.36497			County: Sarasota Site Number: MR015 Reach Length: 100 ft. Landowner: Sarasota County

Risk Factor	Ranking	Score	Restoration Option 2
Pfankuch-Channel Stability:	Good	0	
Channel Alteration:	None	0	
Bank Erosion:	Active Erosion	1	
BEHI:	High (35.8)	1	
Local NPSP:	No Evidence	0	
Shoring Structures:	None	0	
Pipe Discharge:	Not Present	0	Additional Site Features
Water Odor:	Normal	0	Stream Channel Woody Material: Numerous
Fish Passage Barrier:	None	0	Impoundments: None
RB: Riparian Buffer (ft.):	100	0	Substrate Composition: Medium Sand
LB: Riparian Buffer (ft.):	100	0	Bank Material: Sand
RB: Floodplain Access:	Full	0	Near Bank Stress: Low
LB: Floodplain Access:	Partial	0.25	RB Landuse: Natural Forest
<b>Severity Scale:</b>		<b>2.25</b>	LB Landuse: Natural Forest
Notes:

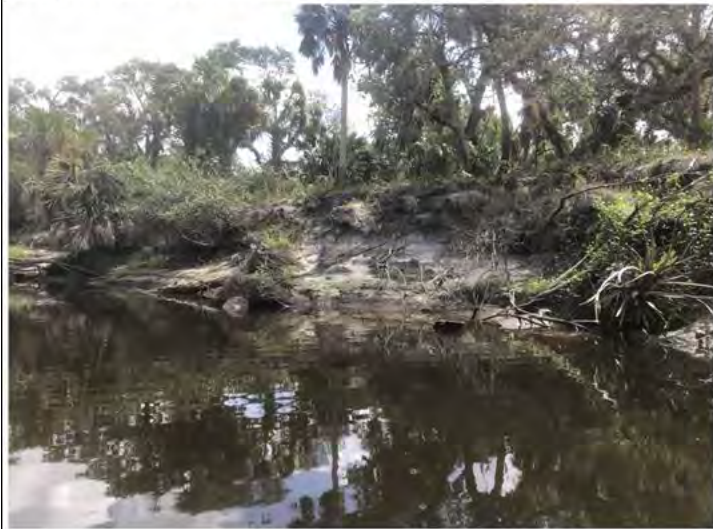
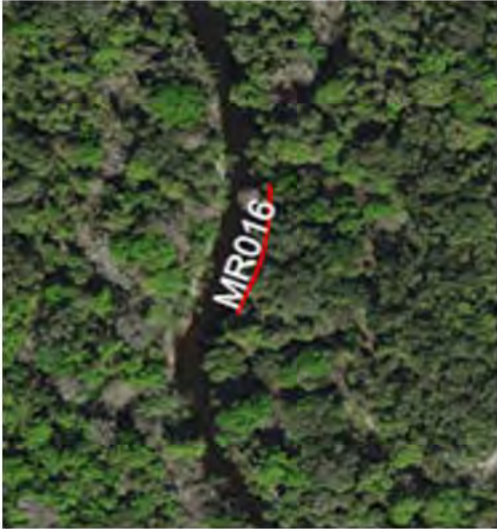
Myakka River			Severity Scale: 2.75 (Low)
Watershed: Myakka River Subwatershed: Harris Camp Latitude: 27.15601 Longitude: -82.36649			County: Sarasota Site Number: MR016 Reach Length: 180 ft. Landowner: Sarasota County

Risk Factor	Ranking	Score	Restoration Option 1
Pfankuch-Channel Stability:	Good	0	
Channel Alteration:	None	0	
Bank Erosion:	Active Erosion	1	
BEHI:	Very High (41)	1.5	
Local NPSP:	No Evidence	0	
Shoring Structures:	None	0	
Pipe Discharge:	Not Present	0	Additional Site Features
Water Odor:	Normal	0	Stream Channel Woody Material: Numerous
Fish Passage Barrier:	None	0	Impoundments: None
RB: Riparian Buffer (ft.):	100	0	Substrate Composition: Medium Sand
LB: Riparian Buffer (ft.):	100	0	Bank Material: Sand
RB: Floodplain Access:	Full	0	Near Bank Stress: Moderate
LB: Floodplain Access:	Partial	0.25	RB Landuse: Natural Forest
<b>Severity Scale:</b>		<b>2.75</b>	LB Landuse: Natural Forest

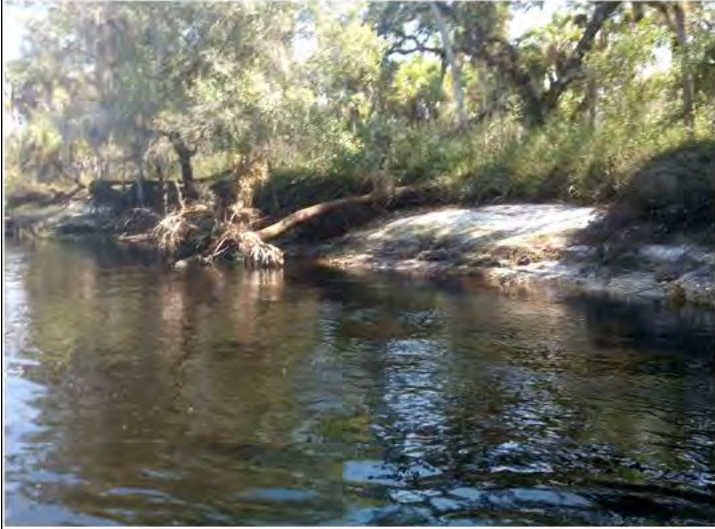
Myakka River			Severity Scale: 2.25 (Low)
Watershed: Myakka River Subwatershed: Harris Camp Latitude: 27.16336 Longitude: -82.36609			County: Sarasota Site Number: MR017 Reach Length: 225 ft. Landowner: Terry G. Green*

Risk Factor	Ranking	Score	<b>Restoration Option 2</b>  <b>Additional Site Features</b> Stream Channel Woody Material: Moderate Impoundments: None Substrate Composition: Medium Sand Bank Material: Sand Near Bank Stress: Moderate RB Landuse: Natural Forest LB Landuse: Natural Forest
Pfankuch-Channel Stability:	Good	0	
Channel Alteration:	None	0	
Bank Erosion:	Active Erosion	1	
BEHI:	High	1	
Local NPSP:	No Evidence	0	
Shoring Structures:	None	0	
Pipe Discharge:	Not Present	0	
Water Odor:	Normal	0	
Fish Passage Barrier:	None	0	
RB: Riparian Buffer (ft.):	100	0	
LB: Riparian Buffer (ft.):	100	0	
RB: Floodplain Access:	Partial	0.25	
LB: Floodplain Access:	Full	0	
<b>Severity Scale:</b>		<b>2.25</b>

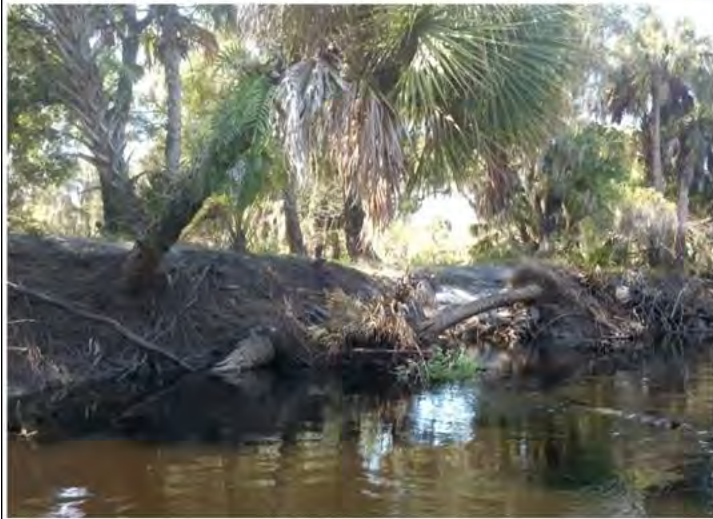
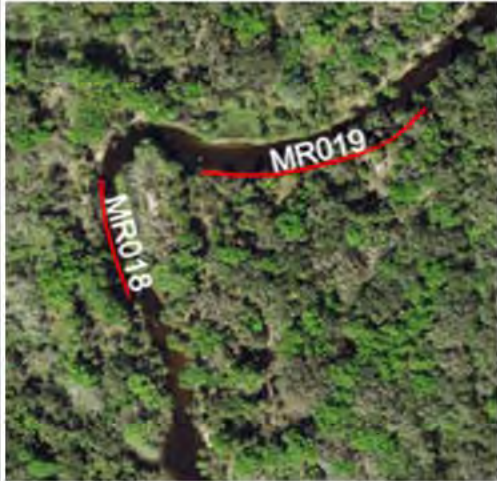
Myakka River			Severity Scale: 2.0 (Low)
Watershed: Myakka River Subwatershed: Harris Camp Latitude: 27.16451 Longitude: -82.36680			County: Sarasota Site Number: MR018 Reach Length: 180 ft. Landowner: Terry G. Green*

Risk Factor	Ranking	Score	Restoration Option 2
Pfankuch-Channel Stability:	Good	0	
Channel Alteration:	None	0	
Bank Erosion:	Active Erosion	1	
BEHI:	High (31.0)	1	
Local NPSP:	No Evidence	0	
Shoring Structures:	None	0	
Pipe Discharge:	Not Present	0	Additional Site Features
Water Odor:	Normal	0	Stream Channel Woody Material: Moderate
Fish Passage Barrier:	None	0	Impoundments: None
RB: Riparian Buffer (ft.):	100	0	Substrate Composition: Medium Sand
LB: Riparian Buffer (ft.):	100	0	Bank Material: Sand
RB: Floodplain Access:	Full	0	Near Bank Stress: Moderate
LB: Floodplain Access:	Full	0	RB Landuse: Natural Forest
<b>Severity Scale:</b>		<b>2</b>	LB Landuse: Natural Forest
Notes:

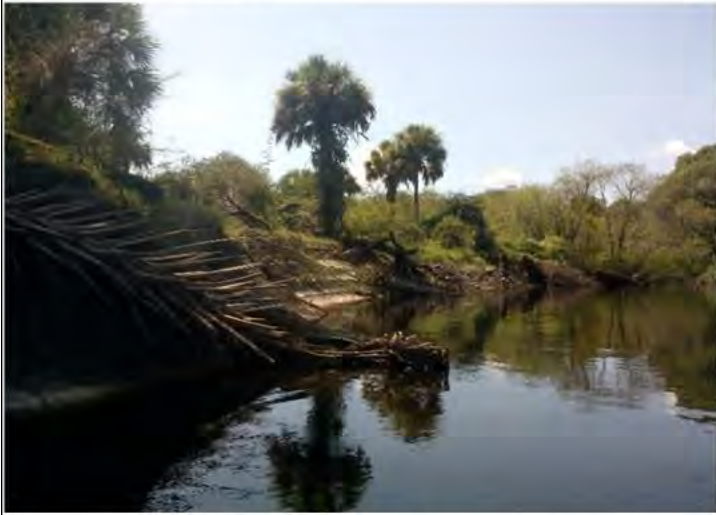
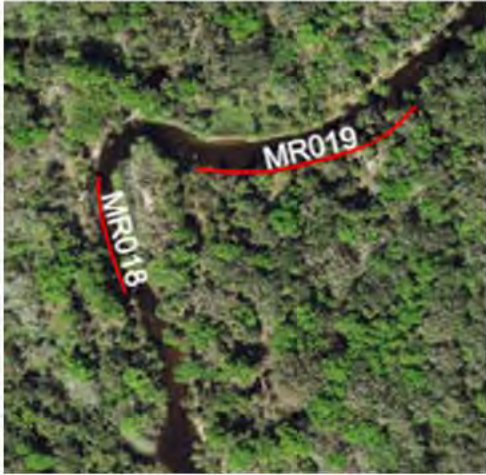
Myakka River			Severity Scale: 2.0 (Low)
Watershed: Myakka River Subwatershed: Harris Camp Latitude: 27.16484 Longitude: -82.36583			County: Sarasota Site Number: MR019 Reach Length: 360 ft. Landowner: Sarasota County

Risk Factor	Ranking	Score	Restoration Option 2
Pfankuch-Channel Stability:	Good	0	
Channel Alteration:	None	0	
Bank Erosion:	Active Erosion	1	
BEHI:	High (34.7)	1	
Local NPSP:	No Evidence	0	
Shoring Structures:	None	0	
Pipe Discharge:	Not Present	0	Additional Site Features
Water Odor:	Normal	0	Stream Channel Woody Material: Moderate
Fish Passage Barrier:	None	0	Impoundments: None
RB: Riparian Buffer (ft.):	100	0	Substrate Composition: Medium Sand
LB: Riparian Buffer (ft.):	100	0	Bank Material: Sand
RB: Floodplain Access:	Full	0	Near Bank Stress: Low
LB: Floodplain Access:	Full	0	RB Landuse: Natural Forest
<b>Severity Scale:</b>		<b>2</b>	LB Landuse: Natural Forest
Notes:

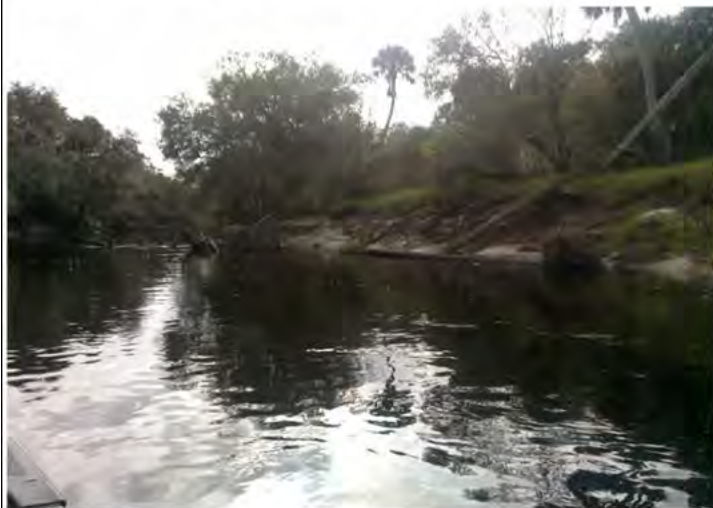
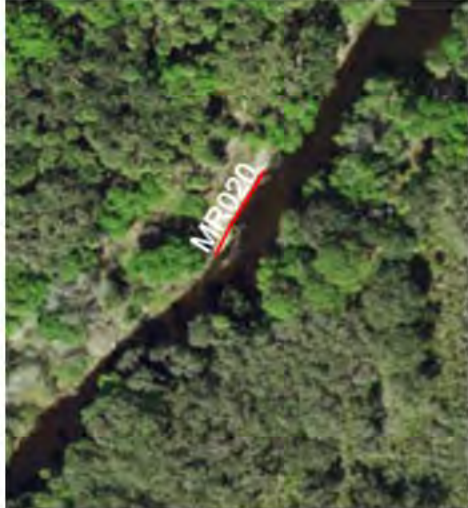
Myakka River			Severity Scale: 2.25 (Low)
Watershed: Myakka River Subwatershed: Harris Camp Latitude: 27.16628 Longitude: -82.36404			County: Sarasota Site Number: MR020 Reach Length: 80 ft. Landowner: Sarasota County

Risk Factor	Ranking	Score	Restoration Option 2
Pfankuch-Channel Stability:	Good	0	
Channel Alteration:	None	0	
Bank Erosion:	Active Erosion	1	
BEHI:	High (36.83)	1	
Local NPSP:	No Evidence	0	
Shoring Structures:	None	0	
Pipe Discharge:	Not Present	0	Additional Site Features
Water Odor:	Normal	0	Stream Channel Woody Material: Numerous
Fish Passage Barrier:	None	0	Impoundments: None
RB: Riparian Buffer (ft.):	80	0.25	Substrate Composition: Medium Sand
LB: Riparian Buffer (ft.):	100	0	Bank Material: Sand
RB: Floodplain Access:	Full	0	Near Bank Stress: High
LB: Floodplain Access:	Full	0	RB Landuse: Natural Forest
<b>Severity Scale:</b>		<b>2.25</b>	LB Landuse: Natural Forest
Notes:

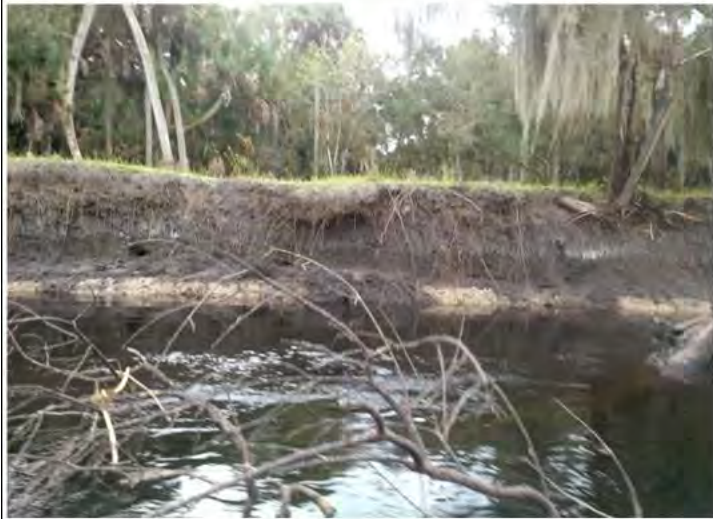
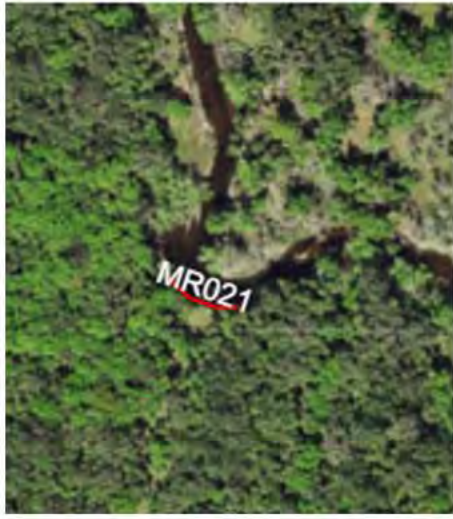
Myakka River			Severity Scale: 3.25 (Low)
Watershed: Myakka River Subwatershed: Harris Camp Latitude: 27.16927 Longitude: -82.36315			County: Sarasota Site Number: MR021 Reach Length: 135 ft. Landowner: Sarasota County

Risk Factor	Ranking	Score	Restoration Option 2
Pfankuch-Channel Stability:	Good	0	
Channel Alteration:	None	0	
Bank Erosion:	Mass-wasting	1.5	
BEHI:	Very High (43.67)	1.5	
Local NPSP:	No Evidence	0	
Shoring Structures:	None	0	
Pipe Discharge:	Not Present	0	Additional Site Features
Water Odor:	Normal	0	Stream Channel Woody Material: Numerous
Fish Passage Barrier:	None	0	Impoundments: None
RB: Riparian Buffer (ft.):	60	0.25	Substrate Composition: Medium Sand
LB: Riparian Buffer (ft.):	100	0	Bank Material: Sand/Silt
RB: Floodplain Access:	Full	0	Near Bank Stress: High
LB: Floodplain Access:	Full	0	RB Landuse: Historic, Natural Forest
<b>Severity Scale:</b>		<b>3.25</b>	LB Landuse: Natural Forest

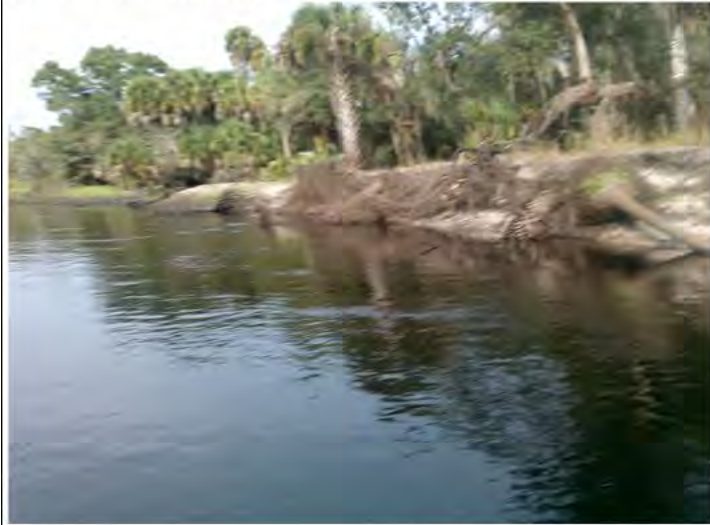
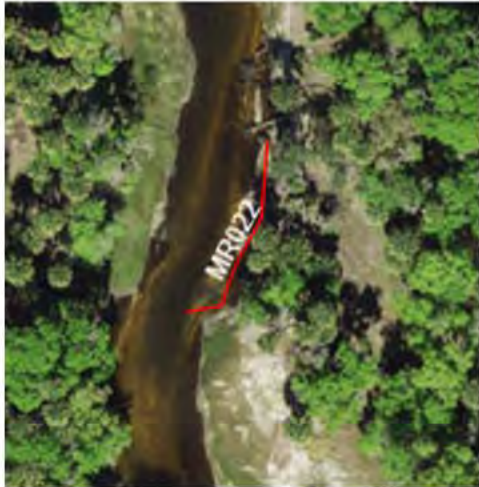
Myakka River			Severity Scale: 1.5 (Low)
Watershed: Myakka River Subwatershed: Harris Camp Latitude: 27.18011 Longitude: -82.35672			County: Sarasota Site Number: MR022 Reach Length: 100 ft. Landowner: Sarasota County

Risk Factor	Ranking	Score	Restoration Option 2
Pfankuch-Channel Stability:	Good	0	
Channel Alteration:	None	0	
Bank Erosion:	Active Erosion	1	
BEHI:	Moderate (29.68)	0.5	
Local NPSP:	No Evidence	0	
Shoring Structures:	None	0	
Pipe Discharge:	Not Present	0	Additional Site Features
Water Odor:	Normal	0	Stream Channel Woody Material: Moderate
Fish Passage Barrier:	None	0	Impoundments: None
RB: Riparian Buffer (ft.):	100	0	Substrate Composition: Medium Sand
LB: Riparian Buffer (ft.):	100	0	Bank Material: Sand
RB: Floodplain Access:	Full	0	Near Bank Stress: Moderate
LB: Floodplain Access:	Full	0	RB Landuse: Natural Forest
<b>Severity Scale:</b>		<b>1.5</b>	LB Landuse: Natural Forest

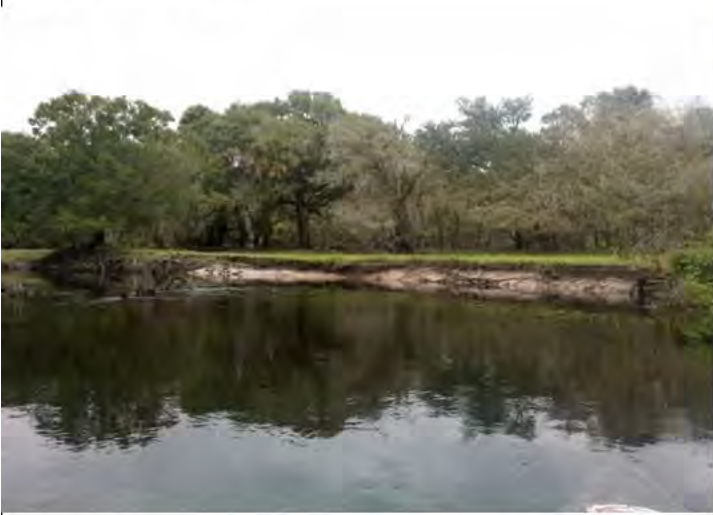
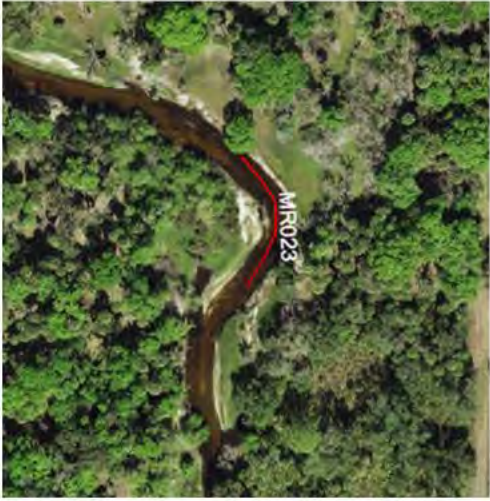
Myakka River			Severity Scale: 1.5 (Low)
Watershed: Myakka River Subwatershed: Harris Camp Latitude: 27.18394 Longitude: -82.35239			County: Sarasota Site Number: MR023 Reach Length: 165 ft. Landowner: TIITF*

Risk Factor	Ranking	Score	Restoration Option 3
Pfankuch-Channel Stability:	Good	0	
Channel Alteration:	None	0	
Bank Erosion:	Active Erosion	1	
BEHI:	Moderate (29.88)	0.5	
Local NPSP:	No Evidence	0	
Shoring Structures:	None	0	
Pipe Discharge:	Not Present	0	Additional Site Features
Water Odor:	Normal	0	Stream Channel Woody Material: Infrequent
Fish Passage Barrier:	None	0	Impoundments: None
RB: Riparian Buffer (ft.):	100	0	Substrate Composition: Medium Sand
LB: Riparian Buffer (ft.):	100	0	Bank Material: Sand
RB: Floodplain Access:	Full	0	Near Bank Stress: High
LB: Floodplain Access:	Full	0	RB Landuse: Natural Forest
<b>Severity Scale:</b>		<b>1.5</b>	LB Landuse: Natural Forest
Notes:			
*Additional Landowners: DEP - Rec & Park Myakka River State Park

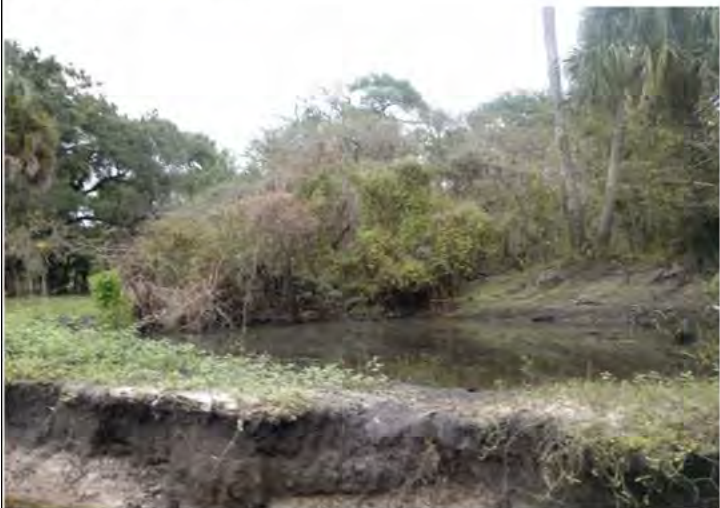
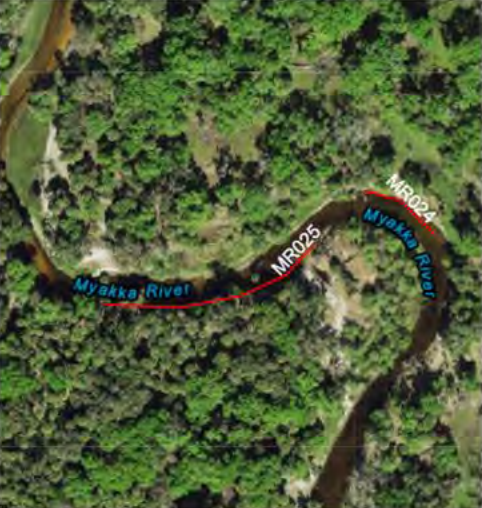
Myakka River			Severity Scale: 2.5 (Low)
Watershed: Myakka River Subwatershed: Harris Camp Latitude: 27.1858 Longitude: -82.35334			County: Sarasota Site Number: MR024 Reach Length: 105 ft. Landowner: TIITF*

Risk Factor	Ranking	Score	Restoration Option 2
Pfankuch-Channel Stability:	Good	0	
Channel Alteration:	None	0	
Bank Erosion:	Active Erosion	1	
BEHI:	High (33.51)	1	
Local NPSP:	No Evidence	0	
Shoring Structures:	None	0	
Pipe Discharge:	Not Present	0	Additional Site Features
Water Odor:	Normal	0	Stream Channel Woody Material: Moderate
Fish Passage Barrier:	None	0	Impoundments: None
RB: Riparian Buffer (ft.):	80	0.25	Substrate Composition: Medium Sand
LB: Riparian Buffer (ft.):	80	0.25	Bank Material: Sand
RB: Floodplain Access:	Full	0	Near Bank Stress: Moderate
LB: Floodplain Access:	Full	0	RB Landuse: Historic, Natural Forest
<b>Severity Scale:</b>		<b>2.5</b>	LB Landuse: Historic, Natural Forest

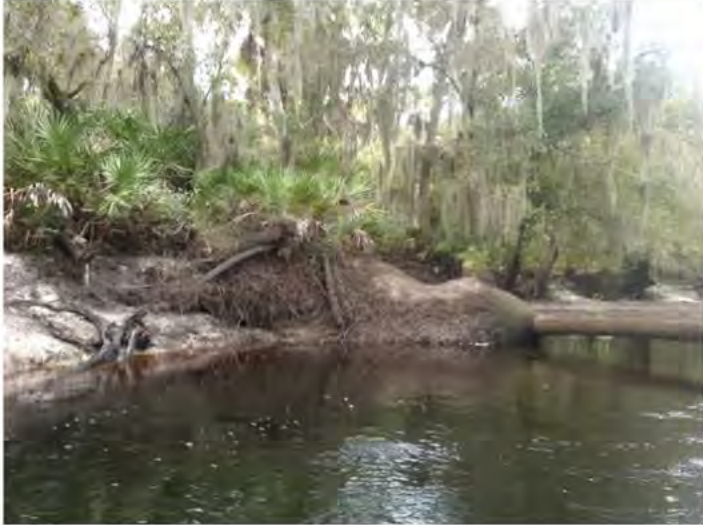
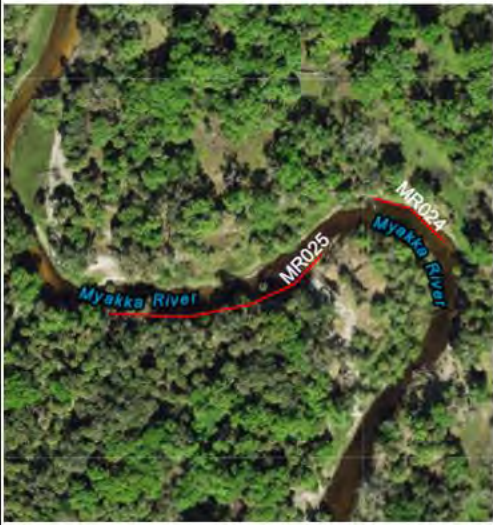
Myakka River			Severity Scale: 2.5 (Low)
Watershed: Myakka River Subwatershed: Harris Camp Latitude: 27.18551 Longitude: -82.35403			County: Sarasota Site Number: MR025 Reach Length: 290 ft. Landowner: D Bar F Ranch LLC

Risk Factor	Ranking	Score	<b>Restoration Option 2</b>  <b>Additional Site Features</b> Stream Channel Woody Material: Numerous Impoundments: None Substrate Composition: Medium Sand Bank Material: Sand Near Bank Stress: Moderate RB Landuse: Historic, Natural Forest LB Landuse: Historic, Natural Forest
Pfankuch-Channel Stability:	Good	0	
Channel Alteration:	None	0	
Bank Erosion:	Active Erosion	1	
BEHI:	High (31.08)	1	
Local NPSP:	No Evidence	0	
Shoring Structures:	None	0	
Pipe Discharge:	Not Present	0	
Water Odor:	Normal	0	
Fish Passage Barrier:	None	0	
RB: Riparian Buffer (ft.):	80	0.25	
LB: Riparian Buffer (ft.):	80	0.25	
RB: Floodplain Access:	Full	0	
LB: Floodplain Access:	Full	0

<b>Severity Scale:</b>		<b>2.5</b>	
Notes:

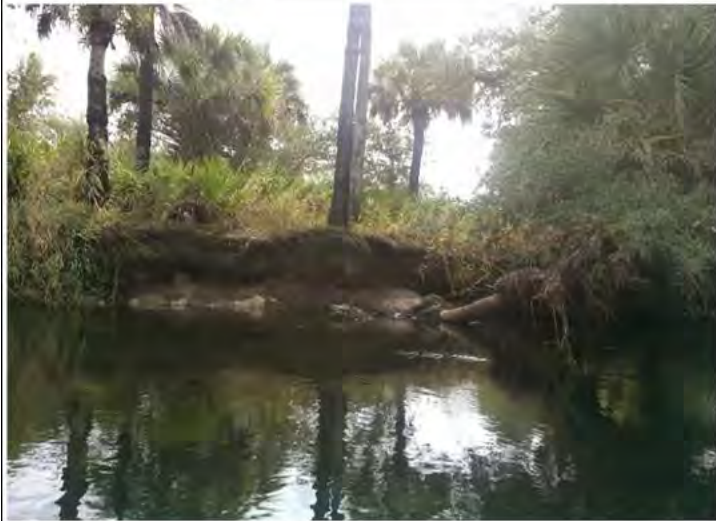
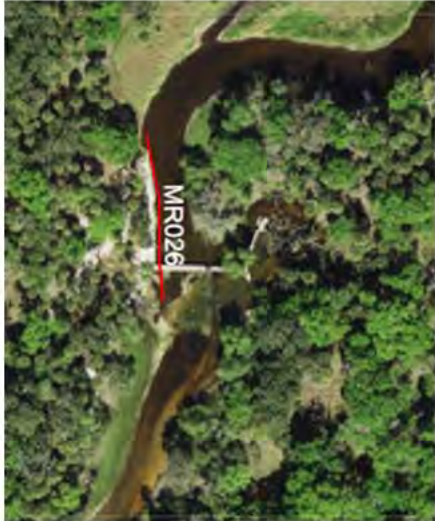
Myakka River			Severity Scale: 7.5 (High)
Watershed: Myakka River Subwatershed: Harris Camp Latitude: 27.18697 Longitude: -82.35458			County: Sarasota Site Number: MR026 Reach Length: 150 ft. Landowner: D Bar F Franch LLC

Risk Factor	Ranking	Score	Restoration Option 1
Pfankuch-Channel Stability:	Good	0	
Channel Alteration:	No Recovery	1.5	
Bank Erosion:	Active Erosion	1	
BEHI:	High (33.80)	1	
Local NPSP:	Slight	0.5	
Shoring Structures:	Present	1.5	
			Additional Site Features
Pipe Discharge:	Not Present	0	Stream Channel Woody Material: Infrequent
Water Odor:	Normal	0	Impoundments: Manmade Impoundment*
Fish Passage Barrier:	Present	1.5	Substrate Composition: Medium Sand
RB: Riparian Buffer (ft.):	40	0.5	Bank Material: Sand
LB: Riparian Buffer (ft.):	100	0	Near Bank Stress: Moderate
RB: Floodplain Access:	Full	0	RB Landuse: Recreational, Natural Forest
LB: Floodplain Access:	Full	0	LB Landuse: Natural Forest

<b>Severity Scale:</b>	<b>7.5</b>
Notes:			
*Locally known as Down's Dam, currently a feasibility study is being conducted for dam removal

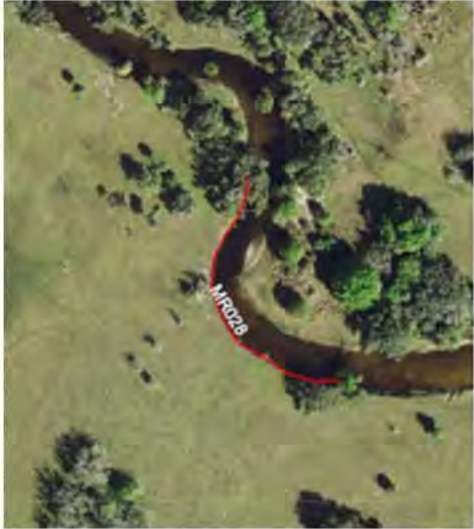
Myakka River			Severity Scale: 6.5 (Moderate)
Watershed: Myakka River Subwatershed: Tatum Sawgrass Swamp Latitude: 27.30536 Longitude: -82.24487			County: Manatee Site Number: MR028 Reach Length: 377 ft. Landowner: Triangle Ranch LLC.

Risk Factor	Ranking	Score	<b>Restoration Option 2</b>  <b>Additional Site Features</b> Stream Channel Woody Material: Infrequent Impoundments: None Substrate Composition: Fine sand Bank Material: Sand Near Bank Stress: Moderate Livestock Access: Yes RB Landuse: Pasture and Natural Forest LB Landuse: Pasture and Natural Forest
Pfankuch-Channel Stability:	Poor	1.5	
Channel Alteration:	None	0	
Bank Erosion:	Active Erosion	1	
BEHI:	High (37.37)	1	
Local NPSP:	Obvious Sources	1.5	
Shoring Structures:	None	0	
Pipe Discharge:	Not Present	0	
Water Odor:	Normal	0	
Fish Passage Barrier:	Not Present	0	
RB: Riparian Buffer (ft.):	25	0.75	
LB: Riparian Buffer (ft.):	0	0.75	
RB: Floodplain Access:	Full	0

LB: Floodplain Access:	Full	0	
		<b>Severity Scale:</b>	<b>6.5</b>
Notes:

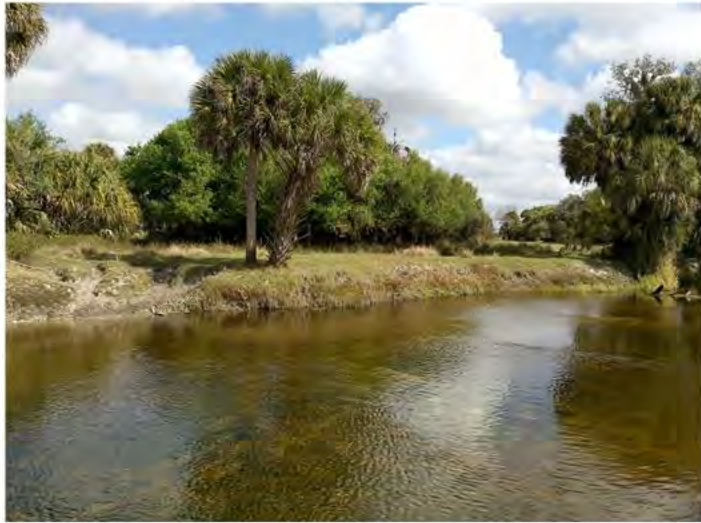
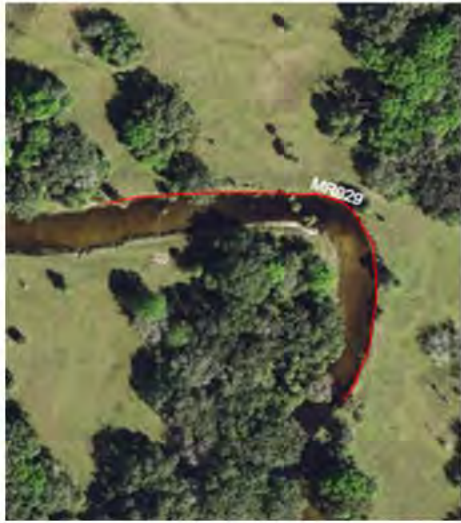
Myakka River			Severity Scale: 6.0 (Moderate)
Watershed: Myakka River Subwatershed: Tatum Sawgrass Swamp Latitude: 27.30522 Longitude: -82.24293			County: Manatee Site Number: MR029 Reach Length: 590 ft. Landowner: Triangle Ranch LLC.

Risk Factor	Ranking	Score	<b>Restoration Option 2</b>  <b>Additional Site Features</b> Stream Channel Woody Material: Infrequent Impoundments: None Substrate Composition: Fine sand / Clay Bank Material: Sand / Clay Near Bank Stress: Low Livestock Access: Yes RB Landuse: Pasture and Natural Forest LB Landuse: Pasture and Natural Forest
Pfankuch-Channel Stability:	Poor	1.5	
Channel Alteration:	None	0	
Bank Erosion:	Active Erosion	1	
BEHI:	High (37.63)	1	
Local NPSP:	Obvious Sources	1.5	
Shoring Structures:	None	0	
Pipe Discharge:	Not Present	0	
Water Odor:	Normal	0	
Fish Passage Barrier:	Not Present	0	
RB: Riparian Buffer (ft.):	0	0.75	
LB: Riparian Buffer (ft.):	75	0.25

RB: Floodplain Access:	Full	0	
LB: Floodplain Access:	Full	0	
<b>Severity Scale:</b>		<b>6</b>	
Notes: Potential fish passage barrier at low water.

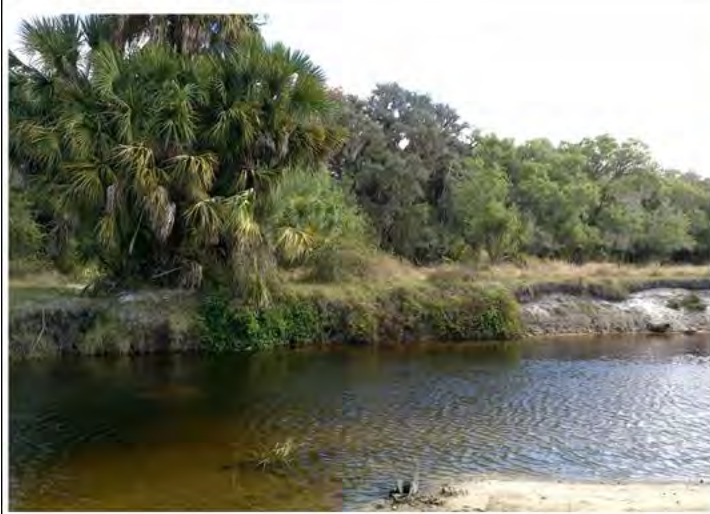
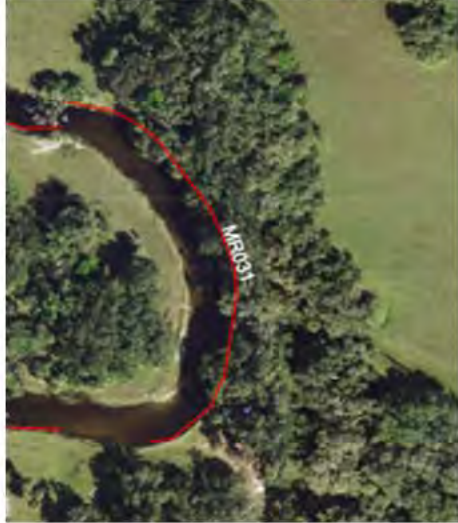
Myakka River			Severity Scale: 5.75 (Moderate)
Watershed: Myakka River Subwatershed: Tatum Sawgrass Swamp Latitude: 27.30315 Longitude: -82.24197			County: Manatee Site Number: MR031 Reach Length: 520 ft. Landowner: Triangle Ranch LLC.

Risk Factor	Ranking	Score	Restoration Option 2
Pfankuch-Channel Stability:	Poor	1.5	
Channel Alteration:	None	0	
Bank Erosion:	Active Erosion	1	
BEHI:	High (31.43)	1	
Local NPSP:	Obvious Sources	1.5	
Shoring Structures:	None	0	
			Additional Site Features
Pipe Discharge:	Not Present	0	Stream Channel Woody Material: Infrequent
Water Odor:	Normal	0	Impoundments: None
Fish Passage Barrier:	Not Present	0	Substrate Composition: Fine sand
RB: Riparian Buffer (ft.):	100	0	Bank Material: Sand
LB: Riparian Buffer (ft.):	0	0.75	Near Bank Stress: Moderate
RB: Floodplain Access:	Full	0	Livestock Access: Yes
LB: Floodplain Access:	Full	0	RB Landuse: Pasture and Natural Forest

<b>Severity Scale:</b>	LB Landuse: Pasture and Natural Forest
		<b>5.75</b>	
Notes:			
Potential fish passage barrier at low water.

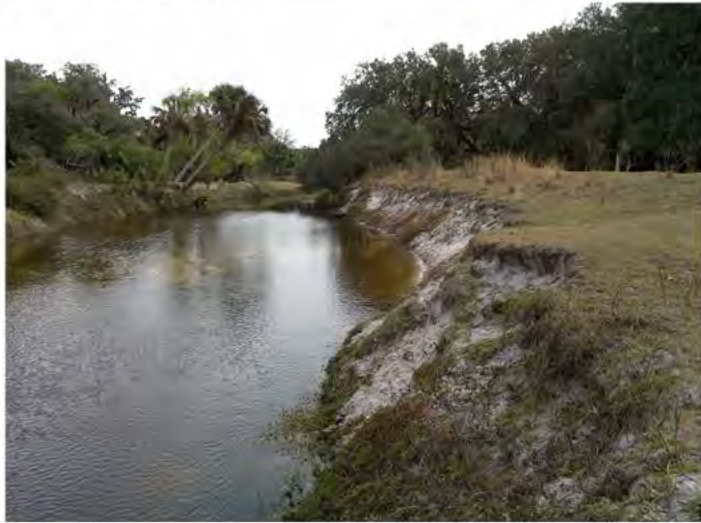
Myakka River			Severity Scale: 7.0 (Moderate)
Watershed: Myakka River Subwatershed: Tatum Sawgrass Swamp Latitude: 27.29788 Longitude: -82.24174			County: Manatee Site Number: MR035 Reach Length: 190 ft. Landowner: Triangle Ranch LLC.

Risk Factor	Ranking	Score	Restoration Option 2
Pfankuch-Channel Stability:	Poor	1.5	
Channel Alteration:	None	0	
Bank Erosion:	Mass-Wasting	1.5	
BEHI:	High (39.5)	1	
Local NPSP:	Obvious Sources	1.5	
Shoring Structures:	None	0	Additional Site Features
Pipe Discharge:	Not Present	0	Stream Channel Woody Material: Infrequent
Water Odor:	Normal	0	Impoundments: None
Fish Passage Barrier:	Not Present	0	Substrate Composition: Fine sand
RB: Riparian Buffer (ft.):	25	0.75	Bank Material: Sand
LB: Riparian Buffer (ft.):	0	0.75	Near Bank Stress: Low
RB: Floodplain Access:	Full	0	Livestock Access: Yes
LB: Floodplain Access:	Full	0	RB Landuse: Pasture and Natural Forest
<b>Severity Scale:</b>		<b>7</b>	LB Landuse: Pasture and Natural Forest

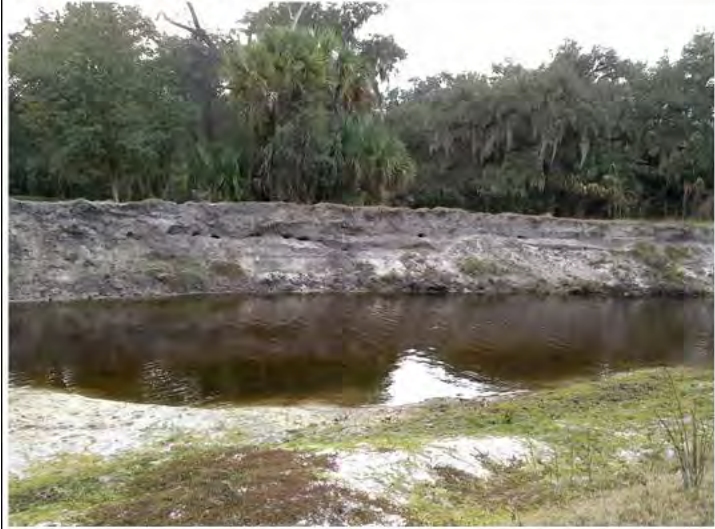
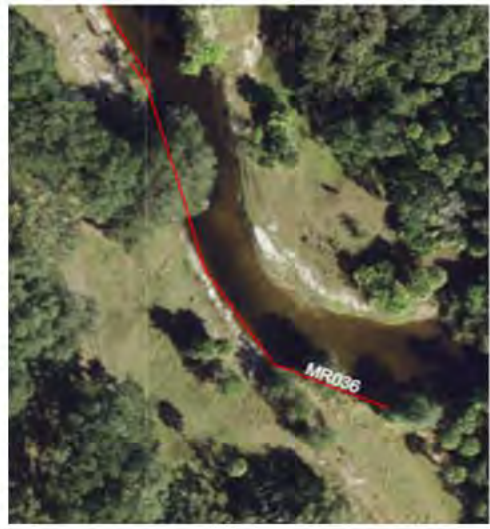
Myakka River			Severity Scale: 7.5 (High)
Watershed: Myakka River Subwatershed: Tatum Sawgrass Swamp Latitude: 27.29721 Longitude: -82.24139		County: Manatee Site Number: MR036 Reach Length: 300 ft. Landowner: Triangle Ranch LLC.

Risk Factor	Ranking	Score	Restoration Option 1
Pfankuch-Channel Stability:	Poor	1.5	
Channel Alteration:	None	0	
Bank Erosion:	Mass-Wasting	1.5	
BEHI:	Very High (43.53)	1.5	
Local NPSP:	Obvious Sources	1.5	
Shoring Structures:	None	0	
Pipe Discharge:	Not Present	0	
Water Odor:	Normal	0	
Fish Passage Barrier:	Not Present	0	
			Additional Site Features
RB: Riparian Buffer (ft.):	25	0.75	Stream Channel Woody Material: Moderate
LB: Riparian Buffer (ft.):	25	0.75	Impoundments: None
RB: Floodplain Access:	Full	0	Substrate Composition: Fine sand
LB: Floodplain Access:	Full	0	Bank Material: Sand
		<b>Severity Scale: 7.5</b>	Near Bank Stress: Moderate
			Livestock Access: Yes

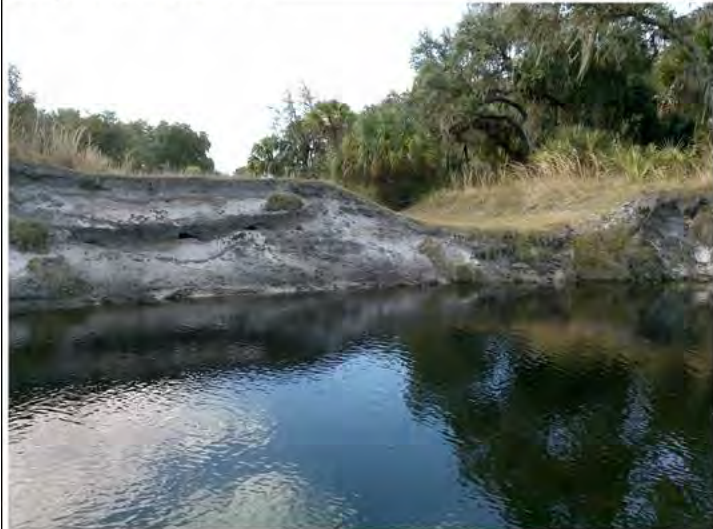
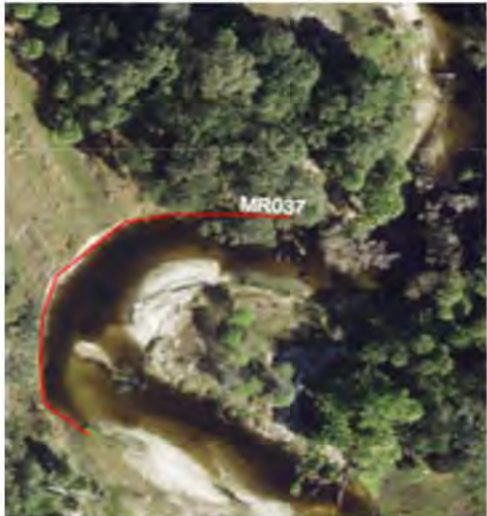
Myakka River			Severity Scale: 7.25 (Moderate)	
Watershed: Myakka River Subwatershed: Tatum Sawgrass Swamp Latitude: 27.29654 Longitude: -82.24088			County: Manatee Site Number: MR037 Reach Length: 200 ft. Landowner: Triangle Ranch LLC.

Risk Factor	Ranking	Score	Restoration Option 1	
Pfankuch-Channel Stability:	Poor	1.5		
Channel Alteration:	None	0		
Bank Erosion:	Mass-Wasting	1.5		
BEHI:	Very High (40.28)	1.5		
Local NPSP:	Obvious Sources	1.5		
Shoring Structures:	None	0		
			Additional Site Features	
Pipe Discharge:	Not Present	0	Stream Channel Woody Material: Moderate	
Water Odor:	Normal	0	Impoundments: None	
Fish Passage Barrier:	Not Present	0	Substrate Composition: Fine sand	
RB: Riparian Buffer (ft.):	50	0.5	Bank Material: Sand	
LB: Riparian Buffer (ft.):	0	0.75	Near Bank Stress: Low	
RB: Floodplain Access:	Full	0	Livestock Access: Yes	
LB: Floodplain Access:	Full	0	RB Landuse: Pasture and Natural Forest

<b>Severity Scale:</b>	<b>7.25</b>	LB Landuse: Pasture and Natural Forest
Notes:

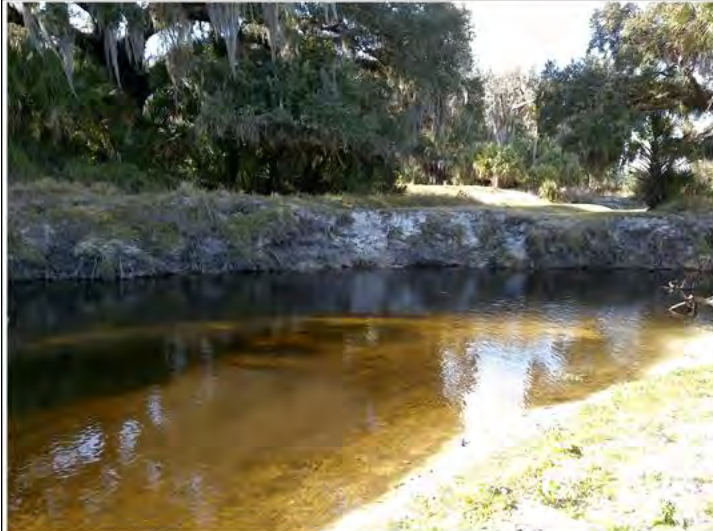
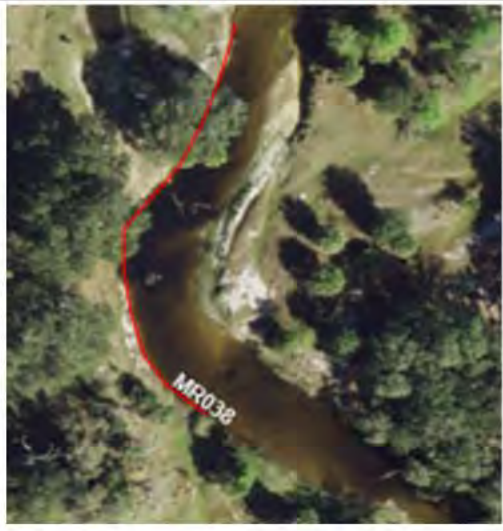
Myakka River			Severity Scale: 6.75 (Moderate)
Watershed: Myakka River			County: Manatee
Subwatershed: Tatum Sawgrass Swamp			Site Number: MR038
Latitude: 27.29583			Reach Length: 220 ft.
Longitude: -82.24064			Landowner: Triangle Ranch LLC.

Risk Factor	Ranking	Score	Restoration Option 2
Pfankuch-Channel Stability:	Poor	1.5	
Channel Alteration:	None	0	
Bank Erosion:	Active Erosion	1	
BEHI:	Very High (43.56)	1.5	
Local NPSP:	Obvious Sources	1.5	
			Additional Site Features
Shoring Structures:	None	0	Stream Channel Woody Material: Moderate
Pipe Discharge:	Not Present	0	Impoundments: None
Water Odor:	Normal	0	Substrate Composition: Fine sand
Fish Passage Barrier:	Not Present	0	Bank Material: Sand
RB: Riparian Buffer (ft.):	25	0.75	Near Bank Stress: Low
LB: Riparian Buffer (ft.):	50	0.5	Livestock Access: Yes
RB: Floodplain Access:	Full	0	RB Landuse: Pasture and Natural Forest
LB: Floodplain Access:	Full	0	LB Landuse: Pasture and Natural Forest

<b>Severity Scale:</b>	<b>6.75</b>
Notes:

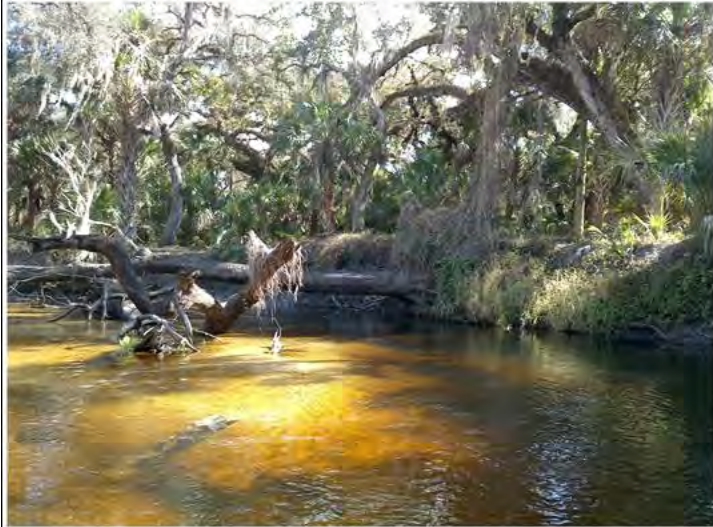
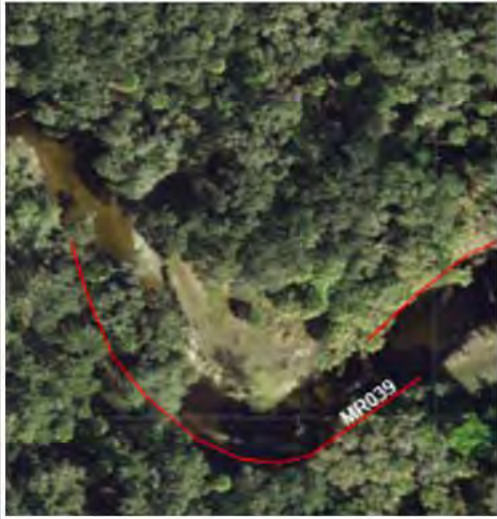
Myakka River			Severity Scale: 6.25 (Moderate)
Watershed: Myakka River Subwatershed: Tatum Sawgrass Swamp Latitude: 27.29489 Longitude: -82.23995			County: Manatee Site Number: MR039 Reach Length: 264 ft. Landowner: Triangle Ranch LLC.

Risk Factor	Ranking	Score	Restoration Option 1
Pfankuch-Channel Stability:	Poor	1.5	
Channel Alteration:	None	0	
Bank Erosion:	Active Erosion	1	
BEHI:	Very High (41.16)	1.5	
Local NPSP:	Obvious Sources	1.5	
			Additional Site Features
Shoring Structures:	None	0	Stream Channel Woody Material: Moderate
Pipe Discharge:	Not Present	0	Impoundments: None
Water Odor:	Normal	0	Substrate Composition: Fine sand
Fish Passage Barrier:	Not Present	0	Bank Material: Sand
RB: Riparian Buffer (ft.):	25	0.75	Near Bank Stress: High
LB: Riparian Buffer (ft.):	100	0	Livestock Access: Yes
RB: Floodplain Access:	Full	0	RB Landuse: Pasture and Natural Forest
LB: Floodplain Access:	Full	0	LB Landuse: Pasture and Natural Forest

<b>Severity Scale:</b>	<b>6.25</b>
Notes:

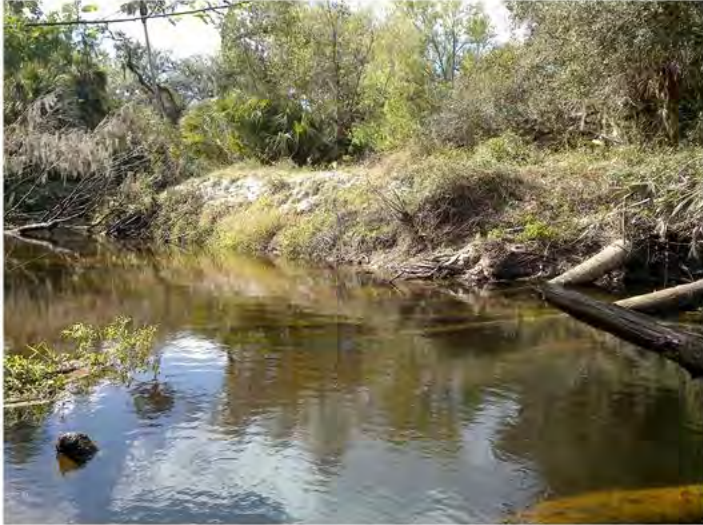
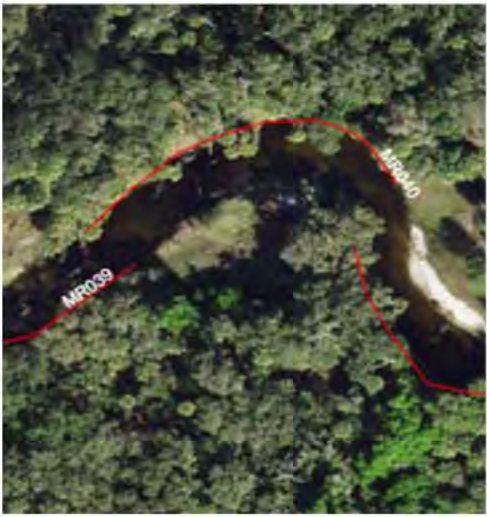
Myakka River			Severity Scale: 5.5 (Moderate)
Watershed: Myakka River Subwatershed: Tatum Sawgrass Swamp Latitude: 27.2952 Longitude: -82.23931			County: Manatee Site Number: MR040 Reach Length: 215 ft. Landowner: Triangle Ranch LLC.

<b>Risk Factor</b>	<b>Ranking</b>	<b>Score</b>	<b>Restoration Option 2</b>
Pfankuch-Channel Stability:	Poor	1.5	
Channel Alteration:	None	0	
Bank Erosion:	Active Erosion	1	
BEHI:	High (37.45)	1	
Local NPSP:	Obvious Sources	1.5	
Shoring Structures:	None	0	
Pipe Discharge:	Not Present	0	
Water Odor:	Normal	0	
Fish Passage Barrier:	Not Present	0	
			<b>Additional Site Features</b>
RB: Riparian Buffer (ft.):	100	0	Stream Channel Woody Material: Moderate
LB: Riparian Buffer (ft.):	50	0.5	Impoundments: None
RB: Floodplain Access:	Full	0	Substrate Composition: Fine sand
LB: Floodplain Access:	Full	0	Bank Material: Sand
	<b>Severity Scale:</b>	<b>5.5</b>	Near Bank Stress: High
