# Peace River Streambank Restoration and Myakka River Watershed Threats Assessment and Fish Assemblage Monitoring

Final Report 1 July 2019 – 31 March 2023  
State Wildlife Grant 2953 – PID 9100 250 2953

Submitted to Florida State Wildlife Grants Program  
1 June 2023

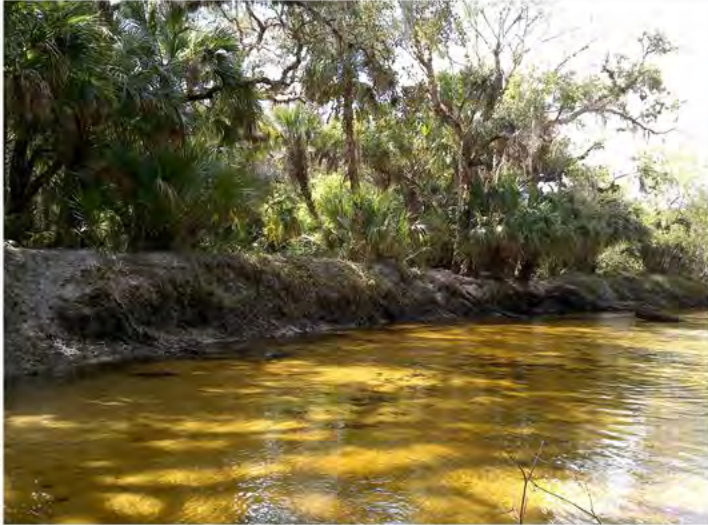
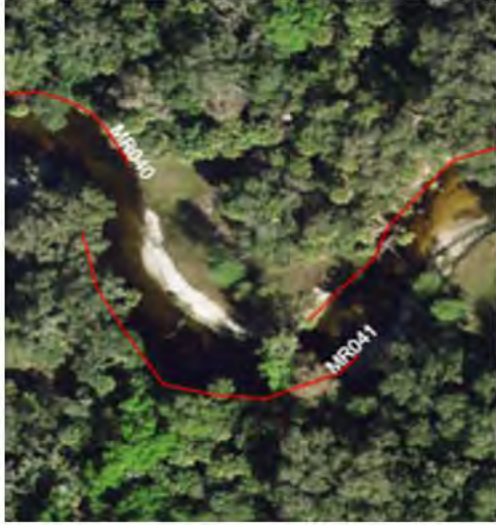
Myakka River			Severity Scale: 5.75 (Moderate)
Watershed: Myakka River Subwatershed: Tatum Sawgrass Swamp Latitude: 27.29481 Longitude: -82.2389			County: Manatee Site Number: MR041 Reach Length: 195 ft. Landowner: Triangle Ranch LLC.

Risk Factor	Ranking	Score	Restoration Option 2
Pfankuch-Channel Stability:	Poor	1.5	
Channel Alteration:	None	0	
Bank Erosion:	Active Erosion	1	
BEHI:	High (36.94)	1	
Local NPSP:	Obvious Sources	1.5	
			Additional Site Features
Shoring Structures:	None	0	Stream Channel Woody Material: Moderate
Pipe Discharge:	Not Present	0	Impoundments: None
Water Odor:	Normal	0	Substrate Composition: Fine sand
Fish Passage Barrier:	Not Present	0	Bank Material: Sand
RB: Riparian Buffer (ft.):	25	0.75	Near Bank Stress: High
LB: Riparian Buffer (ft.):	100	0	Livestock Access: Yes
RB: Floodplain Access:	Full	0	RB Landuse: Pasture and Natural Forest
LB: Floodplain Access:	Full	0	LB Landuse: Pasture and Natural Forest

<b>Severity Scale:</b>	<b>5.75</b>
Notes:

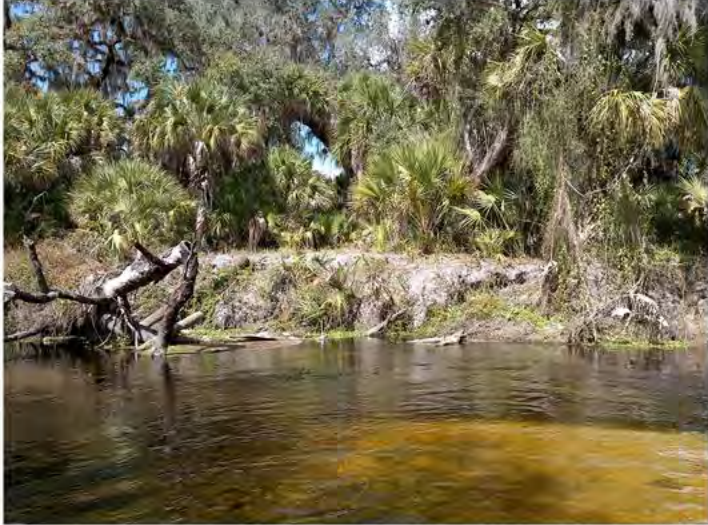
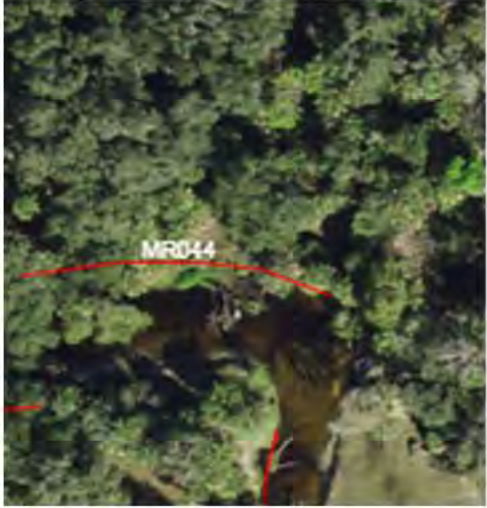
Myakka River			Severity Scale: 5.0 (Moderate)
Watershed: Myakka River Subwatershed: Tatum Sawgrass Swamp Latitude: 27.29511 Longitude: -82.23761			County: Manatee Site Number: MR044 Reach Length: 157 ft. Landowner: Triangle Ranch LLC.

Risk Factor	Ranking	Score	Restoration Option 2
Pfankuch-Channel Stability:	Poor	1.5	
Channel Alteration:	None	0	
Bank Erosion:	Active Erosion	1	
BEHI:	High (39.07)	1	
Local NPSP:	Obvious Sources	1.5	
			Additional Site Features
Shoring Structures:	None	0	Stream Channel Woody Material: Moderate
Pipe Discharge:	Not Present	0	Impoundments: None
Water Odor:	Normal	0	Substrate Composition: Fine sand
Fish Passage Barrier:	Not Present	0	Bank Material: Sand
RB: Riparian Buffer (ft.):	100	0	Near Bank Stress: Low-Moderate
LB: Riparian Buffer (ft.):	100	0	Livestock Access: Yes
RB: Floodplain Access:	Full	0	RB Landuse: Pasture and Natural Forest
LB: Floodplain Access:	Full	0	LB Landuse: Pasture and Natural Forest

<b>Severity Scale:</b>	<b>5</b>
Notes:

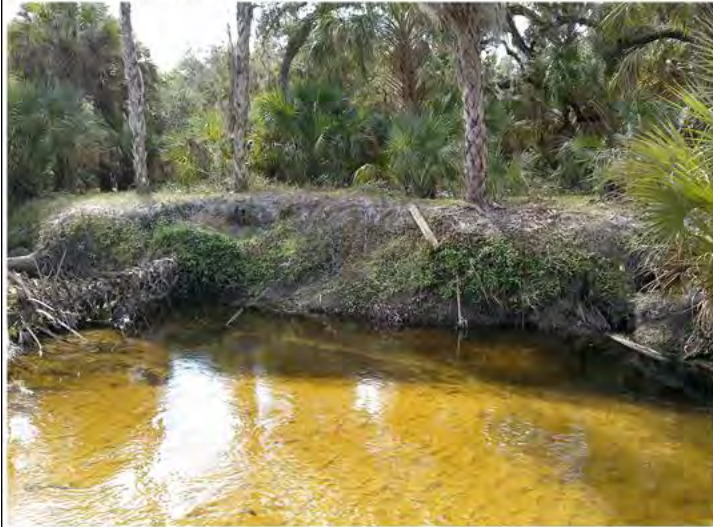
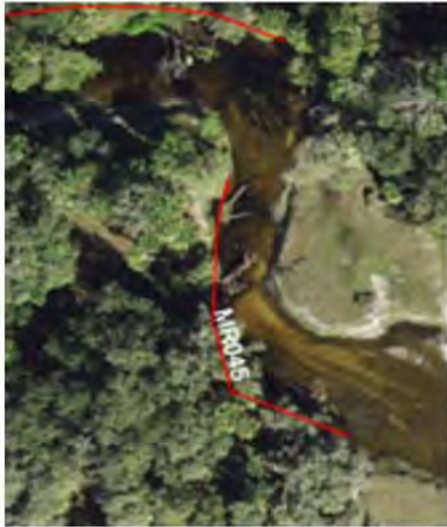
Myakka River			Severity Scale: 5.75 (Moderate)
Watershed: Myakka River Subwatershed: Tatum Sawgrass Swamp Latitude: 27.29475 Longitude: -82.23739			County: Manatee Site Number: MR045 Reach Length: 145 ft. Landowner: Triangle Ranch LLC.

Risk Factor	Ranking	Score	Restoration Option 1
Pfankuch-Channel Stability:	Poor	1.5	
Channel Alteration:	None	0	
Bank Erosion:	Active Erosion	1	
BEHI:	High (37.54)	1	
Local NPSP:	Obvious Sources	1.5	
			Additional Site Features
Shoring Structures:	None	0	Stream Channel Woody Material: Moderate
Pipe Discharge:	Not Present	0	Impoundments: None
Water Odor:	Normal	0	Substrate Composition: Fine sand
Fish Passage Barrier:	Not Present	0	Bank Material: Sand
RB: Riparian Buffer (ft.):	0	0.75	Near Bank Stress: High
LB: Riparian Buffer (ft.):	100	0	Livestock Access: Yes
RB: Floodplain Access:	Full	0	RB Landuse: Pasture and Natural Forest
LB: Floodplain Access:	Full	0	LB Landuse: Pasture and Natural Forest

<b>Severity Scale:</b>	<b>5.75</b>
Notes:

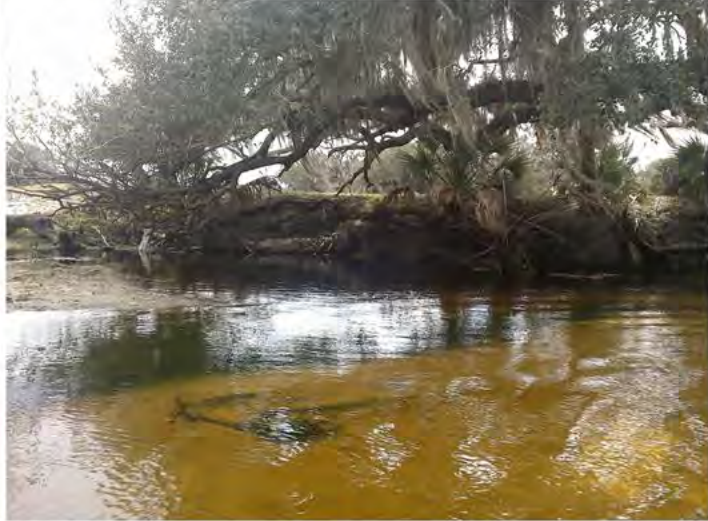
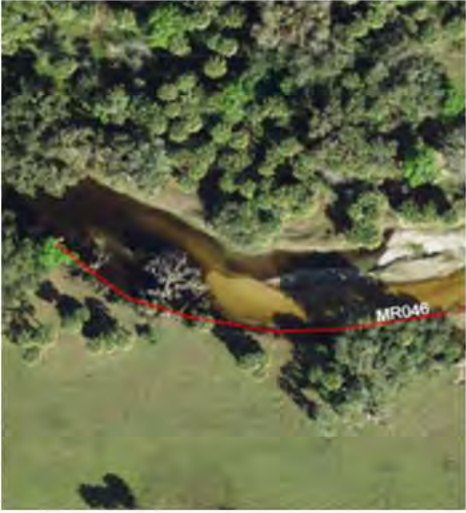
Myakka River			Severity Scale: 6.0 (Moderate)	
Watershed: Myakka River Subwatershed: Tatum Sawgrass Swamp Latitude: 27.29385 Longitude: -82.23539			County: Manatee Site Number: MR046 Reach Length: 268 ft. Landowner: Triangle Ranch LLC.

Risk Factor	Ranking	Score	Restoration Option 1	
Pfankuch-Channel Stability:	Poor	1.5		
Channel Alteration:	None	0		
Bank Erosion:	Active Erosion	1		
BEHI:	High (34.66)	1		
Local NPSP:	Obvious Sources	1.5		
Shoring Structures:	None	0	Additional Site Features	
Pipe Discharge:	Not Present	0	Stream Channel Woody Material: Numerous	
Water Odor:	Normal	0	Impoundments: None	
Fish Passage Barrier:	Not Present	0	Substrate Composition: Fine sand	
RB: Riparian Buffer (ft.):	75	0.25	Bank Material: Sand	
LB: Riparian Buffer (ft.):	25	0.75	Near Bank Stress: High	
RB: Floodplain Access:	Full	0	Livestock Access: Yes	
LB: Floodplain Access:	Full	0	RB Landuse: Pasture and Natural Forest

<b>Severity Scale:</b>	6	LB Landuse: Pasture and Natural Forest
Notes:

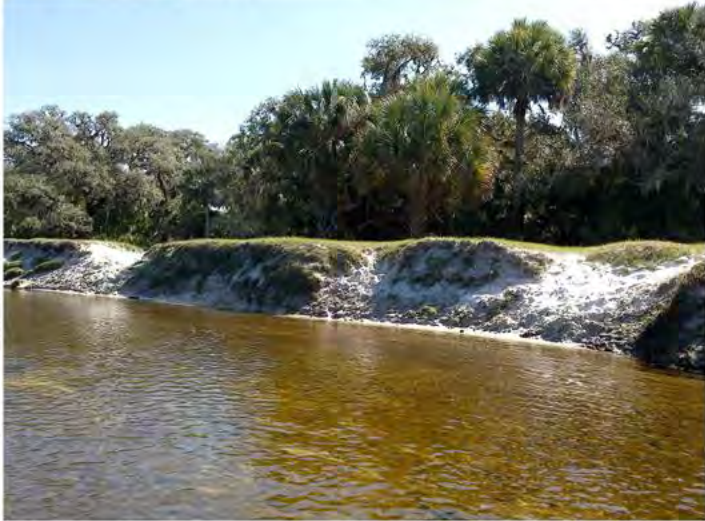
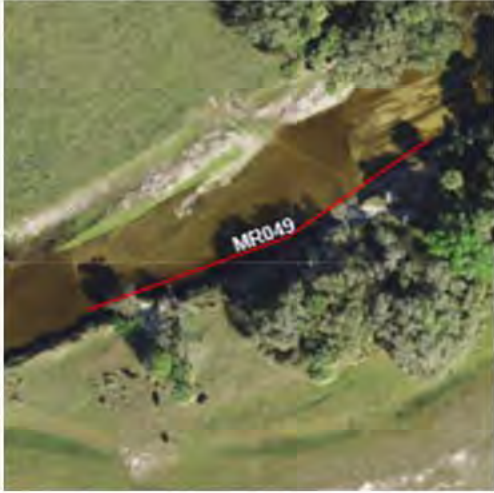
Myakka River			Severity Scale: 7.5 (High)
Watershed: Myakka River Subwatershed: Tatum Sawgrass Swamp Latitude: 27.29439 Longitude: -82.23262			County: Manatee Site Number: MR049 Reach Length: 220 ft. Landowner: Triangle Ranch LLC.

<b>Risk Factor</b>	<b>Ranking</b>	<b>Score</b>	<b>Restoration Option 2</b>
Pfankuch-Channel Stability:	Poor	1.5	
Channel Alteration:	None	0	
Bank Erosion:	Mass-Wasting	1.5	
BEHI:	Very High (40.57)	1.5	
Local NPSP:	Obvious Sources	1.5	
Shoring Structures:	None	0	
Pipe Discharge:	Not Present	0	
Water Odor:	Normal	0	
Fish Passage Barrier:	Not Present	0	
RB: Riparian Buffer (ft.):	0	0.75	<b>Additional Site Features</b>
LB: Riparian Buffer (ft.):	25	0.75	
RB: Floodplain Access:	Full	0	
LB: Floodplain Access:	Full	0	
<b>Severity Scale: 7.5</b>			
<b>Notes:</b>

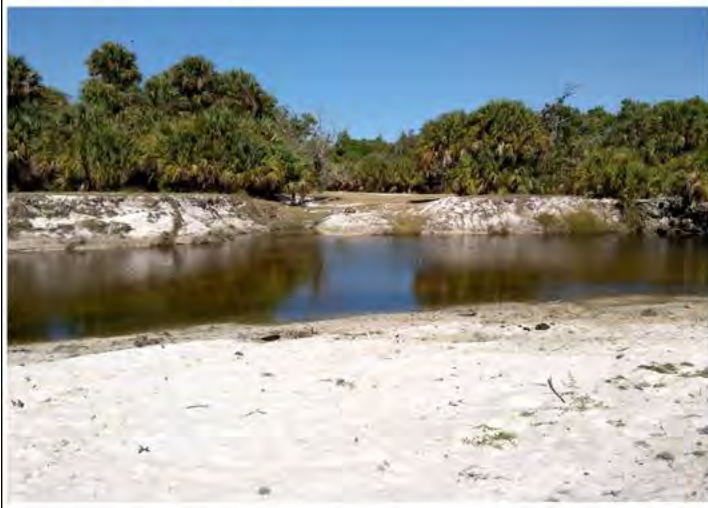
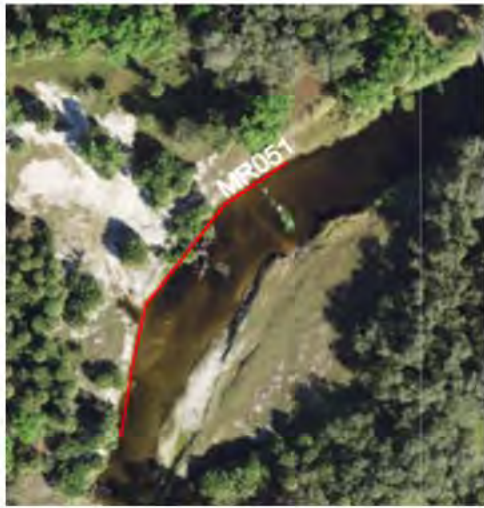
Myakka River			Severity Scale: 7.5 (High)
Watershed: Myakka River Subwatershed: Tatum Sawgrass Swamp Latitude: 27.29609 Longitude: -82.23064			County: Manatee Site Number: MR051 Reach Length: 280 ft. Landowner: Triangle Ranch LLC.

Risk Factor	Ranking	Score	Restoration Option 1
Pfankuch-Channel Stability:	Poor	1.5	
Channel Alteration:	None	0	
Bank Erosion:	Mass-Wasting	1.5	
BEHI:	Very High (42.06)	1.5	
Local NPSP:	Obvious Sources	1.5	
			Additional Site Features
Shoring Structures:	None	0	Stream Channel Woody Material: Moderate
Pipe Discharge:	Not Present	0	Impoundments: None
Water Odor:	Normal	0	Substrate Composition: Fine sand
Fish Passage Barrier:	Not Present	0	Bank Material: Sand
RB: Riparian Buffer (ft.):	25	0.75	Near Bank Stress: Low-Moderate
LB: Riparian Buffer (ft.):	0	0.75	Livestock Access: Yes
RB: Floodplain Access:	Full	0	RB Landuse: Pasture and Natural Forest
LB: Floodplain Access:	Full	0	LB Landuse: Pasture and Natural Forest

<b>Severity Scale:</b>	<b>7.5</b>
Notes:

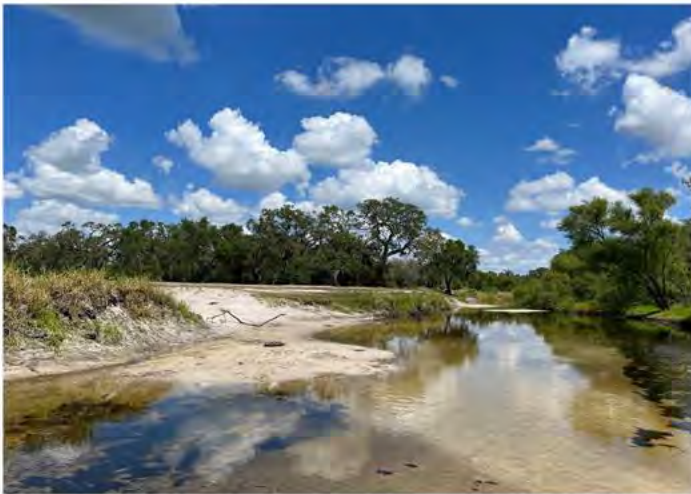
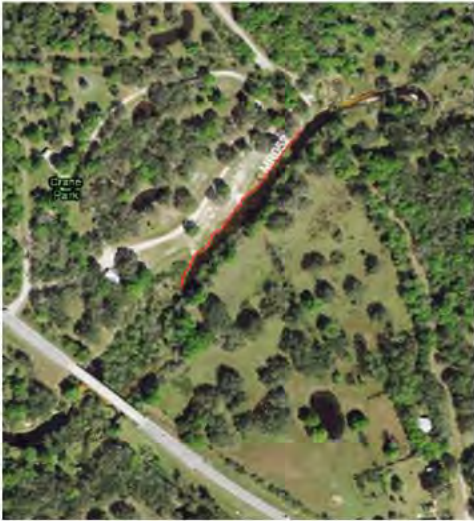
Myakka River			Severity Scale: 4.75 (Moderate)
Watershed: Myakka River Subwatershed: Maple Creek Latitude: 27.34585 Longitude: -82.15548			County: Manatee Site Number: MR052 Reach Length: 700 ft. Landowner: Manatee County

Risk Factor	Ranking	Score	Restoration Option 2
Pfankuch-Channel Stability:	Fair	1	
Channel Alteration:	None	0	
Bank Erosion:	Active	1	
BEHI:	High (34.12)	1	
Local NPSP:	Moderate	1	
Shoring Structures:	None	0	
Pipe Discharge:	Not Present	0	Additional Site Features
Water Odor:	Normal	0	Stream Channel Woody Material: Infrequent
Fish Passage Barrier:	Not Present	0	Impoundments: None
RB: Riparian Buffer (ft.):	20	0.75	Substrate Composition: Medium Sand
LB: Riparian Buffer (ft.):	100	0	Bank Material: Sand
RB: Floodplain Access:	Full	0	Near Bank Stress: Very Low
LB: Floodplain Access:	Full	0	RB Landuse: Other (Recreational Park)
<b>Severity Scale:</b>		<b>4.75</b>	LB Landuse: Natural Forest

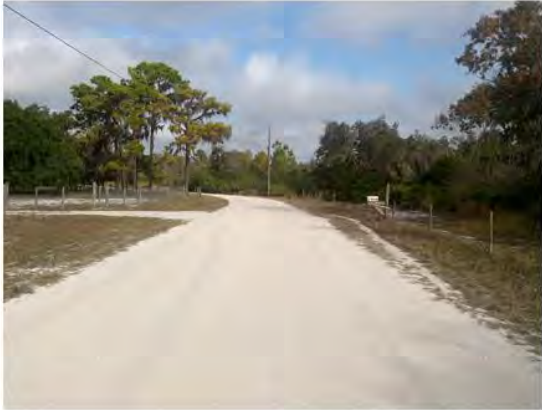
<p>Right Road Approach</p>

Myakka River			Sediment Risk Index: 42 (Moderate)
Watershed: Myakka River		County: Manatee	
Subwatershed: Wingate Creek		Site Number: MU001	
Latitude: 27.48591		LULC: Residential Low Density, Shrub and Brushland, Upland Hardwood	
Longitude: -82.05736			
Road Name: Taylor Road		Land Owner(s): Mosaic Fertilizer LLC

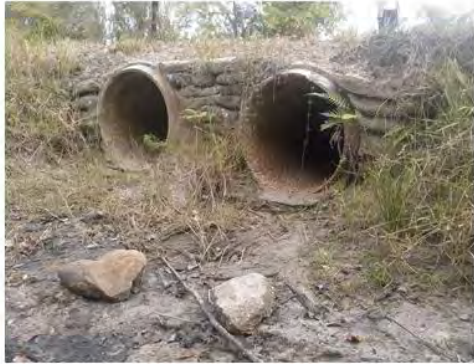
<p>Crossing Structure: Downstream</p>	
Risk Factor	Ranking	Score

<p><b>Additional Site Features</b></p> <p>Crossing Type and Quantity: Culvert, 2</p> <p>Crossing Material: Reinforced Concrete</p> <p>Culvert Outfall Drop: 0.35 in.</p> <p>Fish Passage Barrier: Present</p> <p>Notes: Channel was dry. Upstream crossing has hole between culverts, some damage to structure.</p>
US Channel Morph	Wetland	5	
DS Channel Morph	G	1	
DS Bank Alteration	High	1	
Upstream Skew Angle	5° to 30°	3	
Crossing fill condition	Good/Vegetated	5	
Inlet/Outlet Condition	Sediment/Scouring	3

Potential Eroded Vol.	>40 c.y.	1	
Soil K Factor	<0.20	5	
Approach Slope Mean	<2.0%	5	
Road Approach Materi	All Aggregate	5	
Upstream Rt Outlet	Vegetated	1	
Upstream Lt Outlet	Vegetated	1	
Upstream Rt Ditch	Vegetated	1	
Upstream Lt Ditch	Vegetated	1	
Downstream Rt Outlet	Bare Soil	0	
Downstream Lt Outlet	Bare Soil	0	
Downstream Rt Ditch	Vegetated	1	
Downstream Lt Ditch	Vegetated	1	
Improved Outlet Total	2	1	
Improved Ditches Tota	4	1	
		<b>SRI Total:</b>	<b>42</b>

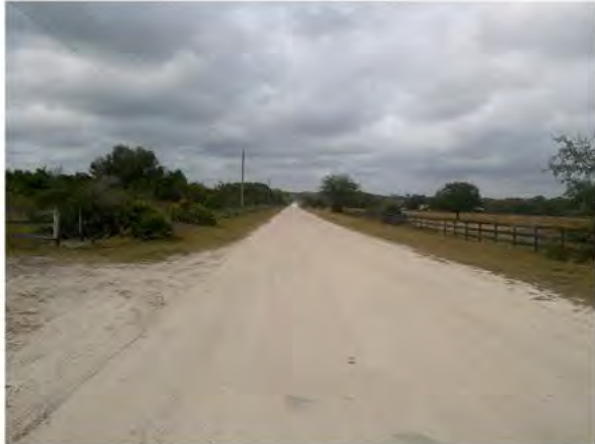
<p>Right Road Approach</p>

Myakka River			Sediment Risk Index: 52 (Low)	
Watershed: Myakka River			County: Manatee	
Subwatershed: Maple Creek			Site Number: MU002	
Latitude: 27.42265			LULC: Bottomland, Residential Low Density, Shrub and Brushland	
Longitude: -82.13895			Land Owner(s): SWFWMD*	
Road Name: Taylor Road

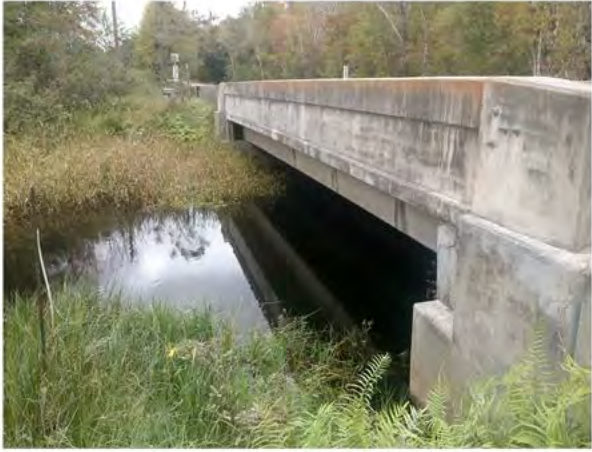
<p style="text-align: center;">Crossing Structure: Downstream</p>

Myakka River			Sediment Risk Index: 56 (Low)
Watershed: Myakka River			County: Mantee
Subwatershed: Maple Creek			Site Number: MU003
Latitude: 27.42300			LULC: Bottomland
Longitude: -82.14110			
Road Name: Taylor Road			Land Owner(s): SWFWMD*

US Channel Morph	Wetland	5	
DS Channel Morph	Wetland	5	
DS Bank Alteration	Natural	5	
Upstream Skew Angle	<5°	5	
Crossing fill condition	Good/Vegetated	5	
Inlet/Outlet Condition	No Impairment	5	
Potential Eroded Vol.	>40 c.y.	1	
Soil K Factor	<0.20	5	
Approach Slope Mean	<2.0%	5	
Road Approach Material	All Aggregate	5	
Upstream Rt Outlet	Vegetated	1	
Upstream Lt Outlet	Vegetated	1	
Upstream Rt Ditch	Vegetated	1	
Upstream Lt Ditch	Vegetated	1	
Downstream Rt Outlet	Vegetated	1	
Downstream Lt Outlet	Vegetated	1	Crossing Type and Quantity: Bridge

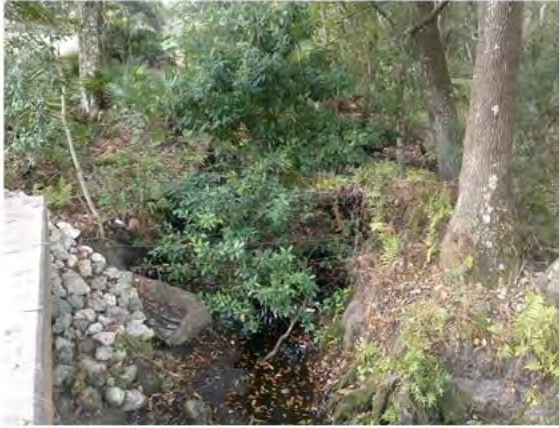
<p style="text-align: center;">Upstream Channel</p>

Taylor Creek			Sediment Risk Index: 46 (Low)	
Watershed: Myakka River			County: Manatee	
Subwatershed: Wingate Creek			Site Number: MU005	
Latitude: 27.43629			LULC: Bottomland, Wetland Coniferous Forest, Shrub and Brushland**	
Longitude: -82.15059				
Road Name: Taylor Road			Land Owner(s): City of Bradenton*

US Channel Morph	G	1		
DS Channel Morph	Ponded	1		
DS Bank Alteration	Minor/Partial	3		
Upstream Skew Angle	<5°	5		
Crossing fill condition	Good/Vegetated	5		
Inlet/Outlet Condition	Sediment/Scouring	3		
Potential Eroded Vol.	21 to 40 c.y.	3		
Soil K Factor	<0.20	5		
Approach Slope Mean	<2.0%	5		
Road Approach Material	All Aggregate	5		
Upstream Rt Outlet	Rip Rap	1		
Upstream Lt Outlet	Vegetated	1		
Upstream Rt Ditch	Vegetated	1		<b>Additional Site Features</b>

Upstream Lt Ditch	Vegetated	1	Crossing Type and Quantity: Bridge	
Downstream Rt Outlet	Vegetated	1	Crossing Material: Reinforced Concrete	
Downstream Lt Outlet	Vegetated	1	Culvert Outfall Drop: 0 in.	
Downstream Rt Ditch	Vegetated	1	Fish Passage Barrier: Not Present	
Downstream Lt Ditch	Vegetated	1	Notes: wing walls present, *additional landowner: Jonathan Pages, **additional LULC: Upland Hardwood Coniferous Mix, Cropland and Pastureland	
Improved Outlet Total	4	1		
Improved Ditches Total	4	1		
	<b>SRI Total:</b>	46

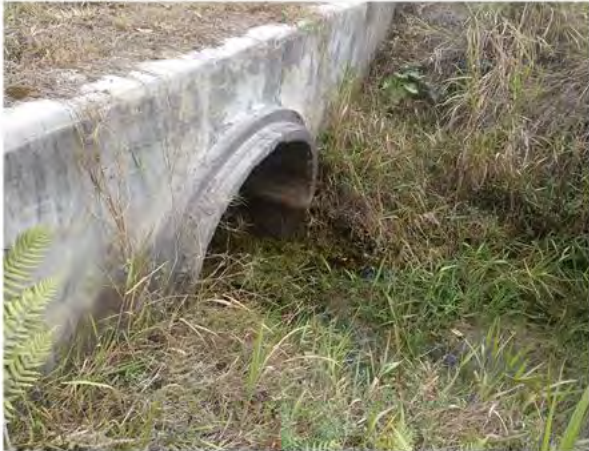
<p style="text-align: center;">Crossing Structure: Downstream</p>

Unnamed Tributary			Sediment Risk Index: 52 (Low)
Watershed: Myakka River			County: Manatee
Subwatershed: Maple Creek			Site Number: MU006
Latitude: 27.36666			LULC: Shrub and Brushland, Bottomland, Freshwater Marshes
Longitude: -82.13871			
Road Name: Ballard Road			Land Owner(s): McClure Properties LTD*

<p><b>Additional Site Features</b></p> <p>Crossing Type and Quantity: Culvert</p> <p>Crossing Material: Reinforced Concrete</p> <p>Culvert Outfall Drop: 0 in.</p> <p>Fish Passage Barrier: Not Present</p> <p>Notes: *additional landowner: Firouz Azima</p>
US Channel Morph	G	1	
DS Channel Morph	Wetland	5	
DS Bank Alteration	Natural	5	
Upstream Skew Angle	<5°	5	
Crossing fill condition	Good/Vegetated	5	
Inlet/Outlet Condition	No Impairment	5

Potential Eroded Vol.	>40 c.y.	1	
Soil K Factor	<0.20	5	
Approach Slope Mean	<2.0%	5	
Road Approach Material	All Aggregate	5	
Upstream Rt Outlet	Vegetated	1	
Upstream Lt Outlet	Vegetated	1	
Upstream Rt Ditch	Vegetated	1	
Upstream Lt Ditch	Vegetated	1	
Downstream Rt Outlet	Vegetated	1	
Downstream Lt Outlet	Vegetated	1	
Downstream Rt Ditch	Vegetated	1	
Downstream Lt Ditch	Vegetated	1	
Improved Outlet Total	4	1	
Improved Ditches Total	4	1	
	<b>SRI Total:</b>	<b>52</b>

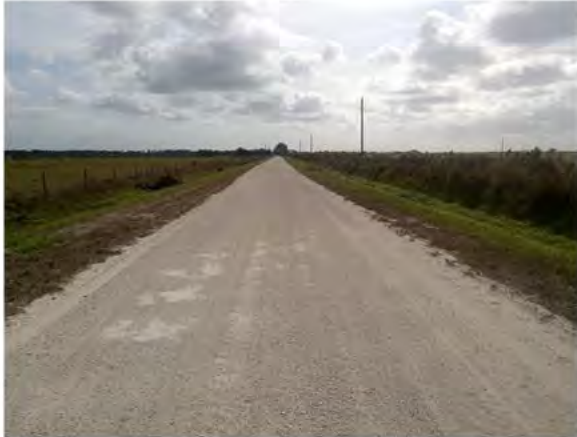
<p>Left Road Approach from Crossing</p>

Sand Branch			Sediment Risk Index: 46 (Low)
Watershed: Myakka River			County: Manatee
Subwatershed: Owen Creek			Site Number: MU007
Latitude: 27.33609			LULC: Cropland and Pastureland
Longitude: -82.08056			
Road Name: Curtis Road			Land Owner(s): P3 Real Estate Holdings LLC.*

<p><b>Additional Site Features</b>                      Crossing Type and Quantity: Culvert, 1                      Crossing Material: Reinforced Concrete                      Culvert Outfall Drop: 0 in.                      Fish Passage Barrier: Not Present                      Notes: *additional landowner: LPK LLC.</p>
US Channel Morph	Wetland	5	
DS Channel Morph	F	1	
DS Bank Alteration	High	1	
Upstream Skew Angle	<5°	5	
Crossing fill condition	Good/Vegetated	5	
Inlet/Outlet Condition	Sediment/Scouring	3

Potential Eroded Vol.	>40 c.y.	1	
Soil K Factor	<0.20	5	
Approach Slope Mean	<2.0%	5	
Road Approach Material	All Aggregate	5	
Upstream Rt Outlet	Vegetated	1	
Upstream Lt Outlet	Vegetated	1	
Upstream Rt Ditch	Vegetated	1	
Upstream Lt Ditch	Vegetated	1	
Downstream Rt Outlet	Vegetated	1	
Downstream Lt Outlet	Vegetated	1	
Downstream Rt Ditch	Vegetated	1	
Downstream Lt Ditch	Vegetated	1	
Improved Outlet Total	4	1	
Improved Ditches Total	4	1	
	<b>SRI Total:</b>	<b>46</b>

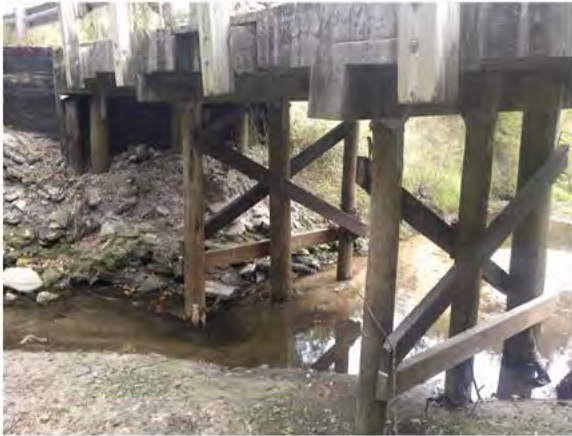
<p style="text-align: center;">Crossing Structure: Upstream</p>

Ogelby Creek			Sediment Risk Index: 44 (Moderate)
Watershed: Myakka River			County: Manatee
Subwatershed: Ogelby Creek			Site Number: MU008
Latitude: 27.39040			LULC: Upland Hardwood Coniferous Mix, Cropland and Pastureland
Longitude: -82.21910			
Road Name: Ogleby Creek Road			Land Owner(s): Matthew Thilbault Pallardy*

<p><b>Additional Site Features</b></p> <p>Crossing Type and Quantity: Bridge</p> <p>Crossing Material: Wood</p> <p>Culvert Outfall Drop: 0 in.</p> <p>Fish Passage Barrier: Not Present</p> <p>Notes: *additional landowners: John Falkner LLC., Kibler Agricultural Corp</p>
US Channel Morph	F	1	
DS Channel Morph	C	5	
DS Bank Alteration	High	1	
Upstream Skew Angle	<5°	5	
Crossing fill condition	Fair/RipRap	3	
Inlet/Outlet Condition	Sediment/Scouring	3

Potential Eroded Vol.	21 to 40 c.y.	3	
Soil K Factor	<0.20	5	
Approach Slope Mean	<2.0%	5	
Road Approach Material	All Aggregate	5	
Upstream Rt Outlet	Vegetated	1	
Upstream Lt Outlet	Vegetated	1	
Upstream Rt Ditch	Vegetated	1	
Upstream Lt Ditch	Vegetated	1	
Downstream Rt Outlet	Bare Soil	0	
Downstream Lt Outlet	Bare Soil	0	
Downstream Rt Ditch	Vegetated	1	
Downstream Lt Ditch	Vegetated	1	
Improved Outlet Total	2	1	
Improved Ditches Total	4	1	
	<b>SRI Total:</b>	<b>44</b>

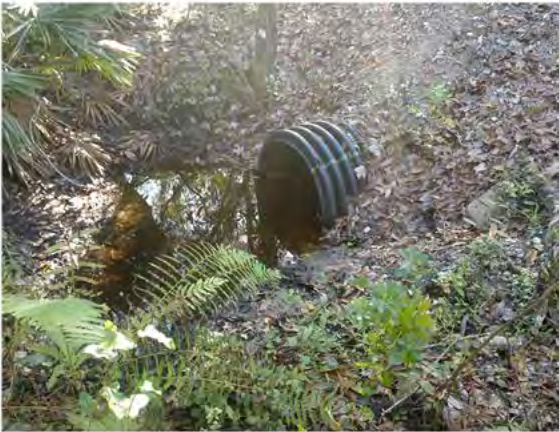
<p style="text-align: center;">Crossing Structure: Upstream</p>

Unnamed Tributary			Sediment Risk Index: 52 (Low)
Watershed: Myakka River			County: Sarasota
Subwatershed: Tatum Sawgrass Swamp			Site Number: MU009
Latitude: 27.33430			LULC: Bottomland, Pine Flatwoods
Longitude: -82.26552			
Road Name: Fruitville Road			Land Owner(s): Sarasota County

<p><b>Additional Site Features</b></p> <p>Crossing Type and Quantity: Culvert, 1</p> <p>Crossing Material: Polyvinyl Chloride</p> <p>Culvert Outfall Drop: 0 in.</p> <p>Fish Passage Barrier: Not Present</p> <p>Notes:</p>
US Channel Morph	E	5	
DS Channel Morph	E	5	
DS Bank Alteration	Natural	5	
Upstream Skew Angle	5° to 30°	3	
Crossing fill condition	Poor/Bare Soil	1	
Inlet/Outlet Condition	No Impairment	5	
Potential Eroded Vol.	21 to 40 c.y.	3

Soil K Factor	<0.20	5	
Approach Slope Mean	<2.0%	5	
Road Approach Material	All Aggregate	5	
Upstream Rt Outlet	Vegetated	1	
Upstream Lt Outlet	Vegetated	1	
Upstream Rt Ditch	Vegetated	1	
Upstream Lt Ditch	Vegetated	1	
Downstream Rt Outlet	Vegetated	1	
Downstream Lt Outlet	Vegetated	1	
Downstream Rt Ditch	Vegetated	1	
Downstream Lt Ditch	Vegetated	1	
Improved Outlet Total	4	1	
Improved Ditches Total	4	1	
	<b>SRI Total:</b>	<b>52</b>

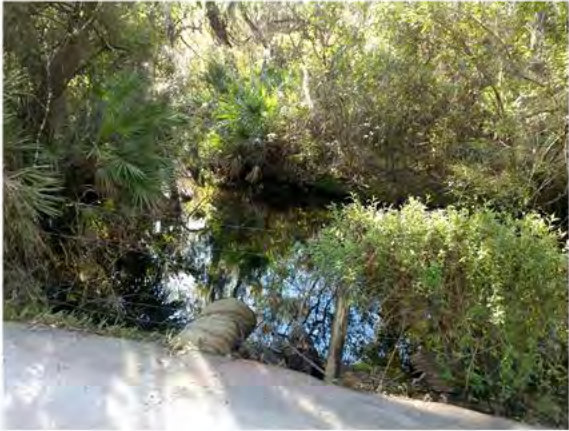
<p style="text-align: center;">Crossing Structure: Downstream</p>

Unnamed Tributary			Sediment Risk Index: 48 (Low)
Watershed: Myakka River			County: Sarasota
Subwatershed: Tatum Sawgrass Swamp			Site Number: MU010
Latitude: 27.32751			LULC: Bottomland, Pine Flatwoods
Longitude: -82.26142			
Road Name: Whidden Road			Land Owner(s): MAG Properties Inc.*

<p><b>Additional Site Features</b></p> <p>Crossing Type and Quantity: Culvert, 7</p> <p>Crossing Material: Corrugated Metal</p> <p>Culvert Outfall Drop: 0 in.</p> <p>Fish Passage Barrier: Not Present</p> <p>Notes: *additional landowners: Sarasota County, James M. Cain</p>
US Channel Morph	Ponded	1	
DS Channel Morph	Ponded	1	
DS Bank Alteration	Minor/Partial	3	
Upstream Skew Angle	<5°	5	
Crossing fill condition	Good/Vegetated	5	
Inlet/Outlet Condition	No Impairment	5

Potential Eroded Vol.	21 to 40 c.y.	3	
Soil K Factor	<0.20	5	
Approach Slope Mean	<2.0%	5	
Road Approach Material	All Aggregate	5	
Upstream Rt Outlet	Vegetated	1	
Upstream Lt Outlet	Vegetated	1	
Upstream Rt Ditch	Vegetated	1	
Upstream Lt Ditch	Vegetated	1	
Downstream Rt Outlet	Vegetated	1	
Downstream Lt Outlet	Vegetated	1	
Downstream Rt Ditch	Vegetated	1	
Downstream Lt Ditch	Vegetated	1	
Improved Outlet Total	4	1	
Improved Ditches Total	4	1	
	<b>SRI Total:</b>	<b>48</b>

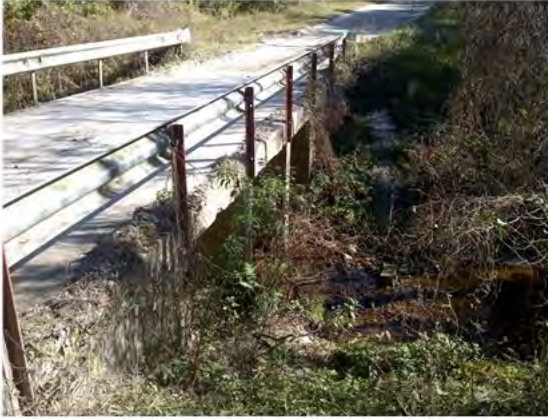
<p>Crossing Structure: Downstream</p>

Unnamed Tributary			Sediment Risk Index: 48 (Low)
Watershed: Myakka River			County: Sarasota
Subwatershed: Tatum Sawgrass Swamp			Site Number: MU011
Latitude: 27.32044			LULC: Bottomland, Pine Flatwoods, Cropland and Pastureland
Longitude: -82.26241			
Road Name: Jomar Road			Land Owner(s): VCH Citrus*

<p><b>Additional Site Features</b>            Crossing Type and Quantity: Bridge            Crossing Material: Reinforced Concrete            Culvert Outfall Drop: 0 in.            Fish Passage Barrier: Not Present            Notes: Fish passage blockage at low flow,            *additional landowners: Sarasota County, Sandlot Boys LLC.</p>
US Channel Morph	Ponded	1	
DS Channel Morph	C	5	
DS Bank Alteration	Natural	5	
Upstream Skew Angle	<5°	5	
Crossing fill condition	Good/Vegetated	5	
Inlet/Outlet Condition	Sediment/Scouring	3

Potential Eroded Vol.	21 to 40 c.y.	3	
Soil K Factor	<0.20	5	
Approach Slope Mean	<2.0%	5	
Road Approach Material	All Aggregate	5	
Upstream Rt Outlet	Vegetated	1	
Upstream Lt Outlet	Vegetated	1	
Upstream Rt Ditch	Bare Soil	0	
Upstream Lt Ditch	Bare Soil	0	
Downstream Rt Outlet	Vegetated	1	
Downstream Lt Outlet	Vegetated	1	
Downstream Rt Ditch	Bare Soil	0	
Downstream Lt Ditch	Bare Soil	0	
Improved Outlet Total	4	1	
Improved Ditches Total	0	1	
	<b>SRI Total:</b>	<b>48</b>

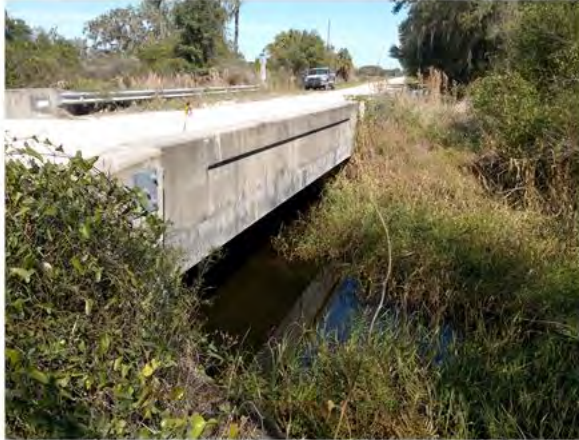
<p style="text-align: center;">Crossing Structure: Upstream</p>

Bud Slough			Sediment Risk Index: 42 (Moderate)
Watershed: Myakka River			County: Manatee
Subwatershed: Mud Lake Slough			Site Number: MU012
Latitude: 27.261090			LULC: Freshwater Marshes, Cropland and Pastureland
Longitude: -82.158050			Land Owner(s): Blackbeards Ranch LLC.
Road Name: Coker Gully Road

<p><b>Additional Site Features</b></p> <p>Crossing Type and Quantity: Bridge</p> <p>Crossing Material: Reinforced Concrete</p> <p>Culvert Outfall Drop: 0 in.</p> <p>Fish Passage Barrier: Not Present</p> <p>Notes: Looks channelized downstream</p>
US Channel Morph	Ponded	1	
DS Channel Morph	Ponded	1	
DS Bank Alteration	High	1	
Upstream Skew Angle	<5°	5	
Crossing fill condition	Good/Vegetated	5	
Inlet/Outlet Condition	Sediment/Scouring	3

Potential Eroded Vol.	>40 c.y.	1	
Soil K Factor	<0.20	5	
Approach Slope Mean	<2.0%	5	
Road Approach Material	All Aggregate	5	
Upstream Rt Outlet	Vegetated	1	
Upstream Lt Outlet	Vegetated	1	
Upstream Rt Ditch	Vegetated	1	
Upstream Lt Ditch	Vegetated	1	
Downstream Rt Outlet	Vegetated	1	
Downstream Lt Outlet	Vegetated	1	
Downstream Rt Ditch	Vegetated	1	
Downstream Lt Ditch	Vegetated	1	
Improved Outlet Total	4	1	
Improved Ditches Total	4	1	
	<b>SRI Total:</b>	<b>42</b>

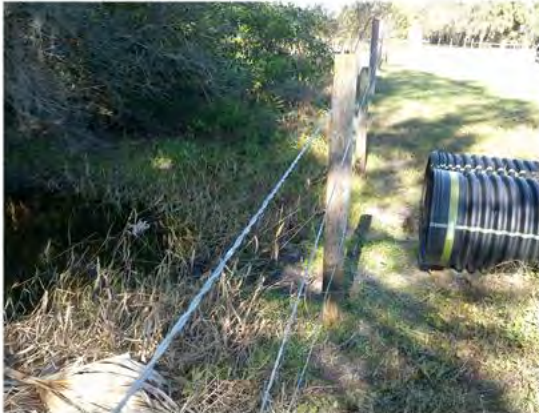
<p>Crossing Structure: Downstream</p>

Unnamed Tributary			Sediment Risk Index: 48 (Low)
Watershed: Myakka River		County: Sarasota	
Subwatershed: West Cocoplum Waterway		Site Number: MU013	
Latitude: 27.124136		LULC: Cropland and Pastureland	
Longitude: -82.153312			
Road Name: Toledo Blade Boulevard		Land Owner(s): Sarasota County

<p><b>Additional Site Features</b>            Crossing Type and Quantity: Culvert, 2            Crossing Material: Polyvinyl Chloride            Culvert Outfall Drop: 0 in.            Fish Passage Barrier: Not Present            Notes: Dry at time of survey</p>
US Channel Morph	F	1	
DS Channel Morph	Ponded	1	
DS Bank Alteration	High	1	
Upstream Skew Angle	<5°	5	
Crossing fill condition	Good/Vegetated	5	
Inlet/Outlet Condition	No Impairment	5	
Potential Eroded Vol.	<21 c.y.	5	
Soil K Factor	<0.20	5	
Approach Slope Mean	<2.0%	5

Road Approach Material	All Aggregate	5	
Upstream Rt Outlet	Vegetated	1	
Upstream Lt Outlet	Vegetated	1	
Upstream Rt Ditch	Vegetated	1	
Upstream Lt Ditch	Vegetated	1	
Downstream Rt Outlet	Vegetated	1	
Downstream Lt Outlet	Vegetated	1	
Downstream Rt Ditch	Vegetated	1	
Downstream Lt Ditch	Vegetated	1	
Improved Outlet Total	4	1	
Improved Ditches Total	4	1	
		<b>SRI Total:</b>	<b>48</b>

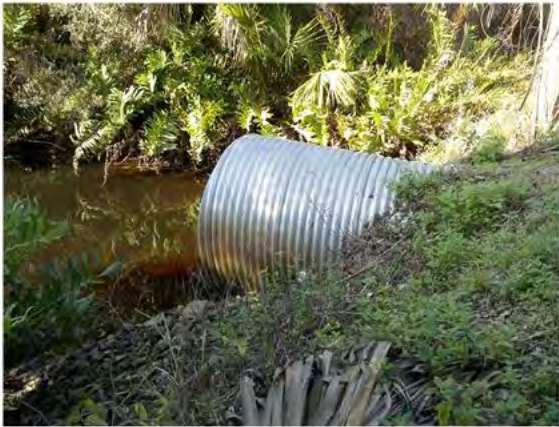
<p style="text-align: center;">Crossing Structure: Downstream</p>

Deer Prarie Creek			Sediment Risk Index: 50 (Low)
Watershed: Myakka River			County: Sarasota
Subwatershed: Deer Prarie Creek			Site Number: MU014
Latitude: 27.06271			LULC: Bottomland, Pine Flatwoods, Other Open Land
Longitude: -82.286943			
Road Name: unnamed road			Land Owner(s): SWFWMD

<p><b>Additional Site Features</b>            Crossing Type and Quantity: Culvert, 1            Crossing Material: Corrugated Metal            Culvert Outfall Drop: 0 in.            Fish Passage Barrier: Not Present            Notes: may be tidal</p>
US Channel Morph	C	5	
DS Channel Morph	C	5	
DS Bank Alteration	Natural	5	
Upstream Skew Angle	5° to 30°	3	
Crossing fill condition	Fair/Rip Rap	3	
Inlet/Outlet Condition	Sediment/Scouring	3

Potential Eroded Vol.	>40 c.y.	1	
Soil K Factor	<0.20	5	
Approach Slope Mean	<2.0%	5	
Road Approach Material	All Aggregate	5	
Upstream Rt Outlet	Vegetated	1	
Upstream Lt Outlet	Vegetated	1	
Upstream Rt Ditch	Vegetated	1	
Upstream Lt Ditch	Vegetated	1	
Downstream Rt Outlet	Vegetated	1	
Downstream Lt Outlet	Vegetated	1	
Downstream Rt Ditch	Vegetated	1	
Downstream Lt Ditch	Vegetated	1	
Improved Outlet Total	4	1	
Improved Ditches Total	4	1	
	<b>SRI Total:</b>	<b>50</b>

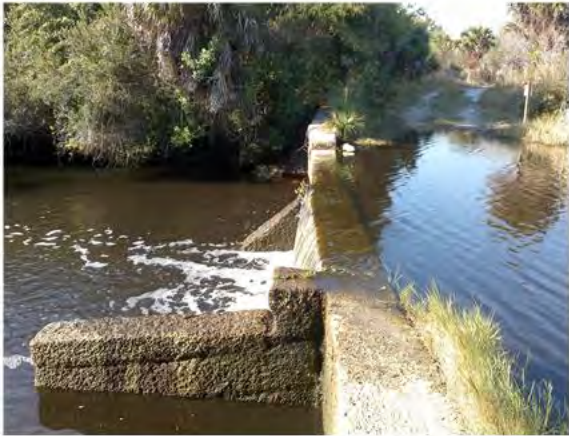
<p style="text-align: center;">Crossing Strucutre: Downstream</p>

Deer Prarie Creek			Sediment Risk Index: 52 (Low)
Watershed: Myakka River			County: Sarasota
Subwatershed: Deer Prarie Creek			Site Number: MU015
Latitude: 27.06427			LULC: Bays and Estuaries, Pine
Longitude: -82.28693			Flatwoods, Bottomland, Other Open
Road Name: unnamed road			Land Owner(s): SWFWMD

Upstream Skew Angle	<5°	5	
Crossing fill condition	Fair/Rip Rap	3	
Inlet/Outlet Condition	Blocked	1	
Potential Eroded Vol.	<21 c.y.	5	
Soil K Factor	<0.20	5	
Approach Slope Mean	<2.0%	5	
Road Approach Material	All Aggregate	5	
Upstream Rt Outlet	Vegetated	1	
Upstream Lt Outlet	Vegetated	1	
Upstream Rt Ditch	Vegetated	1	
Upstream Lt Ditch	Vegetated	1	
Downstream Rt Outlet	Vegetated	1	
Downstream Lt Outlet	Vegetated	1	
Downstream Rt Ditch	Vegetated	1	
Downstream Lt Ditch	Vegetated	1	
Improved Outlet Total	4	1	
Improved Ditches Total	4	1	
		<b>SRI Total:</b>	52

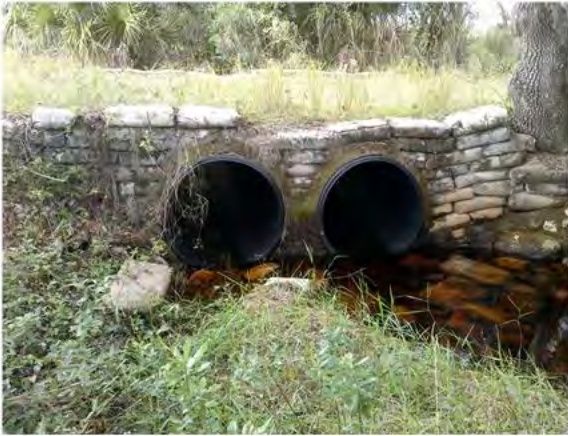
<p>Crossing Structure: Upstream</p>

Unnamed Tributary			Sediment Risk Index: 56-(Low)		
Watershed: Myakka River		County: Sarasota			
Subwatershed: Lake Myakka		Site Number: MU017			
Latitude: 27.25939		LULC: Shrub and Brushland			
Longitude: -82.27511					
Road Name: Myakka State Park Road		Land Owner(s): TIITF (Rec and Parks)

US Channel Morph	C	5			
DS Channel Morph	C	5			
DS Bank Alteration	Natural	5			
Upstream Skew Angle	5° to 30°	3			
Crossing fill condition	Good/Vegetated	5			
Inlet/Outlet Condition	No Impairment	5			
Potential Eroded Vol.	<21 c.y.	5			
Soil K Factor	<0.20	5			
Approach Slope Mean	<2.0%	5			
Road Approach Material	All Aggregate	5			
Upstream Rt Outlet	Vegetated	1			
Upstream Lt Outlet	Vegetated	1			
Upstream Rt Ditch	Vegetated	1		<b>Additional Site Features</b>	
Upstream Lt Ditch	Vegetated	1			Crossing Type and Quantity: Culvert, 2

Downstream Rt Outlet	Bare Soil	0			Crossing Material: Polyvinyl Chloride
Downstream Lt Outlet	Bare Soil	0	Culvert Outfall Drop: 0 in.		
Downstream Rt Ditch	Vegetated	1	Fish Passage Barrier: Not Present		
Downstream Lt Ditch	Vegetated	1	Notes:		
Improved Outlet Total	2	1			
Improved Ditches Total	4	1			
	<b>SRI Total:</b>	56

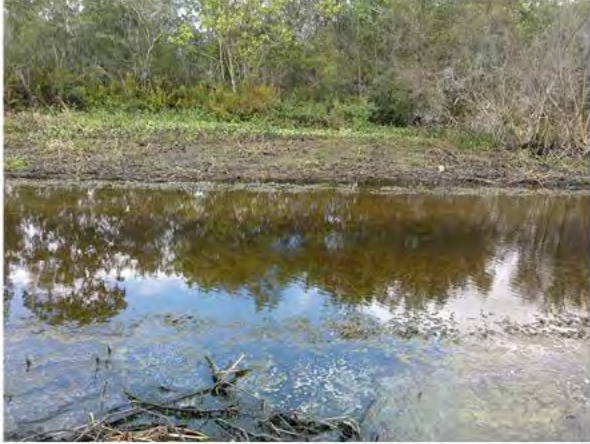
<p>Crossing Structure: Downstream</p>

Unnamed Wetland			Sediment Risk Index: 56 (Low)
Watershed: Myakka River			County: Sarasota
Subwatershed: Lake Myakka			Site Number: MU019
Latitude: 27.24621			LULC: Freshwater Marshes, Bottomland
Longitude: -82.27788			
Road Name: Powerline Road			Land Owner(s): TIITF (Rec and Parks)

<p><b>Additional Site Features</b></p> <p>Crossing Type and Quantity: Ford</p> <p>Crossing Material: Native Soil, Rock</p> <p>Culvert Outfall Drop: 0 in.</p> <p>Fish Passage Barrier: Not Present</p> <p>Notes:</p>
US Channel Morph	Wetland	5	
DS Channel Morph	Wetland	5	
DS Bank Alteration	Natural	5	
Upstream Skew Angle	<5°	5	
Crossing fill condition	Good/Vegetated	5	
Inlet/Outlet Condition	No Impairment	5	
Potential Eroded Vol.	<21 c.y.	5	
Soil K Factor	<0.20	5	
Approach Slope Mean	>4.0%	1	
Road Approach Material	All Aggregate	5

Upstream Rt Outlet	Vegetated	1	
Upstream Lt Outlet	Vegetated	1	
Upstream Rt Ditch	Vegetated	1	
Upstream Lt Ditch	Vegetated	1	
Downstream Rt Outlet	Vegetated	1	
Downstream Lt Outlet	Vegetated	1	
Downstream Rt Ditch	Vegetated	1	
Downstream Lt Ditch	Vegetated	1	
Improved Outlet Total	4	1	
Improved Ditches Total	4	1	
	<b>SRI Total:</b>	<b>56</b>

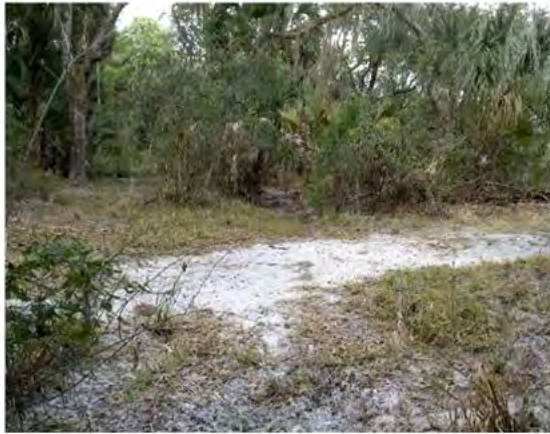
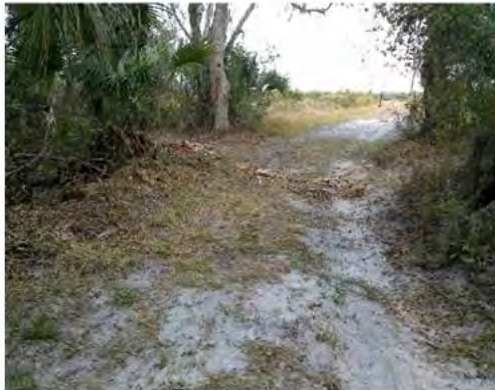
Crossing Structure: Downstream			Right Road Approach
<b>Risk Factor</b>	<b>Ranking</b>	<b>Score</b>

Unnamed Tributary			Sediment Risk Index: 54 (Low)
Watershed: Myakka River			County: Manatee
Subwatershed: Mossy Island Slough			Site Number: MU020
Latitude: 27.27703			LULC: Bottomland, Shrub and Brushland
Longitude: -82.24248			
Road Name: unnamed trail			Land Owner(s): TIITF (Rec and Parks)

US Channel Morph	E	5	
DS Channel Morph	Wetland	5	
DS Bank Alteration	Natural	5	
Upstream Skew Angle	<5°	5	
Crossing fill condition	Poor/Bare Soil	5	
Inlet/Outlet Condition	No Impairment	5	
Potential Eroded Vol.	<21 c.y.	5	
Soil K Factor	<0.20	5	
Approach Slope Mean	>4.0%	1	
Road Approach Material	Aggregate/Native Soil	3	
Upstream Rt Outlet	Vegetated	1	
Upstream Lt Outlet	Vegetated	1	
Upstream Rt Ditch	Vegetated	1	
Upstream Lt Ditch	Vegetated	1	
Downstream Rt Outlet	Vegetated	1	
Downstream Lt Outlet	Vegetated	1	Crossing Type and Quantity: Ford

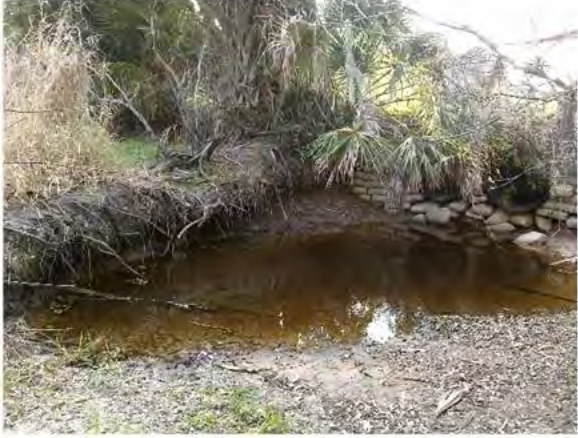
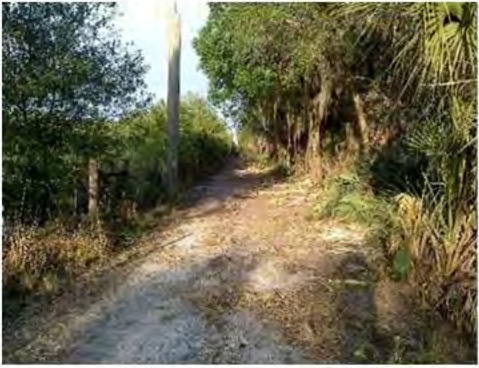
<p>Crossing Structure: Downstream</p>

Unnamed Tributary			Sediment Risk Index: 50 (Low)	
Watershed: Myakka River			County: Sarasota	
Subwatershed: Lake Myakka			Site Number: MU021	
Latitude: 27.24868			LULC: Freshwater Marshes, Bottomland	
Longitude: -82.30792				
Road Name: unnamed trail			Land Owner(s): TIITF (Rec and Parks)

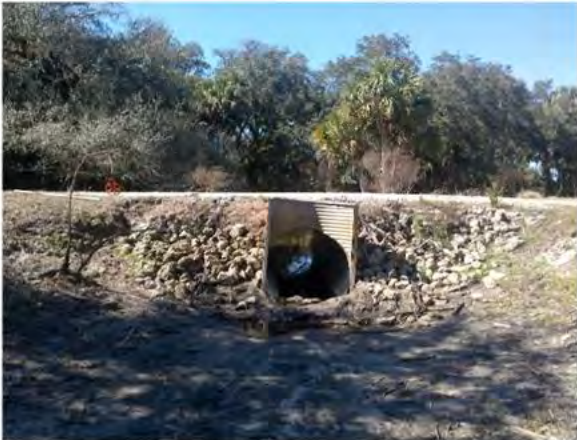
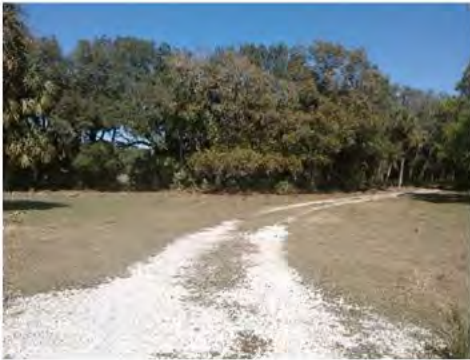
<p>Crossing Structure: Upstream</p>

Unnamed Tributary			Sediment Risk Index: 58 (Low)
Watershed: Myakka River			County: Sarasota
Subwatershed: West Cocoplum Waterway			Site Number: MU023
Latitude: 27.13959			LULC: Cropland and Pastureland, Upland Hardwood Coniferous Mix
Longitude: -82.14603			
Road Name: Toledo Blade Boulevard			Land Owner(s): Sarasota County

US Channel Morph	E	5	
DS Channel Morph	E	5	
DS Bank Alteration	Natural	5	
Upstream Skew Angle	<5°	5	
Crossing fill condition	Fair/Riprap	3	
Inlet/Outlet Condition	No Impairment	5	
Potential Eroded Vol.	<21 c.y.	5	
Soil K Factor	<0.20	5	
Approach Slope Mean	<2.0%	5	
Road Approach Material	All Aggregate	5	
Upstream Rt Outlet	Rip Rap	1	
Upstream Lt Outlet	Rip Rap	1	
Upstream Rt Ditch	Rip Rap	1	
Upstream Lt Ditch	Rip Rap	1	
Downstream Rt Outlet	Rip Rap	1	<b>Additional Site Features</b>
Downstream Lt Outlet	Rip Rap	1	Crossing Type and Quantity: Culvert, 1

Downstream Rt Ditch	Rip Rap	1	Crossing Material: Corrugated Metal
Downstream Lt Ditch	Rip Rap	1	Culvert Outfall Drop: 0 in.
Improved Outlet Total	4	1	Fish Passage Barrier: Not Present
Improved Ditches Total	4	1	Notes:
	<b>SRI Total:</b>	<b>58</b>

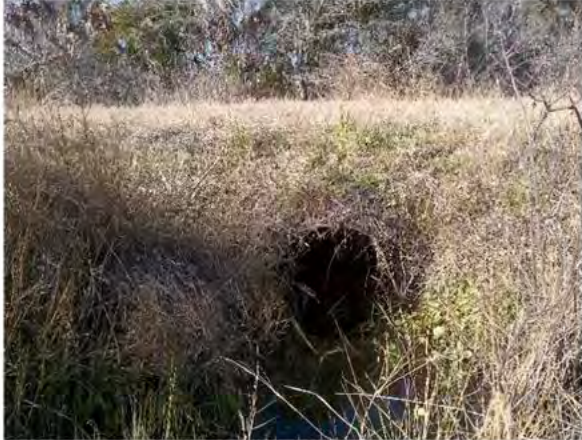
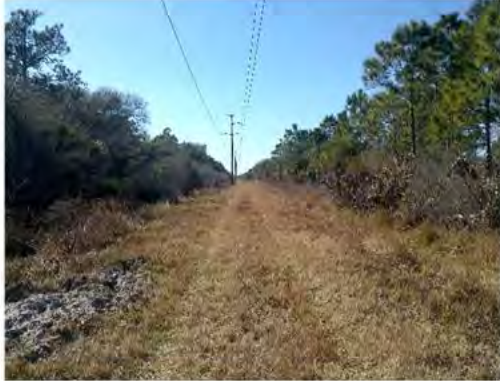
<p>Crossing Structure: Downstream</p>

Unnamed Wetland			Sediment Risk Index: 52 (Low)
Watershed: Myakka River			County: Sarasota
Subwatershed: Harris Camp			Site Number: MU024
Latitude: 27.13526			LULC: Freshwater Marshes, Pine Flatwoods
Longitude: -82.34045			
Road Name: South Powerline Rd			Land Owner(s): Sarasota County

<p><b>Additional Site Features</b>            Crossing Type and Quantity: Culvert, 1            Crossing Material: Polyvinyl Chloride            Culvert Outfall Drop: 0 in.            Fish Passage Barrier: Not Present            Notes: culvert connecting ditches @ 90 degree angle</p>
US Channel Morph	Wetland	5	
DS Channel Morph	Wetland	5	
DS Bank Alteration	Natural	5	
Upstream Skew Angle	>30°	1	
Crossing fill condition	Good/Vegetated	5	
Inlet/Outlet Condition	No Impairment	5	
Potential Eroded Vol.	<21 c.y.	5	
Soil K Factor	<0.20	5

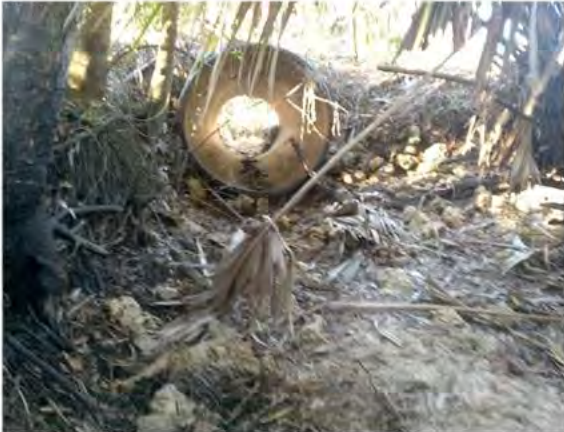
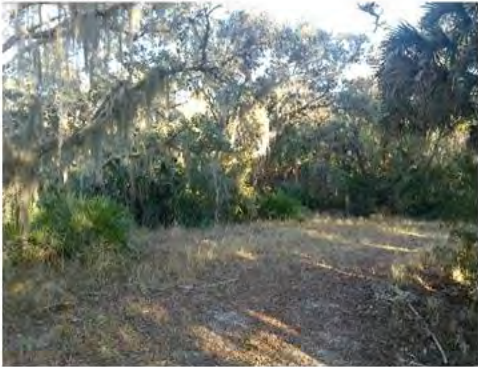
<p>Crossing Structure: Downstream</p>

Unnamed Tributary			Sediment Risk Index: 54 (Low)	
Watershed: Myakka River			County: Sarasota	
Subwatershed: Harris Camp			Site Number: MU027	
Latitude: 27.12784			LULC: Shrub and Brushland, Bottomland	
Longitude: -82.34646				
Road Name: unnamed trail			Land Owner(s): Sarasota County

US Channel Morph	E	5		
DS Channel Morph	E	5		
DS Bank Alteration	Natural	5		
Upstream Skew Angle	5° to 30°	3		
Crossing fill condition	Fair/Riprap	3		
Inlet/Outlet Condition	No Impairment	5		
Potential Eroded Vol.	<21 c.y.	5		
Soil K Factor	<0.20	5		
Approach Slope Mean	<2.0%	5		
Road Approach Material	All Aggregate	5		
Upstream Rt Outlet	Rip Rap	1		
Upstream Lt Outlet	Bare Soil	0		
Upstream Rt Ditch	Vegetated	1		
Upstream Lt Ditch	Vegetated	1		
Downstream Rt Outlet	Rip Rap	1		<b>Additional Site Features</b>
Downstream Lt Outlet	Rip Rap	1		Crossing Type and Quantity: Culvert, 1

Downstream Rt Ditch	Vegetated	1	Crossing Material: Polyvinyl Chloride	
Downstream Lt Ditch	Vegetated	1	Culvert Outfall Drop: 0.8 in.	
Improved Outlet Total	3	0	Fish Passage Barrier: Present	
Improved Ditches Total	4	1	Notes: Riprap falling away	
		<b>SRI Total:</b>	54

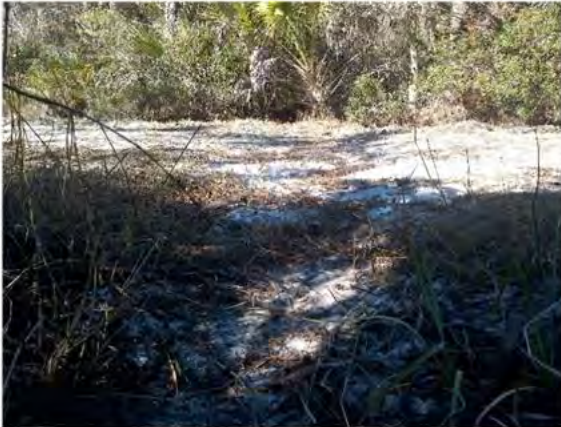
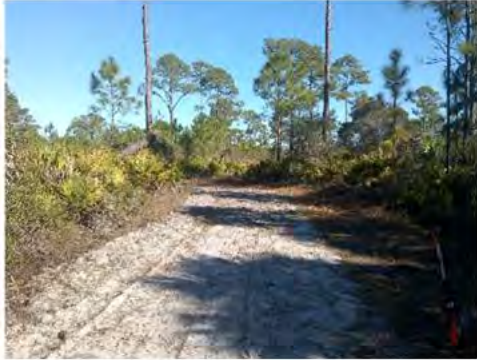
<p>Crossing Structure: Upstream</p>

Unnamed Tributary			Sediment Risk Index: 52 (Low)
Watershed: Myakka River			County: Sarasota
Subwatershed: Harris Camp			Site Number: MU028
Latitude: 27.15319			LULC: Pine Flatwoods
Longitude: -82.35194			
Road Name: Rocky Ford Trail			Land Owner(s): Sarasota County

US Channel Morph	E	5	
DS Channel Morph	E	5	
DS Bank Alteration	Natural	5	
Upstream Skew Angle	<5°	5	
Crossing fill condition	Good/Vegetated	5	
Inlet/Outlet Condition	No Impairment	5	
Potential Eroded Vol.	<21 c.y.	5	
Soil K Factor	<0.20	5	
Approach Slope Mean	<2.0%	5	
Road Approach Material	All Native Soil	1	
Upstream Rt Outlet	Vegetated	1	
Upstream Lt Outlet	Vegetated	1	
Upstream Rt Ditch	Bare Soil	0	
Upstream Lt Ditch	Bare Soil	0	Crossing Type and Quantity: Ford
Downstream Rt Outlet	Vegetated	1	Crossing Material: Native Soil
Downstream Lt Outlet	Vegetated	1	Culvert Outfall Drop: 0 in.

Downstream Rt Ditch	Bare Soil	0	Fish Passage Barrier: Not Present
Downstream Lt Ditch	Bare Soil	0	Notes:
Improved Outlet Total	4	1	
Improved Ditches Total	0	1	
	<b>SRI Total:</b>	52

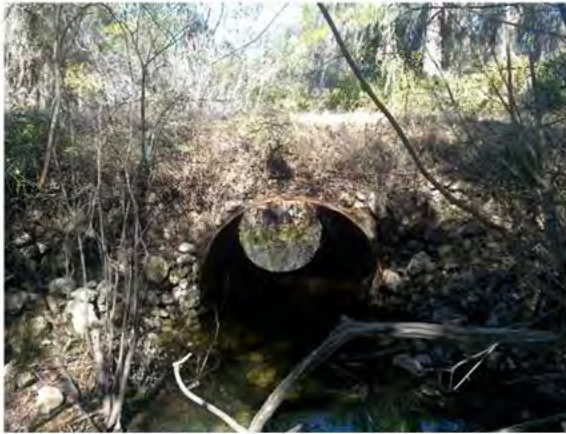
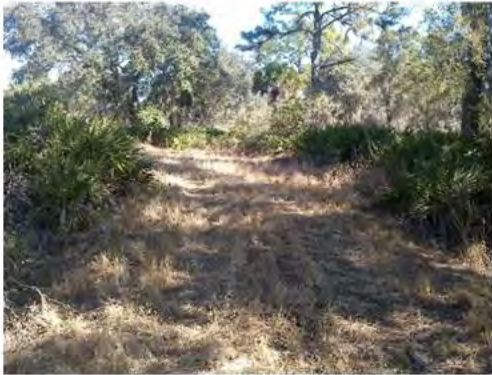
<p style="text-align: center;">Crossing Structure: Upstream</p>

Unnamed Tributary			Sediment Risk Index: 52 (Low)
Watershed: Myakka River			County: Sarasota
Subwatershed: Harris Camp			Site Number: MU029
Latitude: 27.15411			LULC: Pine Flatwoods
Longitude: -82.35980			
Road Name: unnamed trail			Land Owner(s): Sarasota County

<p><b>Additional Site Features</b></p> <p>Crossing Type and Quantity: Culvert, 1</p> <p>Crossing Material: Corrugated Metal</p> <p>Culvert Outfall Drop: 0 in.</p> <p>Fish Passage Barrier: Not Present</p> <p>Notes:</p>
US Channel Morph	E	5	
DS Channel Morph	E	5	
DS Bank Alteration	Natural	5	
Upstream Skew Angle	>30°	1	
Crossing fill condition	Good/Vegetated	5	
Inlet/Outlet Condition	No Impairment	5	
Potential Eroded Vol.	<21 c.y.	5	
Soil K Factor	<0.20	5	
Approach Slope Mean	<2.0%	5	
Road Approach Material	All Native Soil	1

Upstream Rt Outlet	Rip Rap	1	
Upstream Lt Outlet	Rip Rap	1	
Upstream Rt Ditch	Vegetated	1	
Upstream Lt Ditch	Vegetated	1	
Downstream Rt Outlet	Vegetated	1	
Downstream Lt Outlet	Rip Rap	1	
Downstream Rt Ditch	Vegetated	1	
Downstream Lt Ditch	Vegetated	1	
Improved Outlet Total	4	1	
Improved Ditches Total	4	1	
	<b>SRI Total:</b>	<b>52</b>

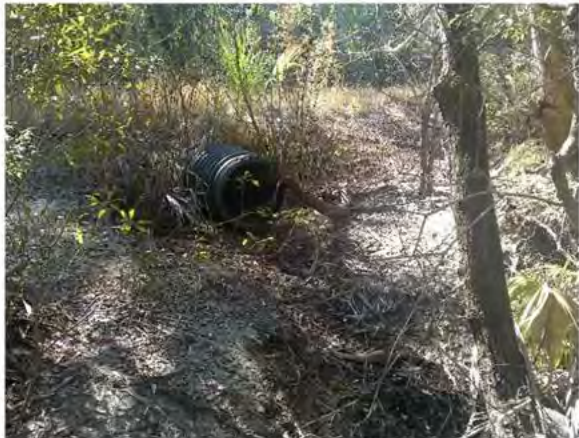
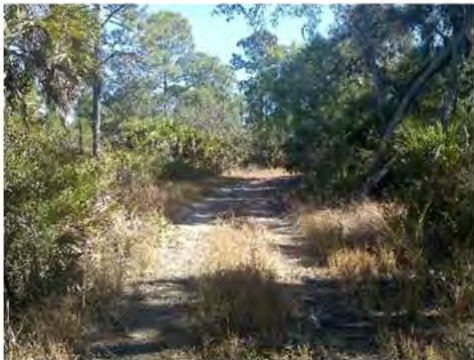
<p>Crossing Structure: Downstream</p>

Unnamed Tributary			Sediment Risk Index: 52 (Low)
Watershed: Myakka River		County: Sarasota	
Subwatershed: Harris Camp		Site Number: MU030	
Latitude: 27.15253		LULC: Bottomland, Shrub and Brushland, Pine Flatwoods	
Longitude: -82.35580		Land Owner(s): Sarasota County	
Road Name: unnamed trail

<p><b>Additional Site Features</b></p> <p>Crossing Type and Quantity: Culvert, 1</p> <p>Crossing Material: Polyvinyl Chloride</p> <p>Culvert Outfall Drop: 0.35 in.</p> <p>Fish Passage Barrier: Present</p> <p>Notes:</p>
US Channel Morph	E	5	
DS Channel Morph	E	5	
DS Bank Alteration	Natural	5	
Upstream Skew Angle	5° to 30°	3	
Crossing fill condition	Good/Vegetated	5	
Inlet/Outlet Condition	No Impairment	5	
Potential Eroded Vol.	<21 c.y.	5	
Soil K Factor	<0.20	5	
Approach Slope Mean	<2.0%	5	
Road Approach Material	All Native Soil	1

Upstream Rt Outlet	Vegetated	1	
Upstream Lt Outlet	Vegetated	1	
Upstream Rt Ditch	Vegetated	1	
Upstream Lt Ditch	Vegetated	1	
Downstream Rt Outlet	Other (Gravel)	0	
Downstream Lt Outlet	Vegetated	1	
Downstream Rt Ditch	Vegetated	1	
Downstream Lt Ditch	Vegetated	1	
Improved Outlet Total	3	0	
Improved Ditches Total	4	1	
	<b>SRI Total:</b>	52

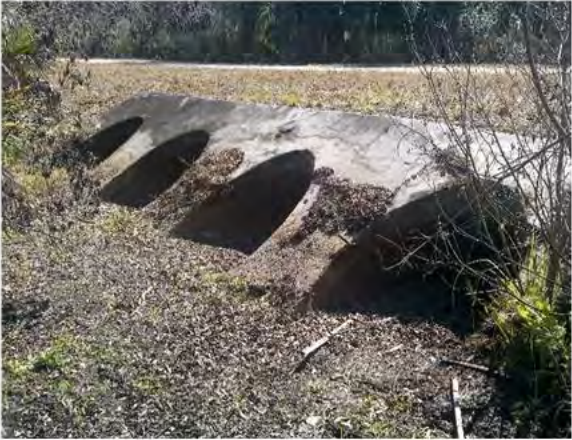
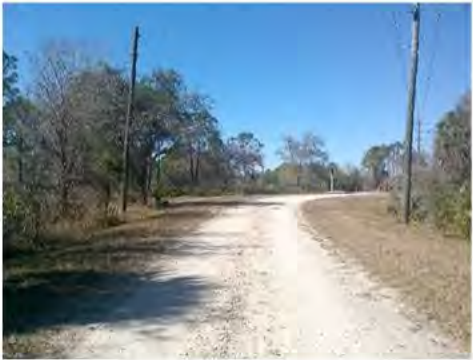
<p>Crossing Structure: Downstream</p>

Unnamed Wetland			Sediment Risk Index: 58 (Low)
Watershed: Myakka River			County: Sarasota
Subwatershed: Harris Camp			Site Number: MU031
Latitude: 27.14332			LULC: Bottomland, Freshwater Marshes, Pine Flatwoods
Longitude: -82.33450			
Road Name: North Mabry Carlton Parkway			Land Owner(s): Sarasota County

<p>Left Road Approach</p>
Risk Factor	Ranking	Score	  <p><b>Additional Site Features</b>            Crossing Type and Quantity: Culvert, 4            Crossing Material: Reinforced Concrete            Culvert Outfall Drop: 0 in.            Fish Passage Barrier: Not Present</p> <p>Notes:</p>
US Channel Morph	Wetland	5	
DS Channel Morph	Wetland	5	
DS Bank Alteration	Natural	5	
Upstream Skew Angle	5° to 30°	3	
Crossing fill condition	Good/Vegetated	5	
Inlet/Outlet Condition	No Impairment	5	
Potential Eroded Vol.	<21 c.y.	5	
Soil K Factor	<0.20	5	
Approach Slope Mean	<2.0	5

Road Approach Material	All Aggregate	5	
Upstream Rt Outlet	Vegetated	1	
Upstream Lt Outlet	Vegetated	1	
Upstream Rt Ditch	Vegetated	1	
Upstream Lt Ditch	Vegetated	1	
Downstream Rt Outlet	Vegetated	1	
Downstream Lt Outlet	Vegetated	1	
Downstream Rt Ditch	Vegetated	1	
Downstream Lt Ditch	Vegetated	1	
Improved Outlet Total	4	1	
Improved Ditches Total	4	1	
		<b>SRI Total:</b>	58
