# Peace River Streambank Restoration and Myakka River Watershed Threats Assessment and Fish Assemblage Monitoring

Final Report 1 July 2019 – 31 March 2023  
State Wildlife Grant 2953 – PID 9100 250 2953

Submitted to Florida State Wildlife Grants Program  
1 June 2023

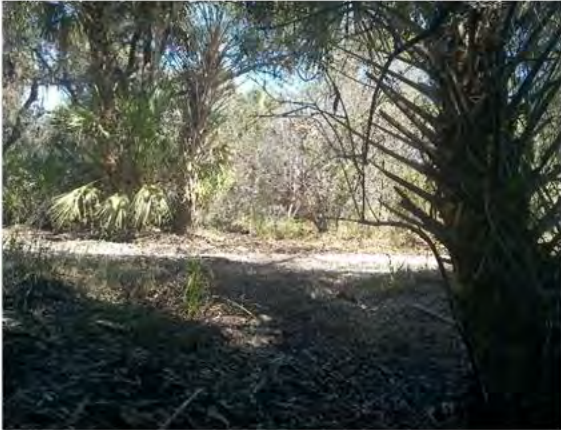
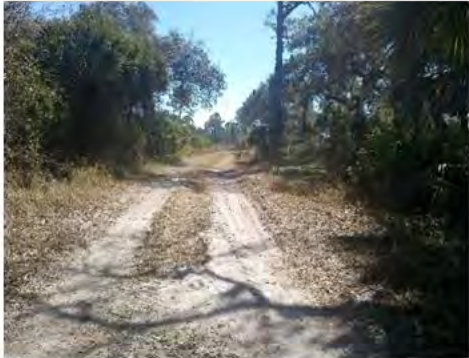
<p>Crossing Structure: Upstream</p>

Unnamed Tributary			Sediment Risk Index: 56 (Low)
Watershed: Myakka River			County: Sarasota
Subwatershed: Harris Camp			Site Number: MU032
Latitude: 27.13814			LULC: Bottomland, Shrub and Brushland, Pine Flatwoods
Longitude: -82.32391			
Road Name: North Mabry Carlton Parkway			Land Owner(s): Sarasota County

US Channel Morph	E	5	
DS Channel Morph	Wetland	5	
DS Bank Alteration	Natural	5	
Upstream Skew Angle	<5°	5	
Crossing fill condition	Good/Vegetated	5	
Inlet/Outlet Condition	No Impairment	5	
Potential Eroded Vol.	<21 c.y.	5	
Soil K Factor	<0.20	5	
Approach Slope Mean	<2.0%	5	
Road Approach Material	Native Soil/Sand/Clay	1	
Upstream Rt Outlet	Vegetated	1	
Upstream Lt Outlet	Vegetated	1	
Upstream Rt Ditch	Vegetated	1	
Upstream Lt Ditch	Vegetated	1	
Downstream Rt Outlet	Vegetated	1

Downstream Lt Outlet	Vegetated	1	Crossing Type and Quantity: Ford
Downstream Rt Ditch	Vegetated	1	Crossing Material: Synthetic Matting/Gravel
Downstream Lt Ditch	Vegetated	1	Culvert Outfall Drop: 0 in.
Improved Outlet Total	4	1	Fish Passage Barrier: Not Present
Improved Ditches Total	4	1	Notes:
		<b>SRI Total:</b>

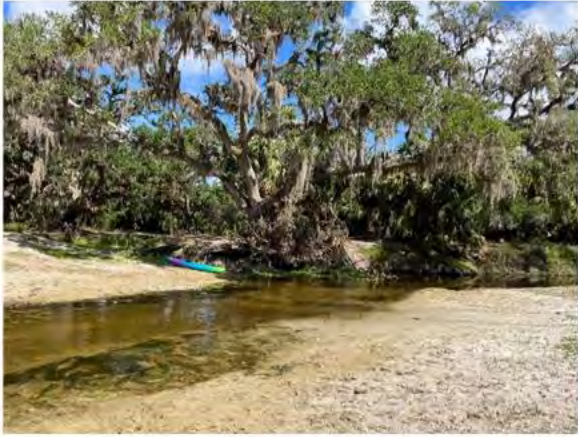
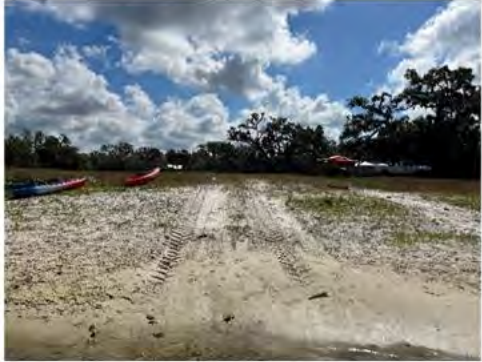
<p>Crossing Structure: Upstream</p>

Unnamed Tributary			Sediment Risk Index: 50 (Low)
Watershed: Myakka River			County: Manatee
Subwatershed: Tatum Sawgrass Swamp			Site Number: MU033
Latitude: 27.30219			LULC: Streams and Waterways, Cropland and Pastureland, Bottomland
Longitude: -82.24369			
Road Name: unnamed road			Land Owner(s): Triangle Ranch LLC

<p><b>Additional Site Features</b></p> <p>Crossing Type and Quantity: Ford</p> <p>Crossing Material: Native Soil/Sand</p> <p>Culvert Outfall Drop: 0 in.</p> <p>Fish Passage Barrier: Not Present</p> <p>Notes:</p>
US Channel Morph	C	5	
DS Channel Morph	C	5	
DS Bank Alteration	Minor/Partial	3	
Upstream Skew Angle	<5°	5	
Crossing fill condition	Good/Vegetated	5	
Inlet/Outlet Condition	No Impairment	5	
Potential Eroded Vol.	<21 c.y.	5	
Soil K Factor	<0.20	5	
Approach Slope Mean	>4.0%	1	
Road Approach Material	Native Soil/Sand/Clay	1

Upstream Rt Outlet	Vegetated	1	
Upstream Lt Outlet	Vegetated	1	
Upstream Rt Ditch	Vegetated	1	
Upstream Lt Ditch	Vegetated	1	
Downstream Rt Outlet	Vegetated	1	
Downstream Lt Outlet	Vegetated	1	
Downstream Rt Ditch	Vegetated	1	
Downstream Lt Ditch	Vegetated	1	
Improved Outlet Total	4	1	
Improved Ditches Total	4	1	
	<b>SRI Total:</b>	<b>50</b>

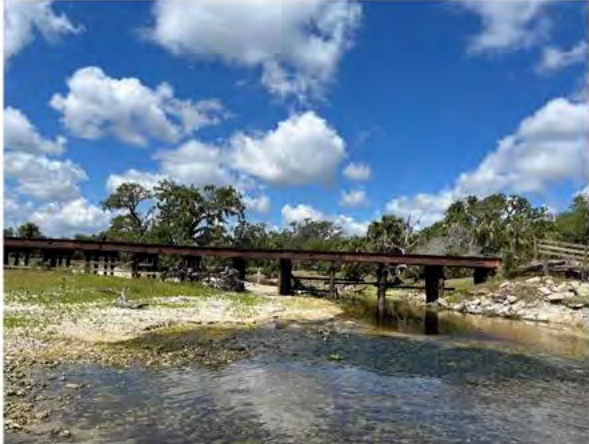
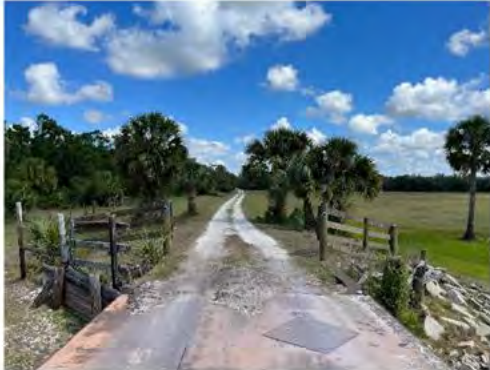
<p style="text-align: center;">Crossing Structure: Upstream</p>

Unnamed Tributary			Sediment Risk Index: 56 (Low)
Watershed: Myakka River			County: Manatee
Subwatershed: Tatum Sawgrass Swamp			Site Number: MU034
Latitude: 27.29397			LULC: Streams and Waterways, Cropland and Pastureland, Wet Prairies,**
Longitude: -82.23476			
Road Name: unnamed road			Land Owner(s): Triangle Ranch LLC

<p><b>Additional Site Features</b></p> <p>Crossing Type and Quantity: Bridge</p> <p>Crossing Material: Iron/Steel, Wood</p> <p>Culvert Outfall Drop: 0 in.</p> <p>Fish Passage Barrier: Not Present</p> <p>Notes: **Upland Hardwood-Coniferous Mix</p>
US Channel Morph	C	5	
DS Channel Morph	C	5	
DS Bank Alteration	Minor/Partial	3	
Upstream Skew Angle	<5°	5	
Crossing fill condition	Good/Vegetated	5	
Inlet/Outlet Condition	Sediment Scouring	3

Potential Eroded Vol.	<21 c.y.	5	
Soil K Factor	<0.20	5	
Approach Slope Mean	<2.0%	5	
Road Approach Material	All Aggregate	5	
Upstream Rt Outlet	Riprap	1	
Upstream Lt Outlet	Riprap	1	
Upstream Rt Ditch	Vegetated	1	
Upstream Lt Ditch	Vegetated	1	
Downstream Rt Outlet	Vegetated	1	
Downstream Lt Outlet	Vegetated	1	
Downstream Rt Ditch	Vegetated	1	
Downstream Lt Ditch	Vegetated	1	
Improved Outlet Total	4	1	
Improved Ditches Total	4	1	
	<b>SRI Total:</b>	<b>56</b>

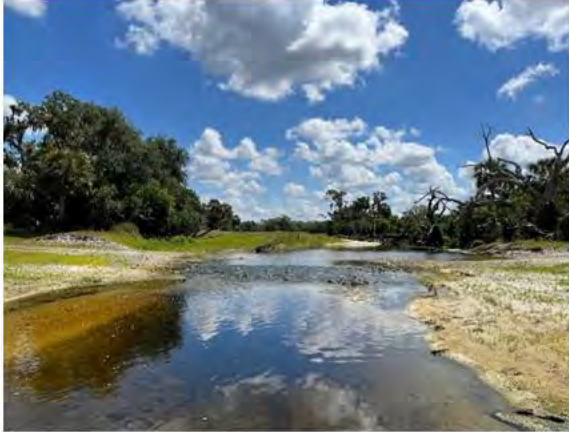
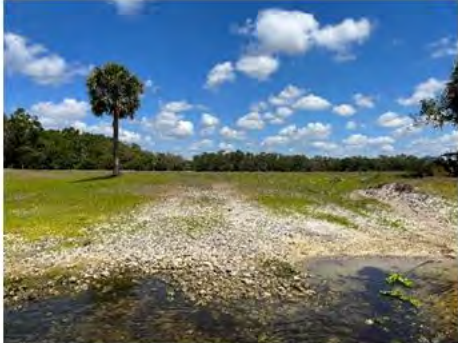
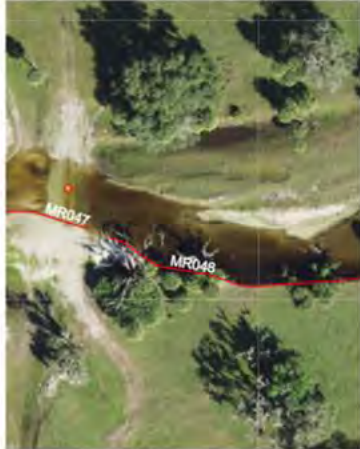
<p>Crossing Structure: Downstream</p>

Unnamed Tributary			Sediment Risk Index: 48 (Low)
Watershed: Myakka River			County: Manatee
Subwatershed: Tatum Sawgrass Swamp			Site Number: MU035
Latitude: 27.29393			LULC: Streams and Waterways, Cropland and Pastureland, Wet Prairies, **
Longitude: -82.23451			
Road Name: unnamed road			Land Owner(s): Triangle Ranch LLC

<p><b>Additional Site Features</b></p> <p>Crossing Type and Quantity: Ford</p> <p>Crossing Material: Rock</p> <p>Culvert Outfall Drop: 0 in.</p> <p>Fish Passage Barrier: Not Present</p> <p>Notes: **Freshwater Marshes</p>
US Channel Morph	C	5	
DS Channel Morph	C	5	
DS Bank Alteration	Minor/Partial	3	
Upstream Skew Angle	<5°	5	
Crossing fill condition	Good/Vegetated	5	
Inlet/Outlet Condition	Sediment Scouring	3	
Potential Eroded Vol.	<21 c.y.	5	
Soil K Factor	<0.20	5

Approach Slope Mean	>4.0%	1	
Road Approach Material	Aggregate/Native Soil	3	
Upstream Rt Outlet	Vegetated	1	
Upstream Lt Outlet	Bare Soil	0	
Upstream Rt Ditch	Vegetated	1	
Upstream Lt Ditch	Vegetated	1	
Downstream Rt Outlet	Vegetated	1	
Downstream Lt Outlet	Vegetated	1	
Downstream Rt Ditch	Vegetated	1	
Downstream Lt Ditch	Vegetated	1	
Improved Outlet Total	3	0	
Improved Ditches Total	4	1	
	<b>SRI Total:</b>	48
