Fish Kill on the Myakka River August 16, 2024

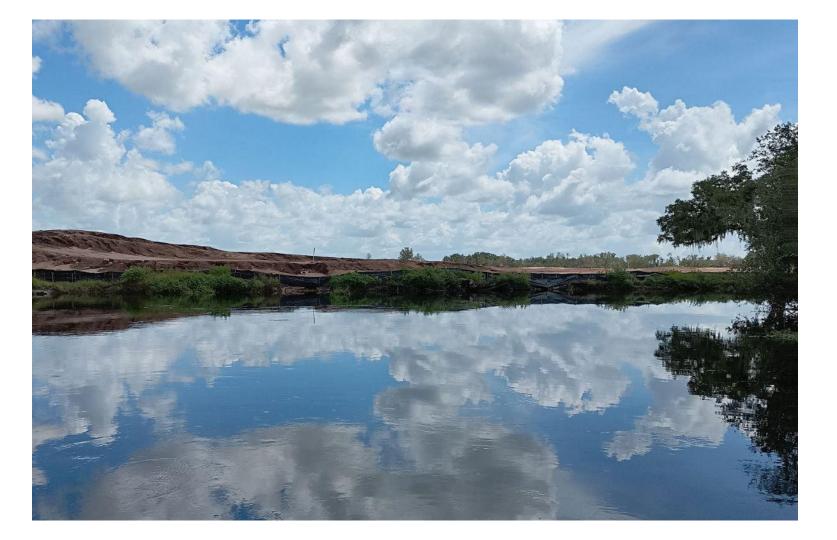
"Since the golf courses began construction we've had bad sediment flow with every rise in the river. When the water drops any low areas have 1-2 inches on average of a black nasty sediment that we've also never had before. The beaches that used to be white when the water drops are now black after each drop as well." Local resident

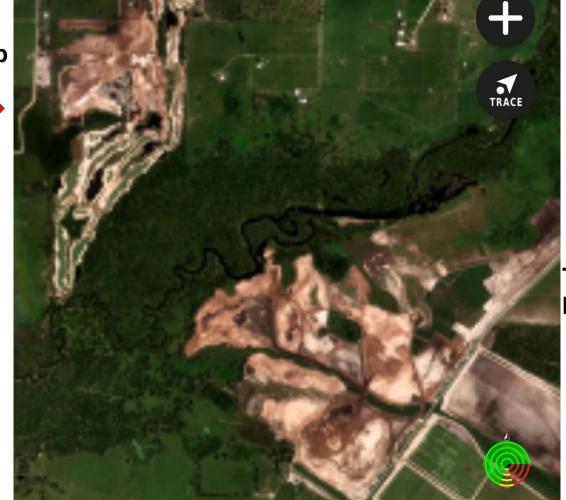
Aerial Photo July 2024

TerraNova Miakka Golf Club

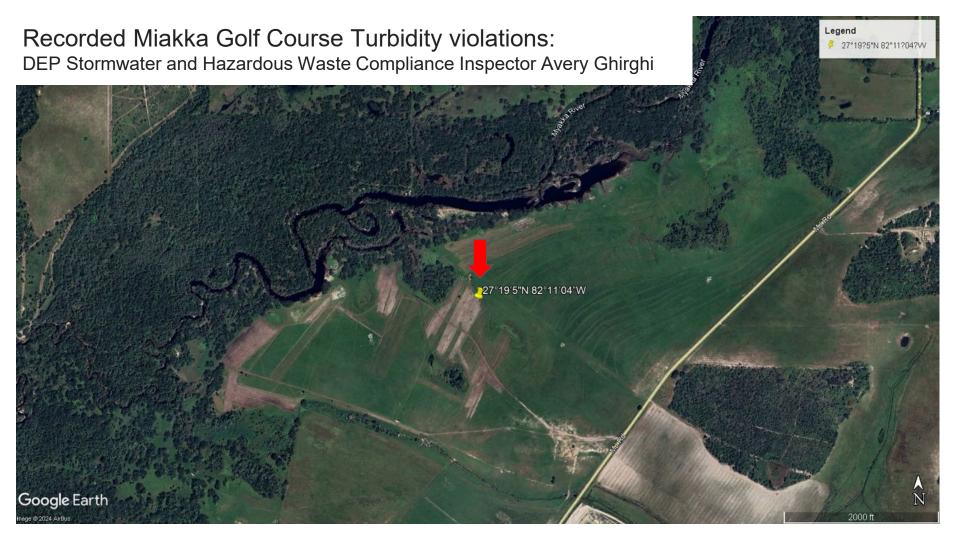
Discharge point from Miakka North into a wetland:

++++ (above meter limit) NTUs reading taken on 8/30 472 NTUs reading taken on 9/9

Background sample taken upstream at the overpass on SR-70 between Singletary and MJ Rds read 2.39 NTUs*.

*Turbidity of any water that leaves the site and impacts the water systems cannot be higher than 29 NTUs above background.
